WEEKLY INCIDENT SUMMARY

Week ending Friday 08 May 2020

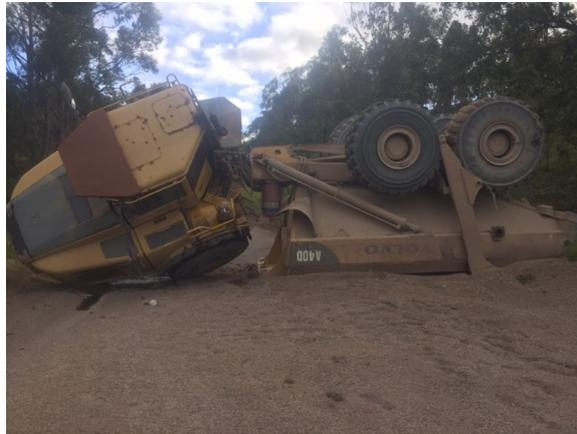
<p>A loaded, articulated haul truck was travelling down the main entry road of a quarry. The road was on a decline and was sealed. The driver tried to slow the truck using the retard brake, but the truck didn't slow sufficiently. The driver used the foot brake, but the wheels on the truck locked up, causing the truck to slide sideways and overturn. The driver was inexperienced, having only operated the truck for one week before the incident.</p> <p>The truck was travelling about 50km/h. The driver was not injured.</p>	<p>Mobile plant characteristics, including stopping distances, maneuverability and operating speeds for both the loaded and unloaded vehicle must be considered when developing control measures to manage the risks to operating vehicles.</p> <p>Mines should consider the use of speed limiting devices and the operating range of retarder systems.</p> <p>The risk of articulated trucks overturning has been highlighted to the industry by the Regulator</p>

through the following publications:

- [SB17-01 Industry reports more truck rollover incidents](#)
- [Articulated truck rollovers and falls from mobile plant](#)

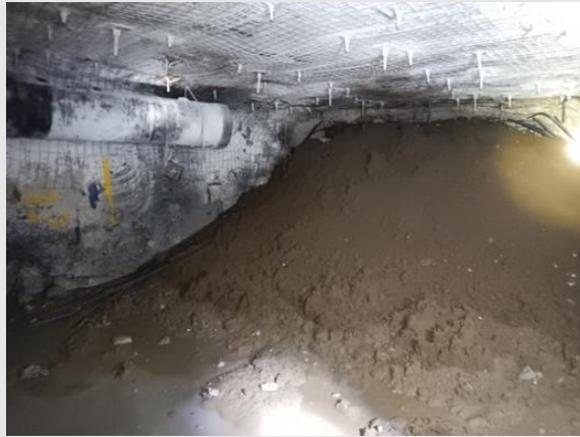
While drilling contractors were drilling a ventilation shaft from the surface of an underground coal mine, they noticed a loss of return water from the shaft. Drilling was stopped.

It was identified that a bulkhead, installed underground to isolate the shaft construction from the mine workings, had failed. Further ground movement into the shaft void destabilised the drilling rig and platform, which partially collapsed into the collar of the shaft.

The Resources Regulator is carrying out a causal investigation with the cooperation of the relevant stakeholders. A preliminary report will be published soon.
