SAFETY BULLETIN

Drill rig operator sustains a serious hand injury

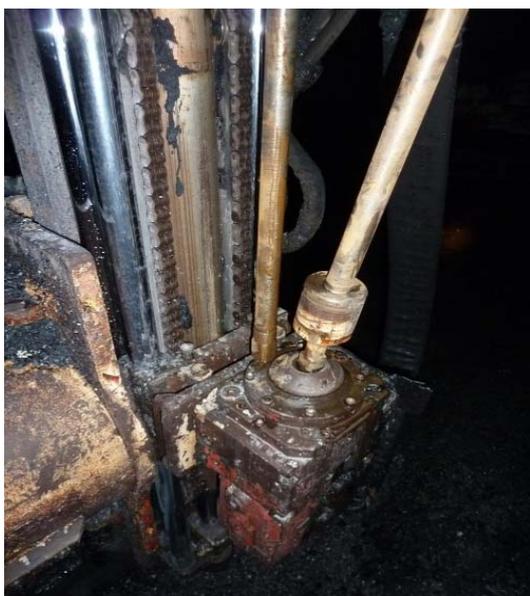
The causal factor of this incident was the inadvertent activation of the gripper jaws by the operator. The causal factors around other database injuries vary from inadvertent activation for the gripper jaws by the operator, to failure of the gripper jaws to hold the drill string from falling out of the hole.

Failure of the gripper jaws to support the drill string leads to a serious hand injury

- 1) Consideration should be given to complying with the relevant parts of the AS 4024.1-2006 'Safety of machinery' series of standards and MDG 35.1 *Bolting and drilling plant in mines.*

In particular AS 4024.1601-2006 'Design of controls, interlocks and guarding—Two-hand control devices—Functional aspects and design principles' provides specific guidance on the prevention of accidental activation and accidental defeat of controls.

- 2) Design and operational risk assessments should consider human error analysis on the particular plant in an attempt to highlight errors in design which could lead to inadvertent activation of a function that has the potential for an injury or incident.
- 3) Operational risk assessments for strata drilling equipment should be reviewed to ensure they address all the risks associated with your particular drilling process or processes.

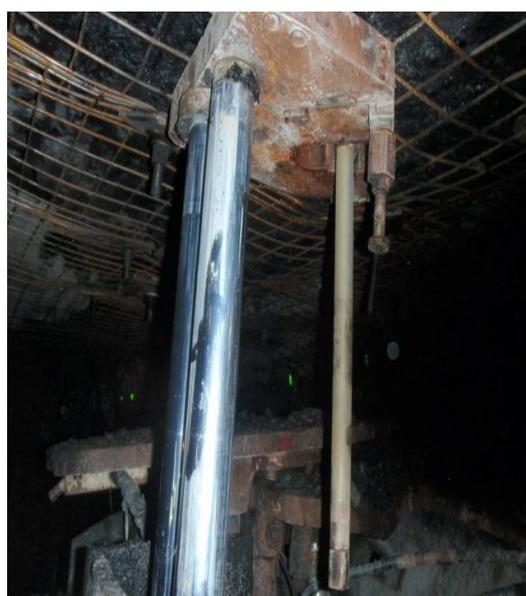
It appears the operator placed his right hand over the drill chuck and attempted to activate the water valve located on the control station. The operator inadvertently operated the gripper jaws release control lever which is located directly above the water control valve. This allowed the drill string to fall from the hole severing the operator's finger.

The control handle for both gripper jaws and water flushing are fitted with the same style handle and the movement of the flushing water 'on' control and gripper release control are in the same direction, which can lead to confusion and potential human error.

Inadvertent operation of the gripper jaw controls leads to a serious hand injury
