SAFETY BULLETIN

DATE: NOVEMBER 2019

Workers injured while installing conveyor boot ends

CM9 reference	DOC19/969192
Mine safety reference	SB19-13
Date published	7 November 2019
Authorised by	Chief Inspector Office of the Chief Inspector

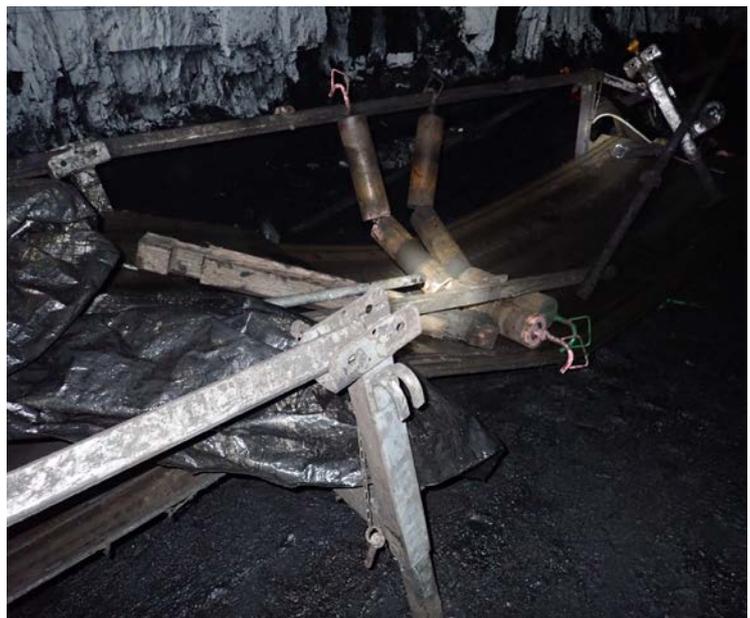
A belt move had been completed and the conveyor was running. A supervisor reviewed the location of the boot end and the loop take-up capacity and determined the boot end was not in the correct position. Tension was removed from the loop take-up. A load haul dump (LHD) machine was attached to the quick detach system (QDS) plate on the boot end and it was moved to the correct position.

A worker was checking the level of the inbye end of the boot end. The boot end unexpectedly released and moved outbye four metres. At the time, the worker was at the outbye end of the boot end. As it moved, the worker was pulled into the boot end and pinned. An emergency response was initiated. The worker was freed and taken to hospital by helicopter. The worker suffered a dislocated shoulder, lacerations and soft tissue injuries.

An investigation identified that the boot end disengaged from the QDS plate because it was not used, not engaged or misaligned.

Figure 1 The damaged conveyor structure

1. Review the risk assessment for conveyor belt extensions to confirm the risks of interactions between workers and plant is as low as reasonably practicable.
2. Review the adequacy of no go zones around attachments when connecting to LHDs.
3. Implement controls to manage the risks when an external load (such as an LHD) is applied to conveyor belts, to remove the tension in the conveyor belt.
4. Schedule workplace inspections to verify compliance with no go zones and other risk controls required to be applied to the task.

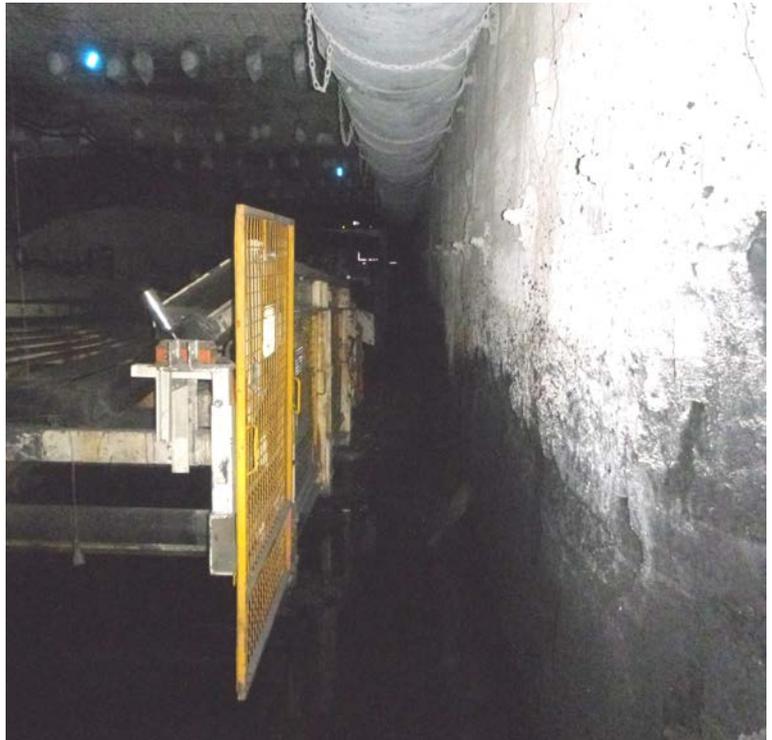
A boot end was attached to an LHD by a QDS plate and was being placed in its final position. While the boot end was raised to allow a worker to place packing timber underneath, he was not in the line of sight and couldn't communicate with the LHD operator. When the worker was about to place the timber, the boot end moved unexpectedly, pushing the worker against the mine rib. The worker was taken to hospital by helicopter and suffered six broken ribs.

An investigation identified that the boot end was on the ground when the LHD was articulated. This loaded the connection between the QDS plate and QDS horns. When the boot end was lifted, this allowed the boot end to swing towards the worker. A job hazard identification check was not completed for the task and a safe work procedure was not available to workers completing the task.

Figure 1 The boot end where the worker was injured
