# SAFETY BULLETIN

## Conveyor pulley failures initiate fires

<b>Mine safety reference</b>	SB19-14
------------------------------	---------

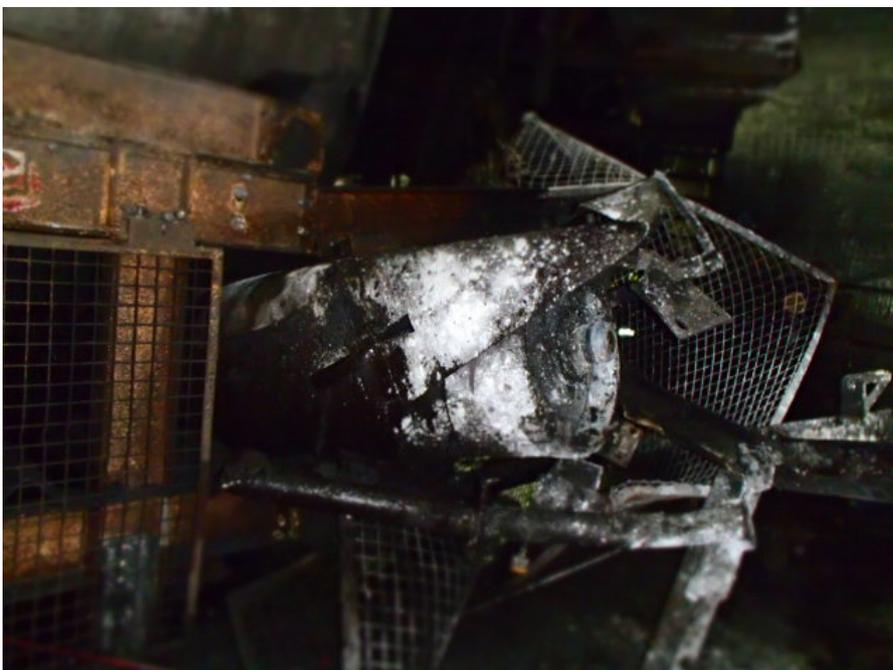
A trunk belt stopped on a lanyard trip. When a worker arrived to inspect the conveyor, the tail pulley was found seven metres outbye of the installed location (refer to figure 1 below). Molten metal was found around the mount plates. A camera was monitoring the transfer. When the footage was reviewed, a glow could be seen for 50 seconds before the failure occurred, with flashes of increasing intensity. At the instant of failure, the structure violently shook (refer to figures 2 and 3). The pulley was fitted with temperature monitoring, which showed an increase from 33°C to 45°C before the failure. A previous vibration survey did not identify any issue. The carbon monoxide monitor detected a 1 ppm rise.

*Figure 1 Failed pulley final location*

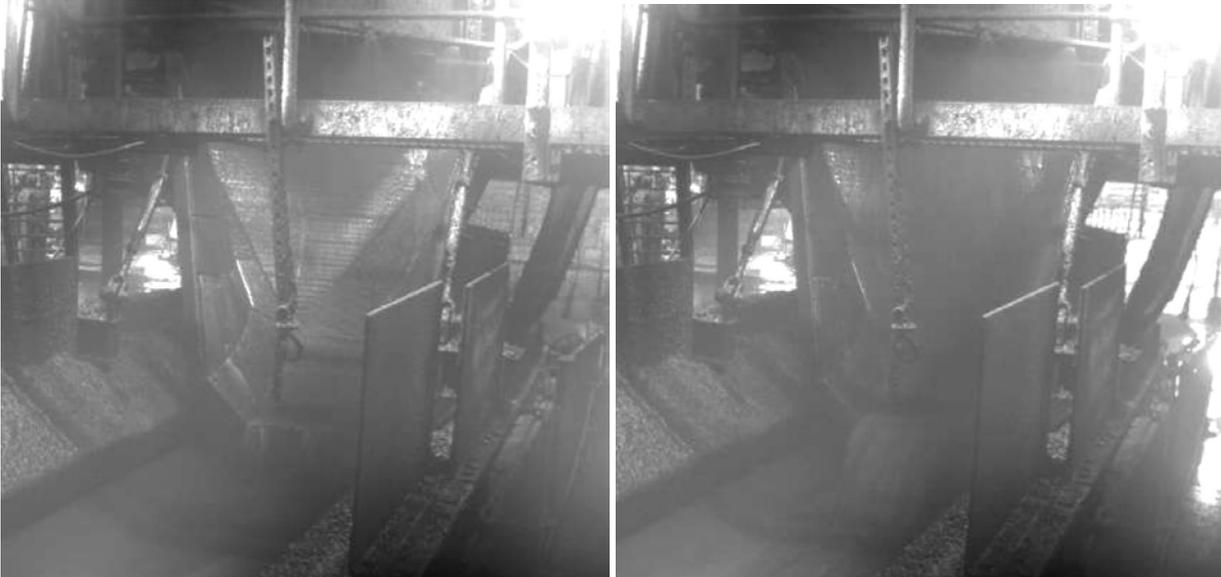
Figure 2 and 3 Transfer before the failure and at time of failure. Flash on right hand side in figure 3

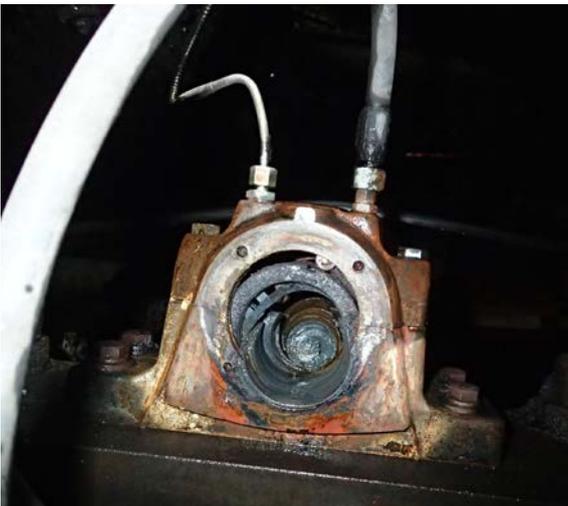
A worker was completing an inspection when he identified a hot bearing in a tension pulley. The belt was stopped and the pulley was doused with water. An investigation identified the pulley had been changed three months prior, with the temperature probe changed at that time. During the change out, the faulty temperature probe was reinstalled, with the new probe left tied up nearby. There were also issues identified where the connections for the new probe had been terminated. Following the incident, the mine audited all other temperature probes to confirm they were operational and measuring correct temperatures.

Figure 3 Failed bearing

The incorrectly installed temperature probe was not measuring the temperature of the bearing housing. At no point was it identified that the bearing temperature was not rising or decaying when the conveyor was operating or stopped.

1. Review the trip points of condition monitoring devices. Consider the location of the device, the heat source and the effect of heat soak into other materials.
2. Periodically test and validate the operation of temperature monitoring devices against the actual temperatures of components when operating.
3. Confirm adequate commissioning checks are in place for condition monitoring devices.
4. Review the location of carbon monoxide monitors. Consider potential carbon monoxide sources and the local effects of the ventilation system.
5. Review the trigger action response plans (TARPs) for condition monitoring. Confirm that any contract condition monitoring providers are aware of the TARP triggers and associated response necessary.
6. Confirm that workers know how to respond to fires on conveyor systems.
