# WEEKLY INCIDENT SUMMARY

Week ending Friday 13 March 2020

This incident summary provides information on reportable incidents and safety advice for the NSW mining industry. To report an incident to the NSW Resources Regulator: phone 1300 814 609 24 hours a day, 7 days a week.

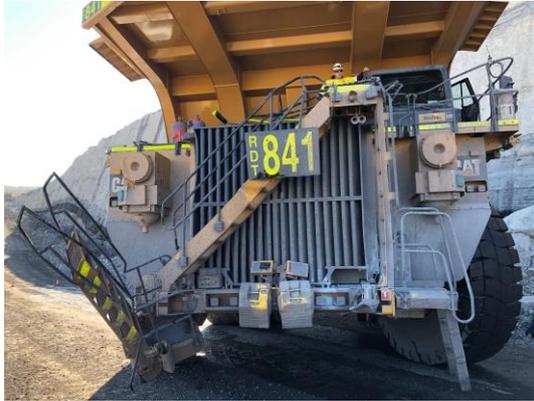
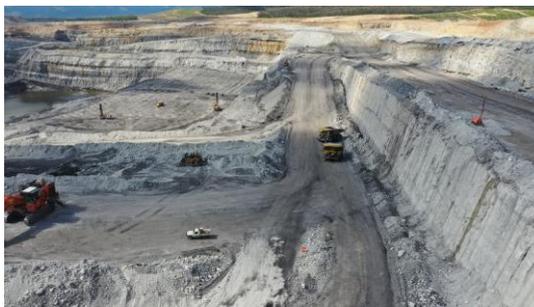
<p>Roads or other vehicle operating areas</p>	<p>Two haul trucks collided nose to tail at an open cut coal mine. There is no evidence that the rear truck attempted to brake before the collision. The operator of the rear truck was found to have a mobile phone in the truck. Neither operator was injured.</p>	<p>Whilst the cause of this incident is not yet known, mines are reminded of the need to monitor and enforce their policies regarding mobile phone usage.</p> <p>Strong consideration should be given to implementing technologies that continuously monitor and identify operator distraction, warning the operator via a tiered alarm system.</p>

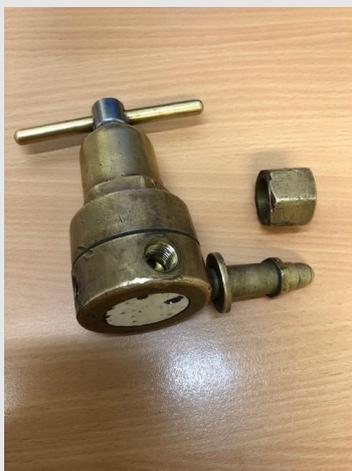
IncNot0036906  
Underground metals mine

A fitter was in the process of re-gassing an accumulator on a drilling jumbo with nitrogen, when the nut connecting the regulator and gauge on the nitrogen bottle failed. This caused the regulator and gauge to be ejected into the air. There were no injuries.

When developing control measures for the unintended release of mechanical energy, mines must consider:

- the identification, assessment, management and rectification of defects that affect the safety of plant
- the risks associated with pressurised fluids
- the inspection and testing of plant, including the testing of safety critical components.
