WEEKLY INCIDENT SUMMARY

Week ending Friday 20 March 2020

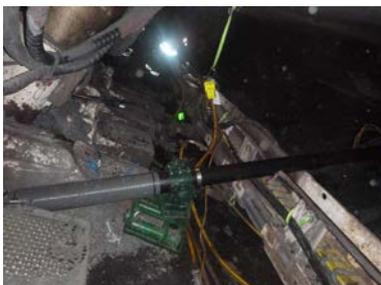
INCIDENT TYPE	SUMMARY	RECOMMENDATIONS TO INDUSTRY
Dangerous incident IncNot0036980 Underground coal mine	<p>An air operated bolting rig dislodged from the spill plate of the AFC mounting and was thrust back into the longwall walkway.</p> <p>The operator of the bolting rig jumped out of the way but was struck on the wrist. It appears the cradle was not properly attached to the pan line spill plate.</p>

<p>Operators must ensure that control measures are in place to manage the risks associated with the dissipation of mechanical energy.</p> <p>Safe work systems must be developed for people dealing with plant - including pre-inspections that identify and check mechanical safeguards used to prevent the dissipation of mechanical energy.</p> <p>Mitigating controls such as No-Go zones should be established in consideration of the energy present.</p>

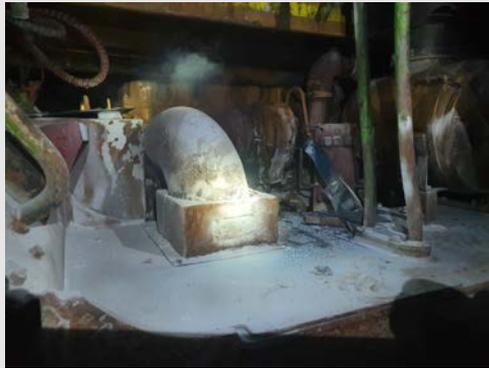
Dangerous
Incident
IncNot0036988
Underground
metals mine

An underground loader was in idle mode when the operator saw smoke and flames at the back of the machine. The operator activated the fire suppression system and extinguished the fire. It appears that the fire may have started in the exhaust box.

The cause of this fire has not yet been established.

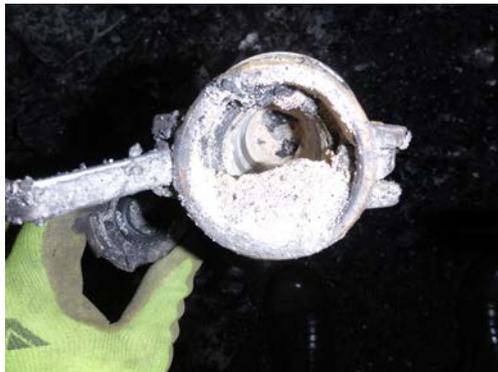
Dangerous
Incident
IncNot0036991
Underground
coal mine

While spraying a ventilation stopping with aquacrete, an operator was sprayed on the forearm. This occurred when he tried to release a hose blockage.

The grout pump had been stopped for a while and upon restarting, the hose appeared to be blocked. The operator turned off the air at the main valve and was undoing a camlock fitting, when the grout released and struck him on the forearm.

Mine operators should review how workers and supervisors are trained in recognising the potential hazards associated with all energy sources. This is especially important when there is the potential for unexpected stored energy, associated with blockages, to be released without warning.
