INVESTIGATION INFORMATION RELEASE

Worker injured on longwall support

Event: Worker seriously injured at an underground coal mine

Location: Ulan Underground Mine, Ulan NSW

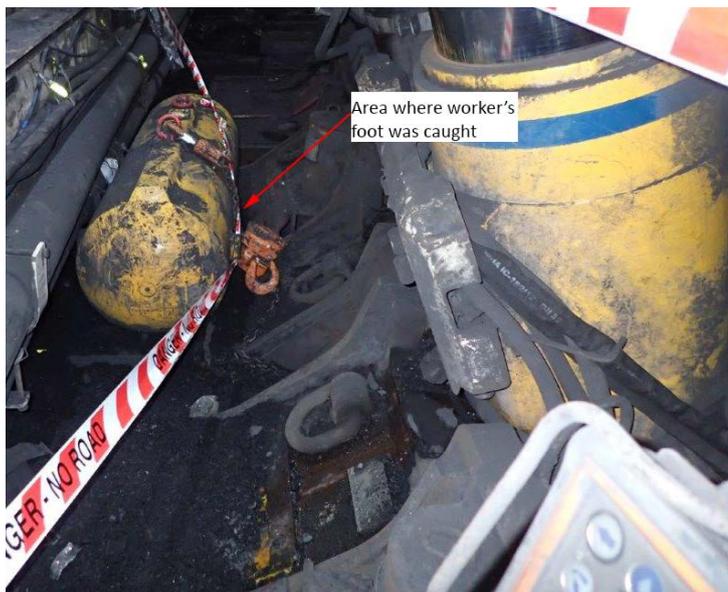
Figure 1 The replacement roof support leg on the roof support pontoon

When the shearer reached the correct location, number 44 roof support was advanced to enable the leg cylinder to be placed onto the support's pontoons. Workers did not isolate the support. The cylinder was lowered onto the pontoon and the shearer's lifting arm was stowed. Two workers planned to secure the cylinder to the roof support using a pull lift to position it. They each straddled the cylinder while standing on the pontoon of the roof support.

The shearer driver began driving the shearer towards the tailgate. This caused an advance prime which was paused at roof support 44 to initiate, thereby advancing the support. A 150-millimetre pump-out line on the rear of the pan line made contact with the unsecured cylinder, pushing it onto one of the worker's lower leg and foot. His lower leg and foot were pinned between the leg cylinder and the roof support.

The risks associated with automated equipment must be considered when developing control measures. The control measures must contain steps for effective isolation and control of all energy sources. Modern longwalls have several forms of isolation. They include electrical and hydraulic isolations that may be applied on roof supports or at the maingate. The range of tasks that may be carried out under each of these types of isolation must be determined by the mine operator.

The functioning of automation used on longwall equipment can vary between manufacturer's, mines and during operations (i.e. the change from sequential support advance to multiple support advance). It is important that all workers on the face understand the automation sequence(s) and what supports may automatically advance. All supports in the area from the last sequentially advanced roof support to the trailing cutter drum of the shearer should be assessed as being capable of automatic advance (that is, a roof support advanced during multiple support advance out of the normal sequence should not be considered the last advanced support).
