# WEEKLY INCIDENT SUMMARY

Week ending Friday 27 March 2020

This incident summary provides information on reportable incidents and safety advice for the NSW mining industry. To report an incident to the NSW Resources Regulator: phone 1300 814 609 24 hours a day, 7 days a week.

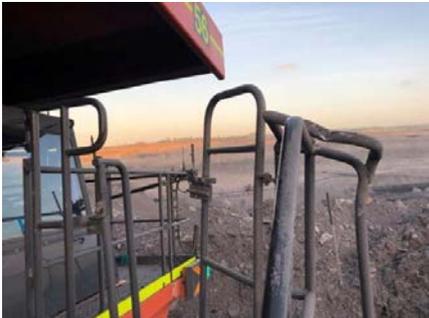
<p>Roads or other vehicle operating areas</p>	<p>A nose to tail contact has occurred between two haul trucks.</p> <p>One truck turned a corner and stopped, waiting to turn onto a dump access road. The second truck turned the same corner, but did not notice that the truck in front was stationary.</p> <p>The contact occurred at low speed. The hand railing on the rear truck was damaged, but there was no contact with the cabin.</p>

<p>Mine operators must conduct an assessment and identify areas where there is a risk of collision. When developing risk control measures, the hierarchy of controls must be considered.</p> <p>Positive communication requirements must be implemented where a risk of collision remains.</p> <p>Systems such as collision detection and avoidance systems, visual aids and segregation should be implemented before relying on procedural controls.</p>

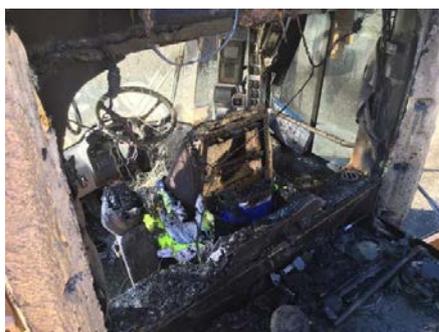
A dump truck operator observed oil on the ground under a front-end loader (FEL) and advised the operator. Some 30 seconds later, the excavator operator, who was loading the dump truck, saw flames on the FEL and instructed the operator to get out of the loader. The fire suppression system and a water cart were used to extinguish the flames. The FEL was extensively damaged.

The cause of this fire has not yet been established.

For further information refer to our dedicated website page about [fires on mobile plant](#)

Refer to our position paper: [Fires-on-mobile-plant-position-paper-October-2019](#).

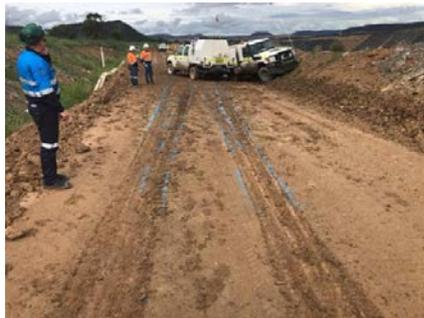
Two light vehicles (LV) came into contact while driving on a designated LV roadway. The roadway was wet and the vehicles were heading towards one another when one began to slide. The second LV took evasive action and mounted a windrow to avoid the oncoming LV, but the sliding vehicle made side contact with the other vehicle. No one was injured.

All mines must consider the hazard of speeding while driving. Vehicles should be operated at a speed that is appropriate to the prevailing conditions.

Engineering controls need to be considered to minimise this risk, including the use of speed monitoring and alarms.

Segregation between vehicles travelling in opposite directions should be considered when developing the principal hazard management plan for roads and other vehicle operating areas.
