INVESTIGATION INFORMATION RELEASE

Worker injured when pulling electrical cable with an integrated tool carrier

Incident date: 1 September 2020

Location: Cadia Valley Operations (CVO) via ORANGE, NSW

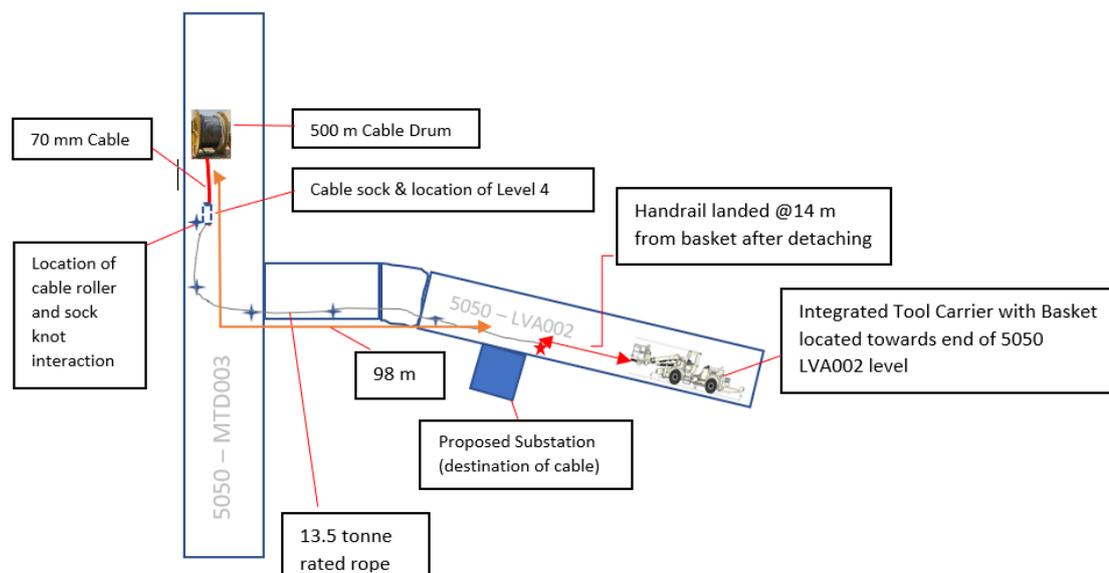
On the evening of the 31 August 2020 at approximately 6:30pm, a group of workers (electricians) were given instructions to install a high voltage (HV) cable in an underground part of the Cadia East Mine known as the 5050 level. A drawing of the proposed method is shown in figure 1.

Figure 1 Layout of the 5050 level at the location of the task

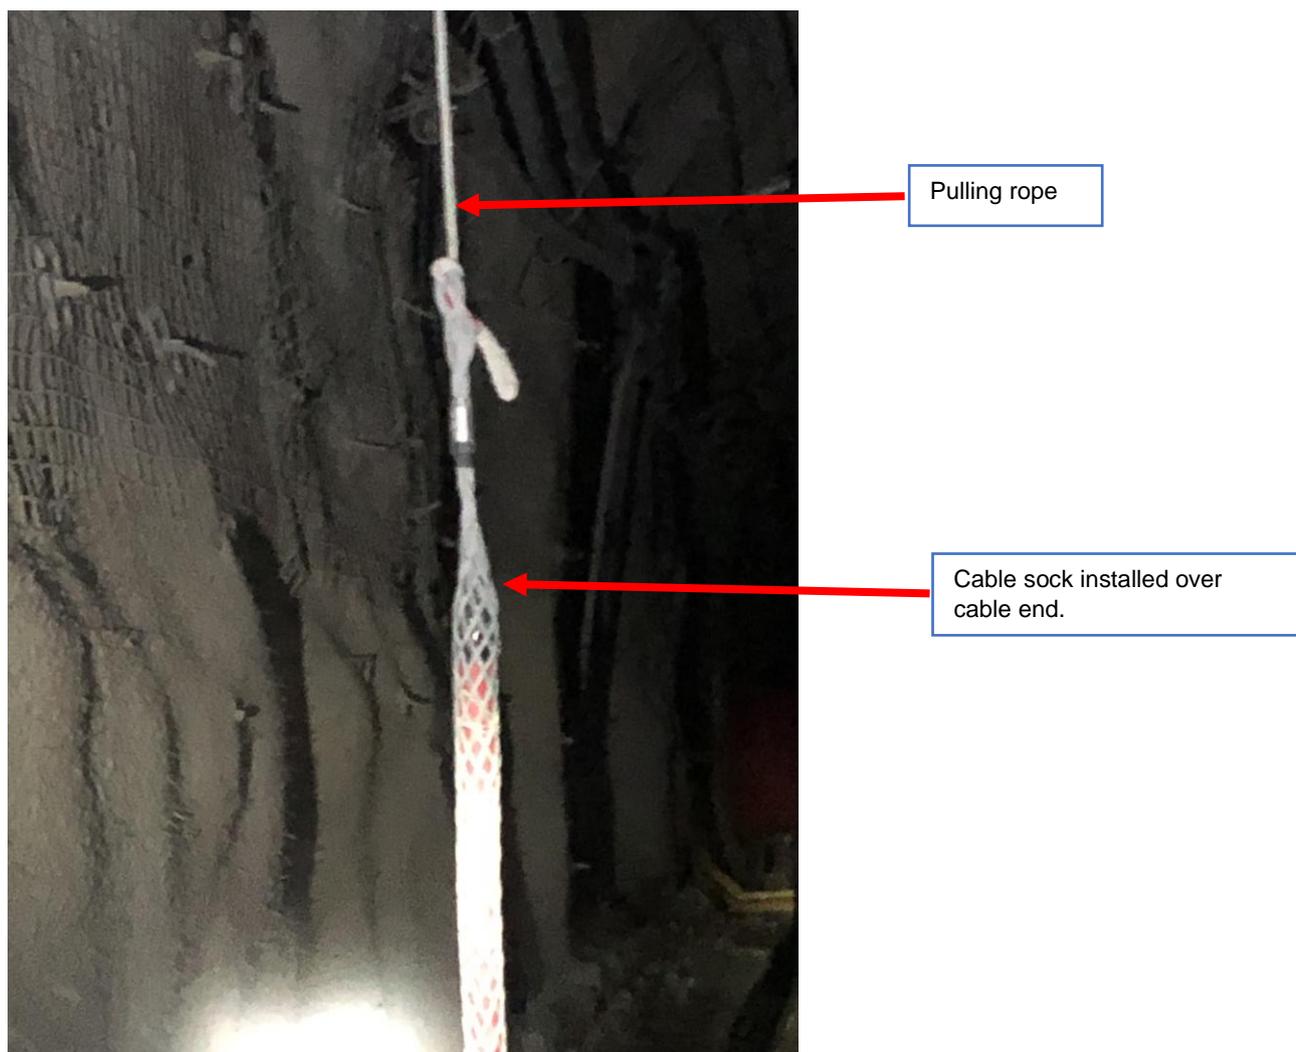
At around the same time, an electrical supervisor arrived at the cable location to check on progress and helped the other worker to attach the rope to the cable pulling sock, which had already been attached to the HV cable. A picture of the cable and sock pulling arrangement is shown in figure 3.

Figure 3 Cable sock over the HV cable connected to the pulling rope

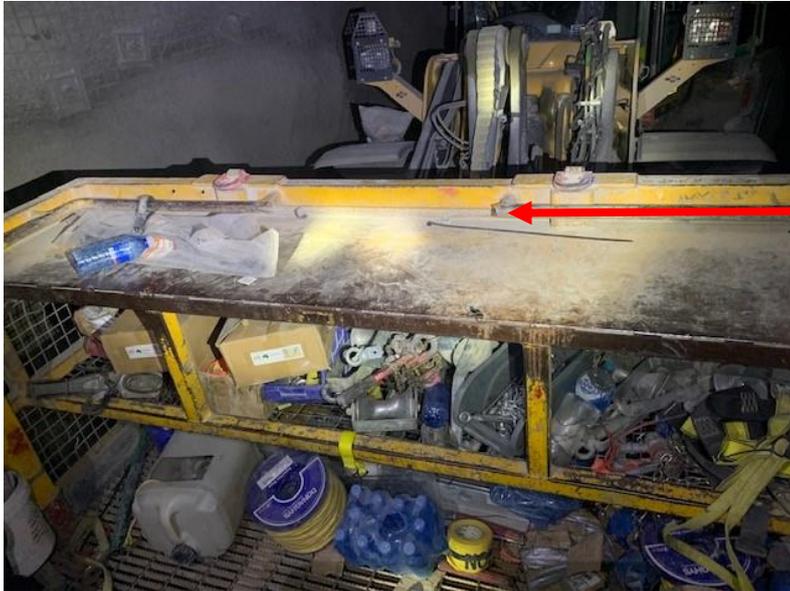
At the other end, two workers attached the rope to a tubular rail section located within the man-basket. After an adjustment was made to the location of the pulling rope with the installation of an additional roller, the crew was ready to start the cable pull. Figure 4 shows the location of the section of handrail that was on the ITC side of the man-basket and figure 5 shows a cable roller used in the work task. It is

Figure 4 Man-basket with missing section of handrail

The use of any part of a man-basket, including a section of handrail for a towing anchor point, was not appropriate. Regardless of the lack of a documented job procedure, the workers, including the electrical supervisor, should have been aware of this. The working at heights procedures at the mine stated that the handrail in the man-basket was not suitable for a harness attachment point. It is reasonable to

expect that a worker could estimate that the forces associated with towing would significantly exceed those associated with working at heights, thus deeming the handrail unsuitable for towing. The workers had not turned their mind to a potential failure of the handrail, given their positioning in the man-basket during the task. A defect (bend) in the handrail had also been present for about six to seven years further highlighting the possibility of the handrail failing during this task.

It was identified during the investigation that no anchor points within the man-basket had been subjected to a pull test or NDT testing, regardless of calibration tags being attached and a rating applied (i.e. safety harness anchors are rated to four tonne). It was further identified that the last monthly inspection carried out on the man-basket required the maintenance worker to visually inspect for cracks, damage, wear, corrosion and sharp edges, however, the deformed and corroded handrail was not identified as a defect. Had this section of handrail been identified as needing repair, it may have prompted an investigation as to why it had permanent deformation, and possibly uncovered prior improper use.

- Engineering rated anchor points to the work basket.
- Installation method to include load cell in the work basket to understand the loads to the basket during cable installation.
- Designing and testing a 'fusible link' (predictable failure mode) to prevent over tension of the basket structure.
- **Administrative**
 - Conducting a robust risk assessment for the conduct of cable installations.
 - Developing a SWI for the conduct of cable installation.
 - Integration of work platform maintenance scheduling to be reviewed to ensure it sits with the execution teams plan.
 - Reviewing qualifications required for the conduct of cable installation.

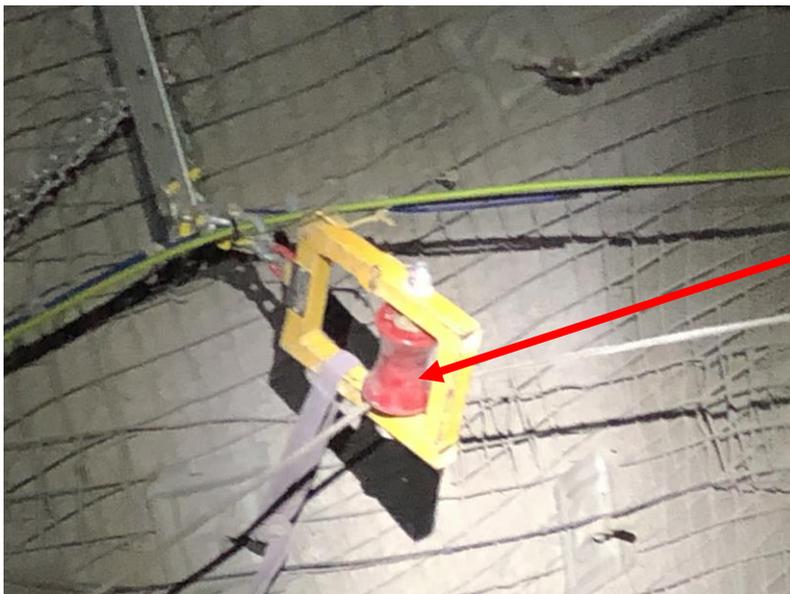
evident in figure 5 that the rope that was attached to the ITC man-basket and cable had slipped off the roller and was likely to have provided extra tension to the line during the pull.

Figure 5 One of the rollers used for the cable pulling task

The cable rollers used in the task were not fit-for-purpose for pulling cable around a corner. Photographic evidence from the incident suggests that the rope attached to the cable had become snagged in at least one of the cable roller axles (refer to figure 5). It is assumed the snag was a contributing factor of an unexpected tension applied to the rope and anchor system (handrail) used in the task.

- Elimination
 - Developing a procedure that eliminates the requirement to use rope to pull the cable through rollers.
- Substitution
 - Identifying /removing/replacing cable rollers extensive side gaps.
- Engineering

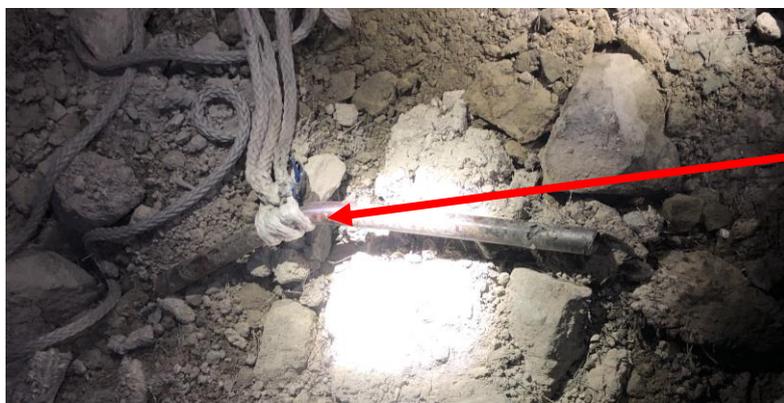
stop, while another worker at the drum end advised the ITC operator by radio to stop the task after noticing the rope binding up in a roller. At this point, the tension applied on the rope was enough to deform the tubular rail section it was attached to in the man-basket. The rail section catastrophically failed and recoiled as a result of the stored elasticity in the rope. A picture of the rope and failed tubular rail section at its final resting place is shown in figure 6. One of the workers was in the direct line of fire and recalls hearing a ‘cracking/ripping’ noise and then suddenly feeling ‘winded’ and breathless. He reported being overcome by pain and was immediately assisted by his co-worker. The co-worker realised what had happened and called in an emergency on the radio.

Figure 6 The failed tubular rail section located some distance from the man-basket

Rope connected to the failed tubular rail section.

The investigation also found this task had been regularly undertaken prior to the incident and that the handrail had been used as the anchor point, as shown by an existing prominent bend in the handrail. A close inspection of the failed section of handrail also found evidence of prior decomposition of the metal. The integrity of the handrail had been compromised for some time and this was not identified by the workers.

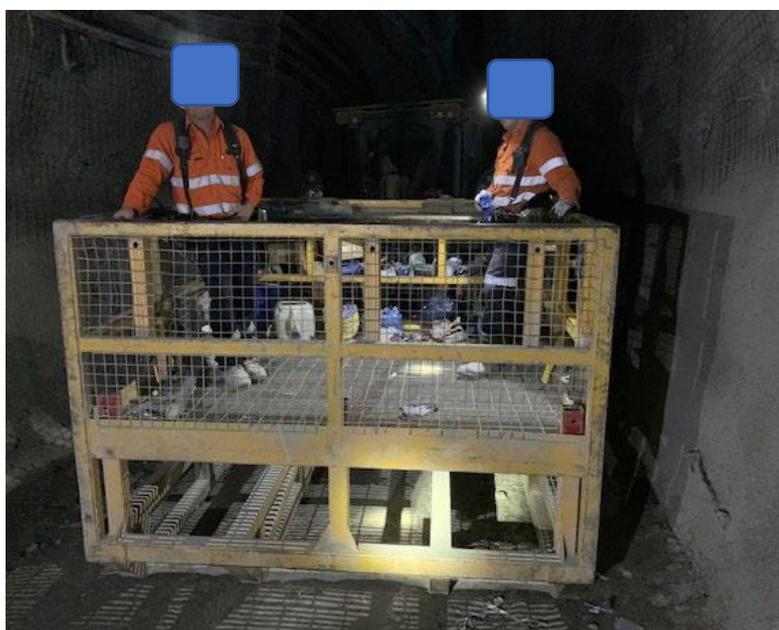
The worker suffered injuries consistent with blunt force trauma to his left torso and was transported to Orange Hospital via the mine’s ambulance. Figure 7 shows the approximate location of the workers in the man-basket at the time of the incident.

Figure 7 Approximate position of the workers in the man-basket during the task
