# Investigation Report

Serious injury involving roof bolter at  
AUSTAR COAL MINE on 3 March 2008

Report prepared for the Director General of NSW DPI.

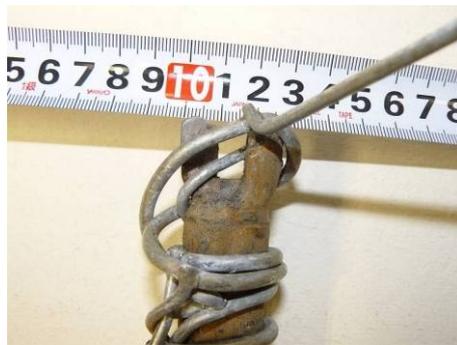
**Photo 1**

The incident occurred because the twin wing drill bit was able to engage the roof mesh, and the measures to prevent unplanned rotation of the drill steel were inadequate. There were also insufficient safeguards to ensure separation at all times between the workman and moving powered equipment.

Result of the drill rotation incident on 3 March 2008

A 27mm twin wing drill bit and drill steel that has engaged a strand of rib mesh.

Mesh is wrapped around drill steel after rotation occurred

Twin wing drill bits were withdrawn from service. A trial with a full spade bit proved unsuccessful. A modified spade bit with a smaller indent was introduced that is expected to reduce the likelihood of mesh becoming caught.

A designated guide steel was introduced with the drill bit thread removed so that a drill bit could not be fitted to it.

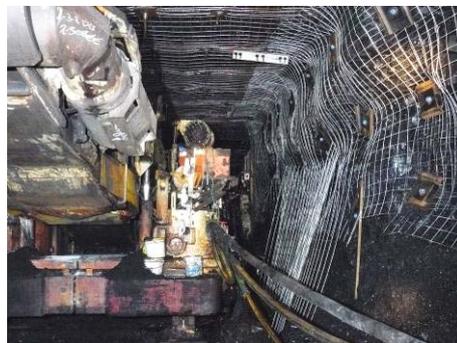
**Photo 2**

Austar developed a practice of installing strata support to reduce the risk of rib spall by bolting sheets of steel mesh to the roof and sides. The practice relied on overlapping a rib mesh sheet with two overlapping roof sheets and simultaneously pinning the three mesh sheets to the roof with the outer roof bolt.

Incident scene showing roadway conditions and installed strata support on the right hand side rear of the continuous miner.

Visible is the overlap of roof and rib mesh at the roof horizon.

Development strata support plans have been revised so that rib mesh is now not pinned by outer roof bolt and rib mesh is not required to overlap the roof mesh.

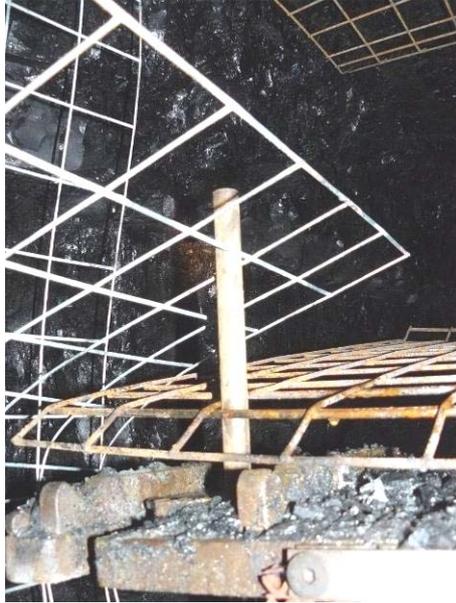
**Photo 3**

1.3m guide steel without a drill tip attached located in the drill rig on the left hand side of the continuous miner as found following the incident.

The guide steel locates the roof mesh and rib mesh above the continuous miner temporary roof support.

The guide steel is then used to locate the third sheet of mesh as seen at the roof level.

No documentation was sighted for preventing the use of a drill steel with drill bit attached and used as a guide rod.

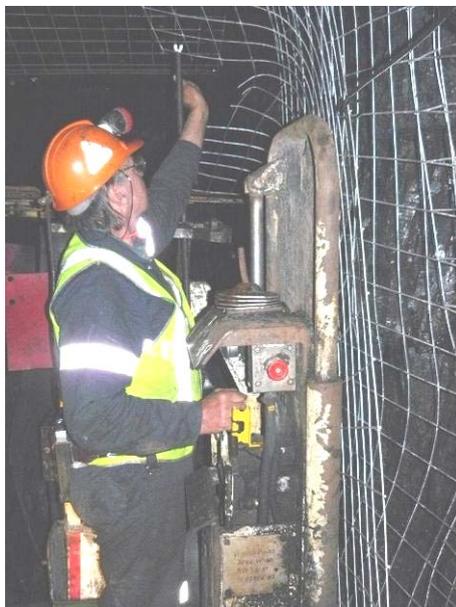
**Photo 3**

Simulation of the approximate position of McSporran's left arm in relation to the drill steel and rib mesh as demonstrated by Inspector of Mechanical Engineering W. Koppe.

The rib mesh sheet wrapped around the twin wing bit and as a consequence pulled McSporran's left hand and arm into the rotating drill steel.

McSporran's left forearm was broken and with severe muscle and nerve damage. The lower left arm was later amputated at the hospital.
