MINE SAFETY

INVESTIGATION UNIT

Serious Injury – Roof Bolting – 3 March 08

Serious Roof Bolting Injury

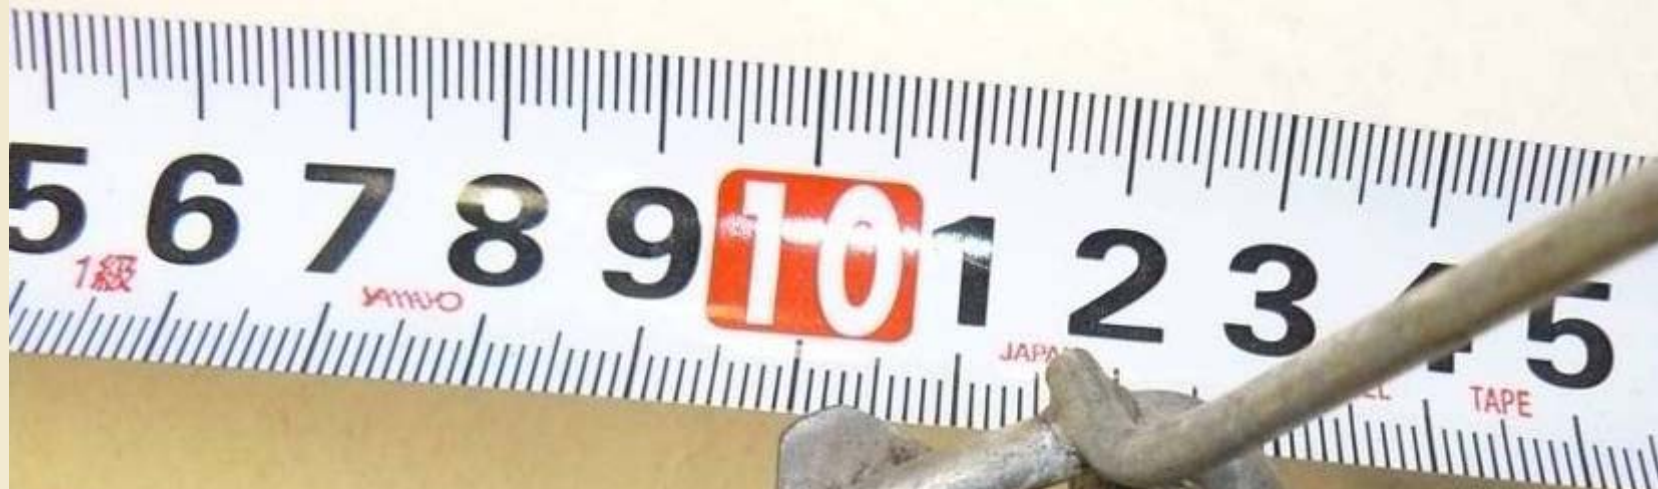
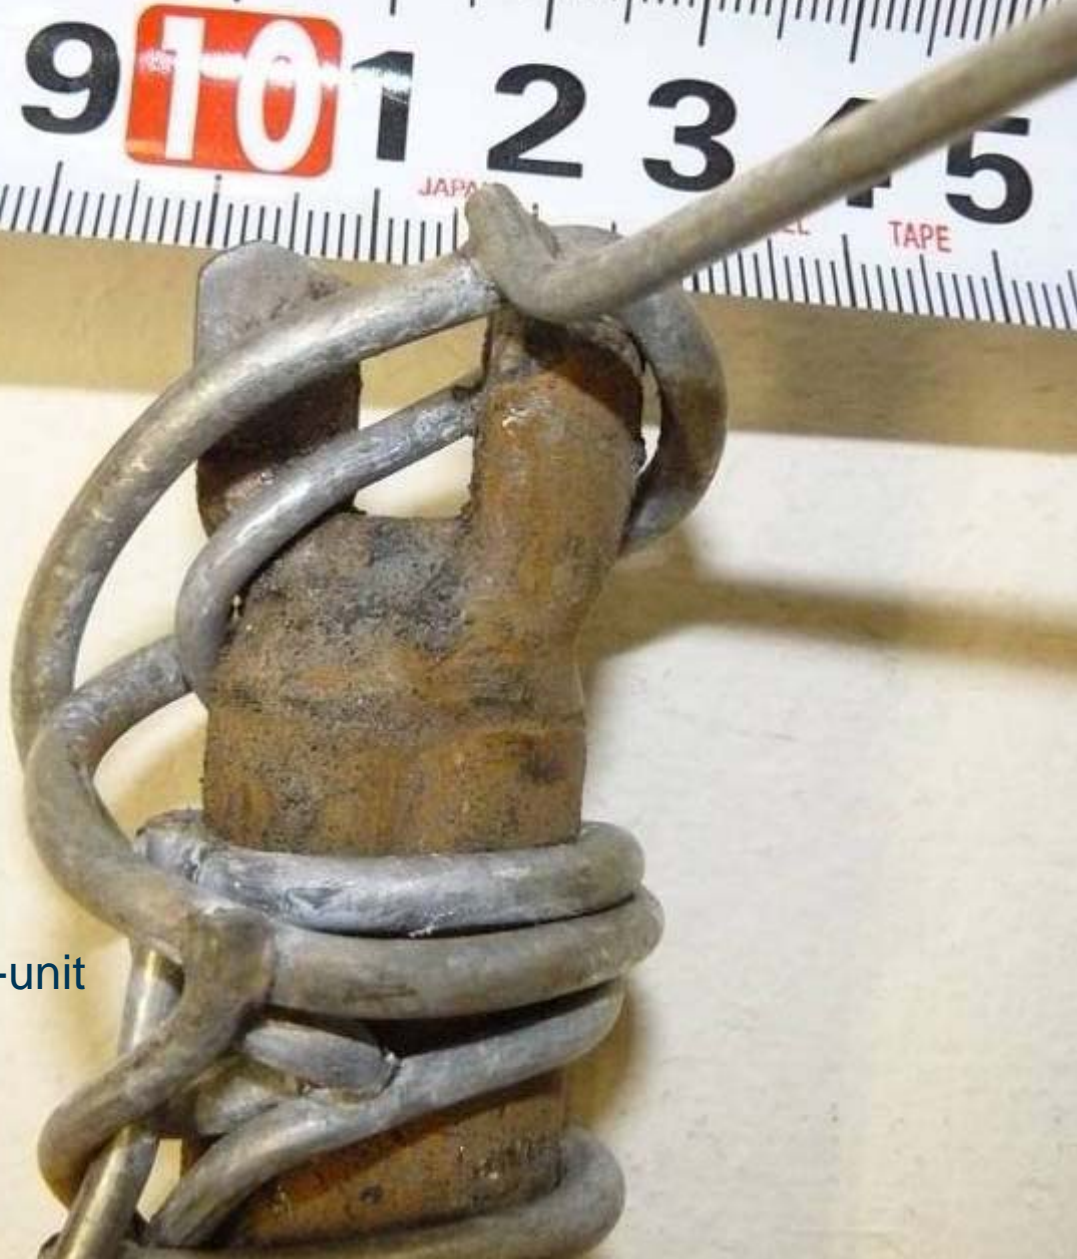
- Incorrect drill steel used to locate mesh.
- Inadequate measures to prevent unplanned operation of rotation.
- Insufficient safeguards to ensure separation of mineworker from moving parts.

- Risk assessment and implementation of risk controls for moving machinery
- Application of standards such as AS4024 and MDG35
- Bolting rigs that need both hands to be on the controls to operate it.
- Control handles that are segregated and readily identified by shape.
