PLANNED INSPECTION PROGRAM

# **Fires on mobile plant at open cut coal mines**

November 2018

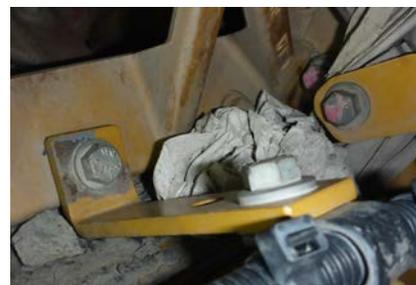
**Issue:** Areas of concern were - housekeeping in the operator's cabin with loose rags and paper towels used for window cleaning, rags found on the floor or behind seats, paper towels washed down into areas adjacent to engines on dozers, grease around centralised grease pumps on excavators, minor miscellaneous oil leaks.

**Response:** Ensure windscreen washing facilities provided by the OEM are serviceable in the first instance. Cleaning liquids should be non-combustible. Waste containers for cleaning materials should be provided for in-cabin. Paper products should be collected before washdown. Grease spills should be cleaned up at the first available opportunity.

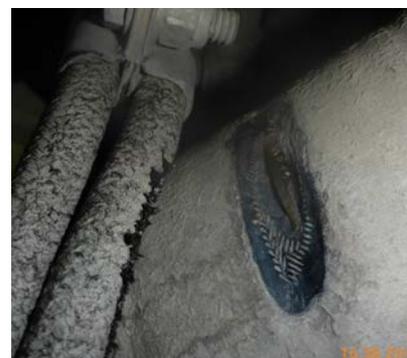
Dozers scored poorly with respect to hose management particularly in the area under the operator's cabin known as the 'hell hole'. A condensed network of hoses showed common occurrences of rubbing of mainly hydraulic lines but diesel fuel lines as well. Rubber barriers between the engine compartment and under cabin area were found damaged and split.

**Response:** In complying with clause 9<sup>4</sup>, mine operators must manage risks to health and safety associated with uncontrolled fires being initiated or fuelled by plant.<sup>5</sup> Mines should implement rigorous processes to verify the effectiveness of all risk controls, including inspections for hydraulic hose installations. Inspections and maintenance must be carried out in accordance with manufacturers recommendations. Additional time for inspections of difficult to access areas and quality oversight by supervisors is required for areas known to be common causes of fuel sources resulting in fires. Haul

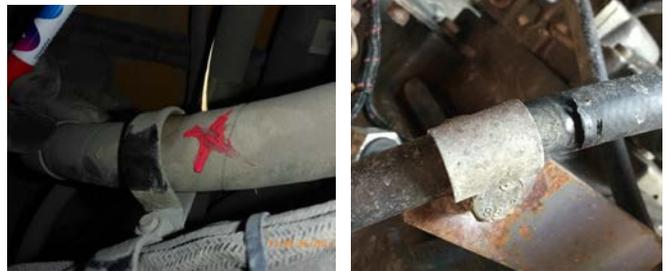
Inspections found many instances of incorrectly sized P-clamps or P-clamps, which had degraded plastic coatings allowing hose movement and damage.

**Response:** Hose segregation and security is a recognised control measure for the prevention of hose failure. Mines should make a range of P-clamps readily available for maintenance personnel to access to maintain the effectiveness of this control measure. Refresher training of workers should be used to reinforce the importance of correct selection and fitment of P-clamps.

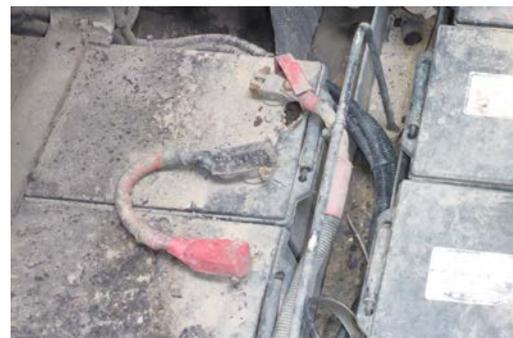
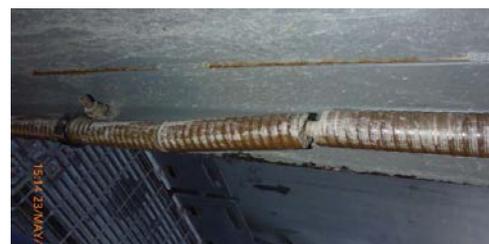
Areas of concern include terminal covers missing from alternators, starter motors and some battery positive terminals. Battery cover support stays were often found to be unserviceable.

Mechanical protection conduits for low voltage control cables for fire suppression systems were found cracked and broken.

Cable glands pulled out of plastic junction boxes compromising cable protection and ingress protection (IP) rating.

**Response:** When developing control measures for fires initiated or fuelled by plant, electrical ignition sources must be considered. Mine operators should ensure protection devices against short circuit and arcing, or sparking are maintained in a fit for purpose condition. This includes boots over positive and negative battery terminals and other full current demand devices. Workers should be encouraged to use defect reporting systems for safety devices such as stays to prevent crush injuries from heavy panel doors or covers.

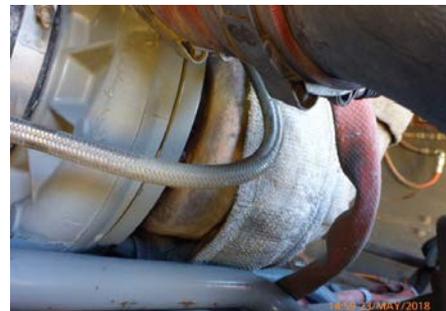
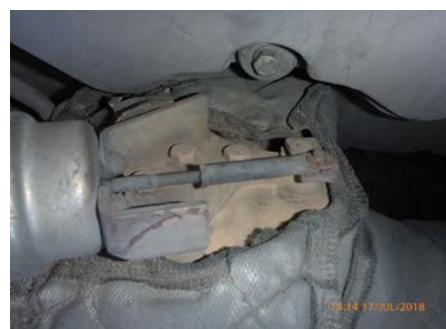
At most sites, examples of exhaust lagging in a non-fit for purpose condition could be found. Evidence of existing or repaired exhaust leaks could be seen at joints in the lagging. Lagging removed for service or repairs had not been re-installed correctly leaving exposed hot surfaces or was not designed for full concealment of the ignition source so far as is reasonably practicable.

Metal 'barbeque' plates over engines were not evaluated for surface temperature but, as the name suggests, appear to get quite hot and may be an ignition source in themselves.

**Response:** When developing control measures for fires initiated or fuelled by plant, high surface temperature ignition sources must be considered. Hot surfaces on engines or components driven by the engine should have their maximum operating temperature measured.<sup>6</sup> Metal covers or shields installed to act as a barrier between hot surface should be evaluated for surface temperature to ensure a new hazard has not been created. Insulated lagging type controls should provide the most complete coverage possible. Thermography or similar temperature measurement should be used to verify control effectiveness after installation as new and during the products lifecycle. Mine operators should provide detailed information for maintenance to maintain lagging in a fit for purpose condition and to allow defects to be recognised and actions to apply.

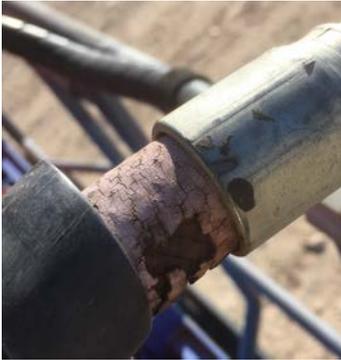
1. Delivery hose deteriorated by sun exposure

- the routing of fluid delivery hoses away from heat and direct sunlight so far as is reasonably practicable.
- the inspection and replacement of fluid delivery hoses made unserviceable engine bay heat or exposure to sunlight.
- routing and securing of fluid delivery hoses away from sharp metal edges or abrasive objects which could result in failure of the hose

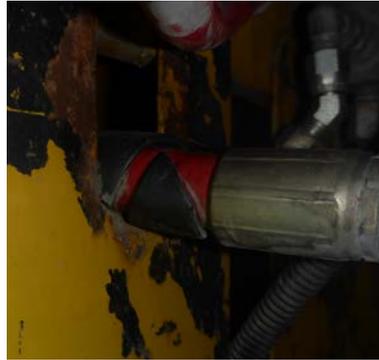
2. Delivery hose contacting sharp metal edges

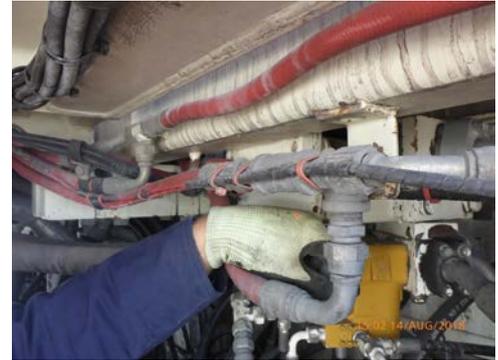
3. Fire wire cable tied to delivery hose with spiral wrap providing thermal insulation

- support and routing fire trip wires or loss of pressure signal tubing with the appropriate stand-off bracketry to eliminate the use of spiral wrapping or conduits which could affect the earliest possible detection of fires
- gauges need to be readily accessible with a clear lens for operators to conduct pre-use inspections effectively.

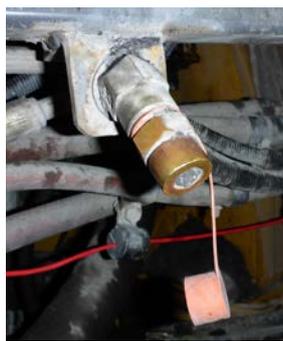
4. Nozzle cap not fitted leading to poor spray performance

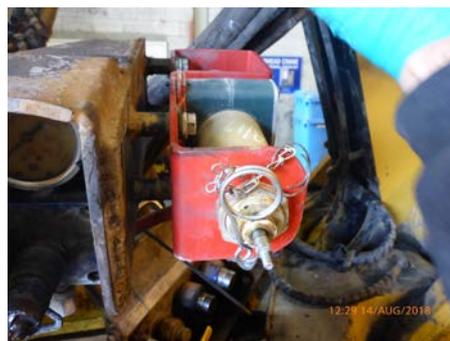
5. Activation point with tag and button missing at rear of dozer

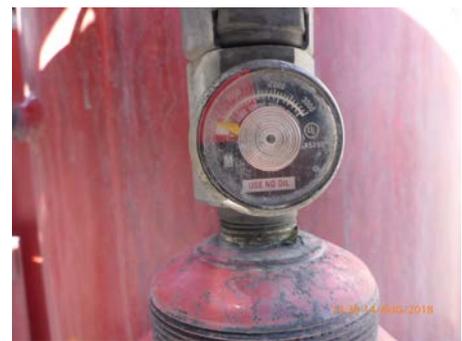
6. Poor access to read gauge leading to unserviceable fire suppression system going undetected

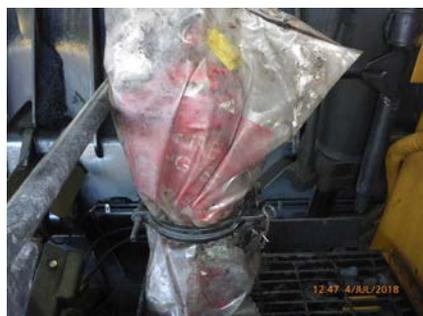
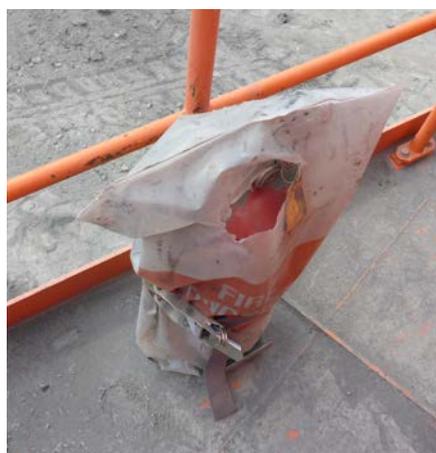
- plastic bags preventing ease of gauge inspection
- two extinguishers found under charge pressure (of about 180 checked)
- opaque lens
- third party inspections were less than adequate

**Response:** When developing control measures for the suppression of fires fuelled by plant, mines should implement processes to verify the effectiveness of controls including fire extinguishers. For example: inspections to verify the service provided by fire safety sub-contractors or safety observations of pre-use inspection performed by operators. Consideration should be given to the suitability of simple plastic protect bags for externally mounted fire extinguishers in dusty environments.
