# INVESTIGATION INFORMATION RELEASE

## Worker injured releasing jammed conveyor chain

**Incident date:** 5 February 2019

**Location:** Springvale Colliery, Lithgow, NSW

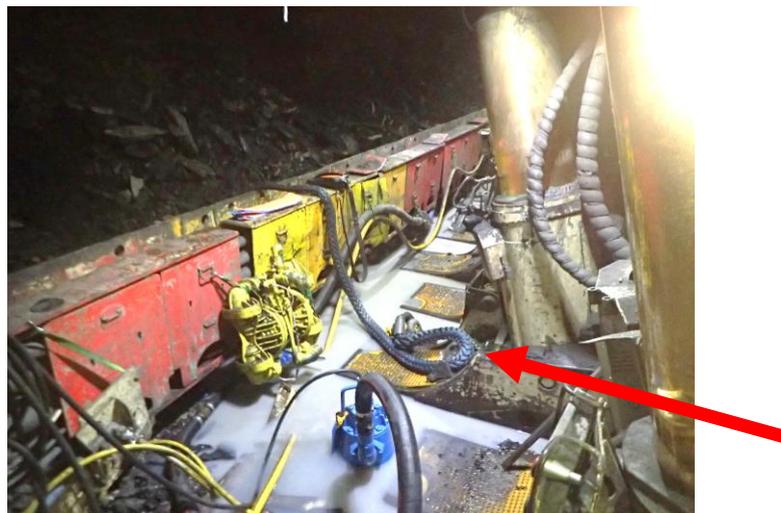
Figure 1: Location of worker struck by the recoiling shackle and blue Amsteel® rope

Shortly after the load was applied to the towing assembly by the shearer, the Rud link failed, the bow shackle and rope recoiled back towards the three workers located at the maingate. The bow shackle struck the shearer operator on the lower right leg. The connection point on the shearer was located approximately 22metres (15 roof supports) from where the injured shearer operator was located.

6. Safe standing zones must be established to account for component failures within the system.
7. Mine operators should review [SA04-09 Broken chain connector results in serious injuries](#)

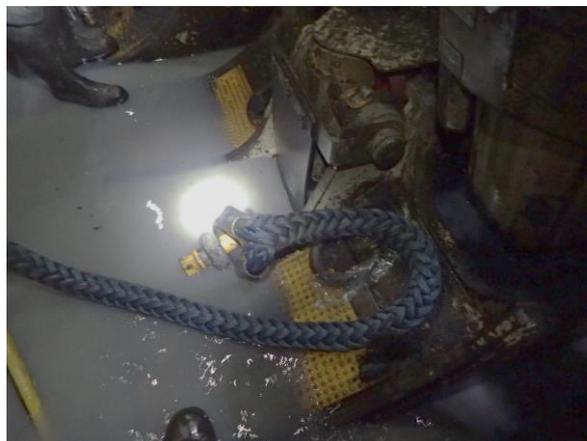
Figure 2: The 35t WLL bow shackle and blue Amsteel® rope on the roof support pontoon

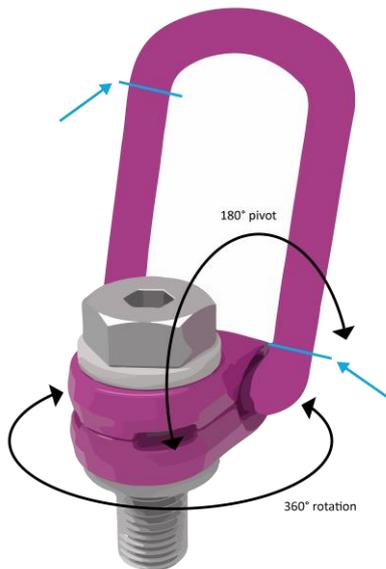
- The Rud link was as Rud VLBG, 8t lifting capacity with an M36 Property class 10.9 bolt.
- The Rud link had fractured transversely at two diagonally opposite corners. (refer figures 3 & 4)

Figure 3: Similar Rud bolt on lifting point. Location of fracture indicated by blue arrows

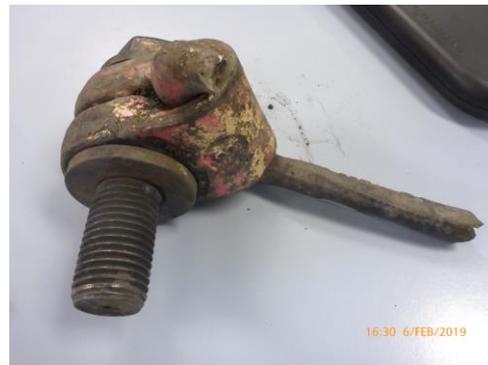
- Both fractures exhibited overload fracture over the entire fracture surface. There was no evidence of fatigue or other pre-existing cracks on either fracture surface.

Figure 4: The failed incident 8t Rud link (source NSW Resources Regulator)

4. When planning a task involving lifting or towing, the rating and yield load of all components, including the connection points, must be considered in the design of the lifting or towing system. Additionally, the structure supporting the connecting point should also be considered.

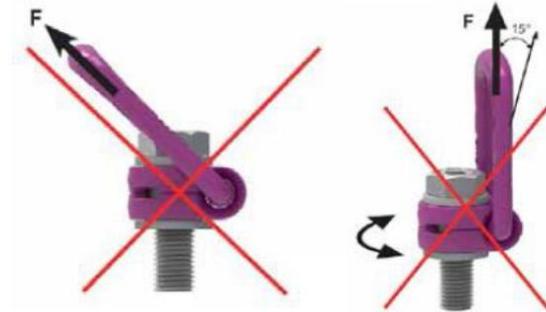
- The bolt on lifting point assembly was designed to rotate about the bolt as well as the lug to pivot through 180°. However, the OEM recommends that the lifting lug not be pivoted back over the bolt and clamp assembly or that the assembly not be rotated while loading in a direction parallel to the bolt axis. (refer figure 6)

Figure 6: Lifting configurations not recommended by Rud (source Rud website)
