Our ref: JWM/DTI/121/11

REPORT
on examination of materials
relating to explosion and fire
at Blakefield South coal mine
on 5 January 2011

James William MUNDAY MIFireE, FSSocDip, IAAI-CFI, FFSSoc

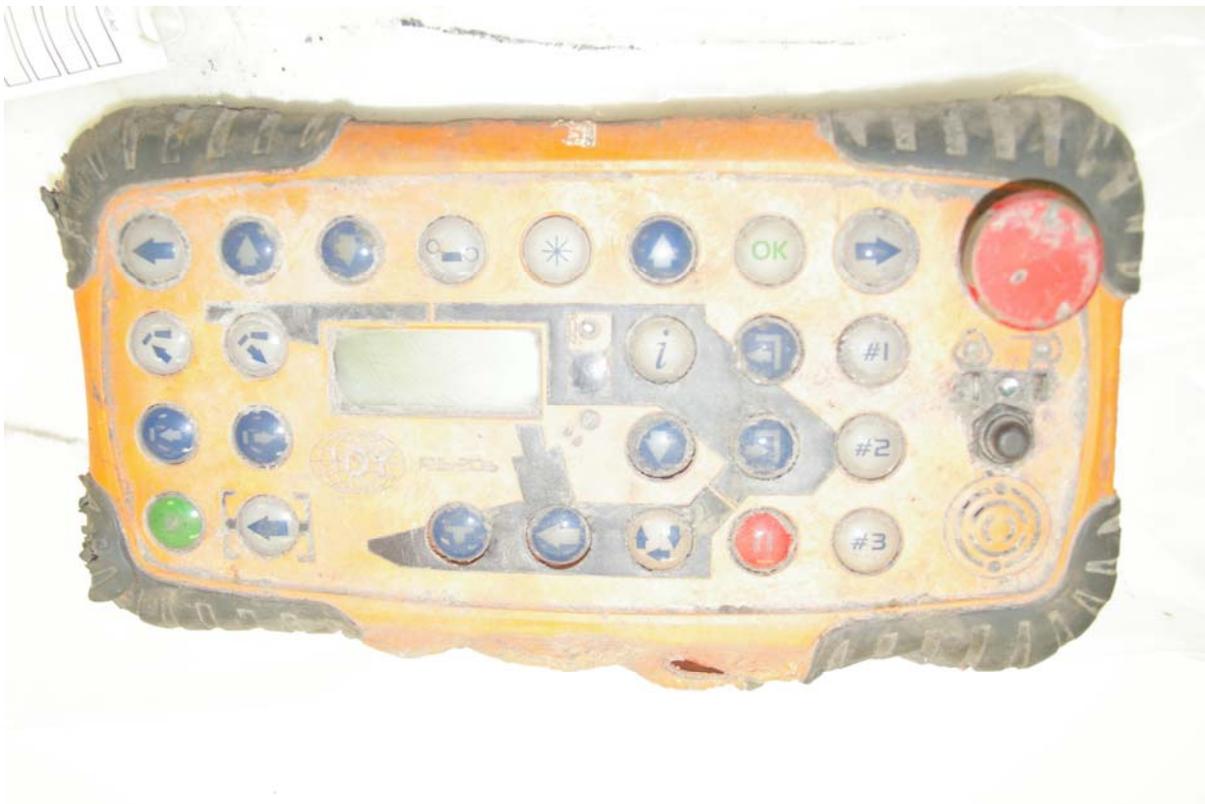
This was a plastic-bodied electronic interface device with a front keypad and the remains of a cable connection to the chock at the rear. My understanding is that each chock was fitted with a similar controller but this was the only one showing heat damage.

3.12 In my opinion, the controller was damaged only by exposure to external heating at relatively low temperatures (probably under 300°C).

Photo 1 – control unit showing keypad

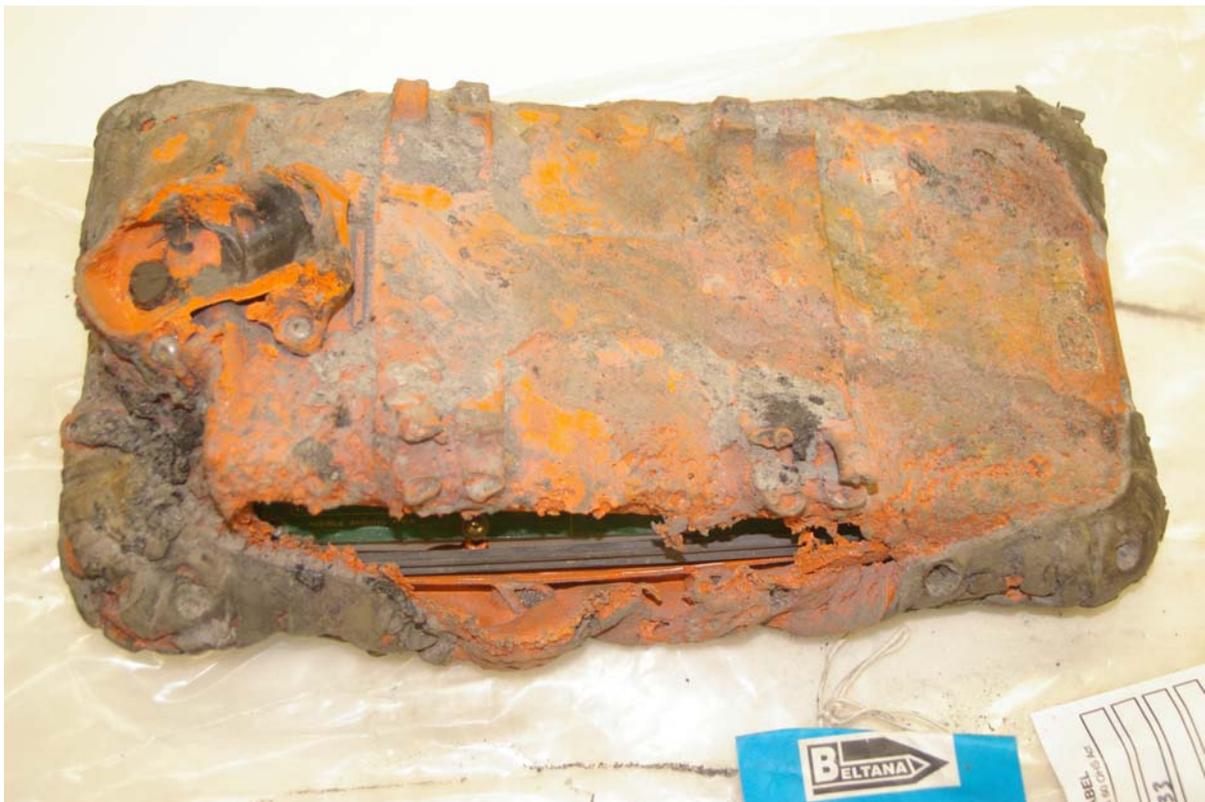
Photo 2 – reverse side of control unit, showing cable entry

4.4 However, the cable connections between the controller and the chock were not examined and I cannot eliminate a low-voltage arc between conductors or to earth as an ignition source. This would require some degree of damage to the cables, to expose one or more conductors, and possibly some abnormal movement to bring them together or in contact with an earthed surface. When full access to the face is possible, this possibility should be checked.

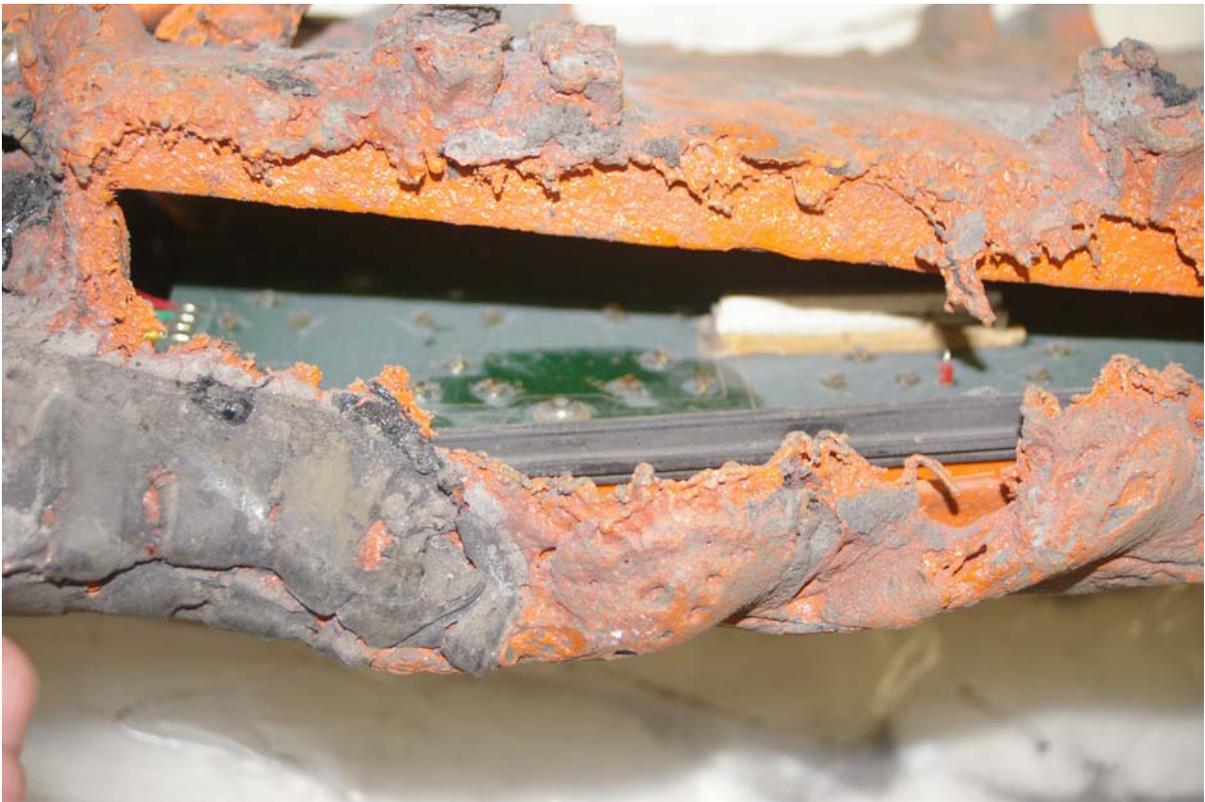
3.9 There was a gap along one edge where the controller appeared to have been broken away from a bracket or mounting. The clean edge showed that this occurred after the heating and I was further advised that the unit was broken away from its location on the chock by the recovery operators. Other than this, the casing remained intact with no heat penetration in either direction.

3.10 Initial inspection of the interior through this gap showed no heat, smoke or other internal damage to the electrical components. The unit was then cut open in the presence of interested parties.

Photo 3 – broken edge with partial view of interior

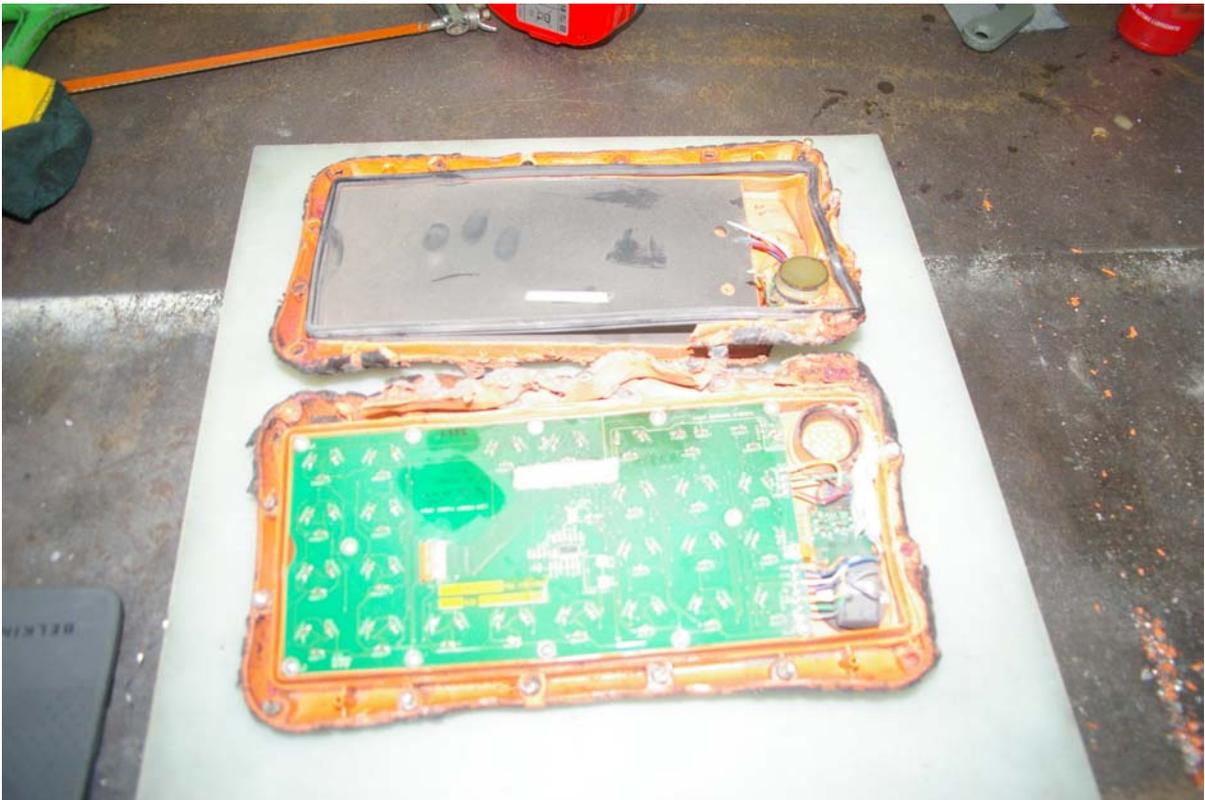
3.11 This revealed no heat or smoke damage to the interior, no indications of dry solder joints, component failures or other localised heat sources.

Photo 4 – control unit opened, showing circuit boards

4.3 Sample 5, the chock controller, showed only external damage with no communication between the outer and inner surfaces. Internally there was nothing to indicate localised overheating or fault conditions capable of igniting a gas-air mixture.

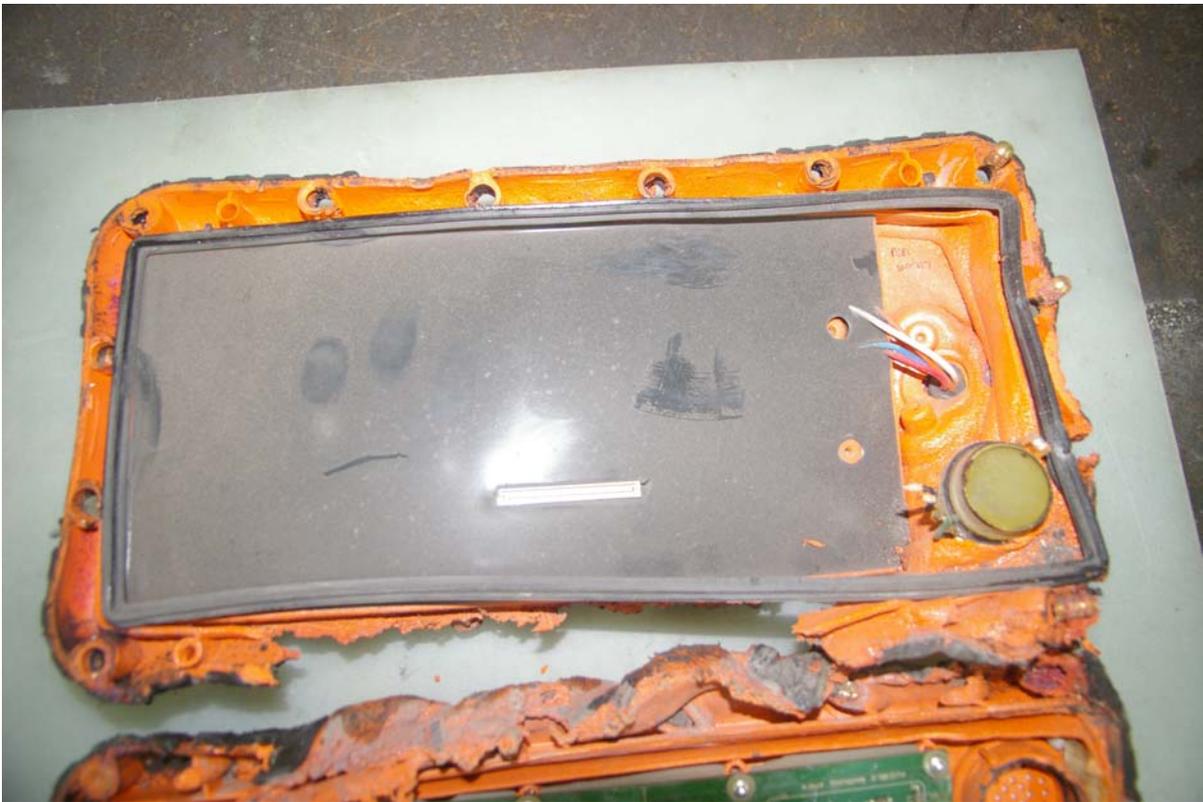
Photo 5 – closer view showing back of main processor board & connector to keypad board

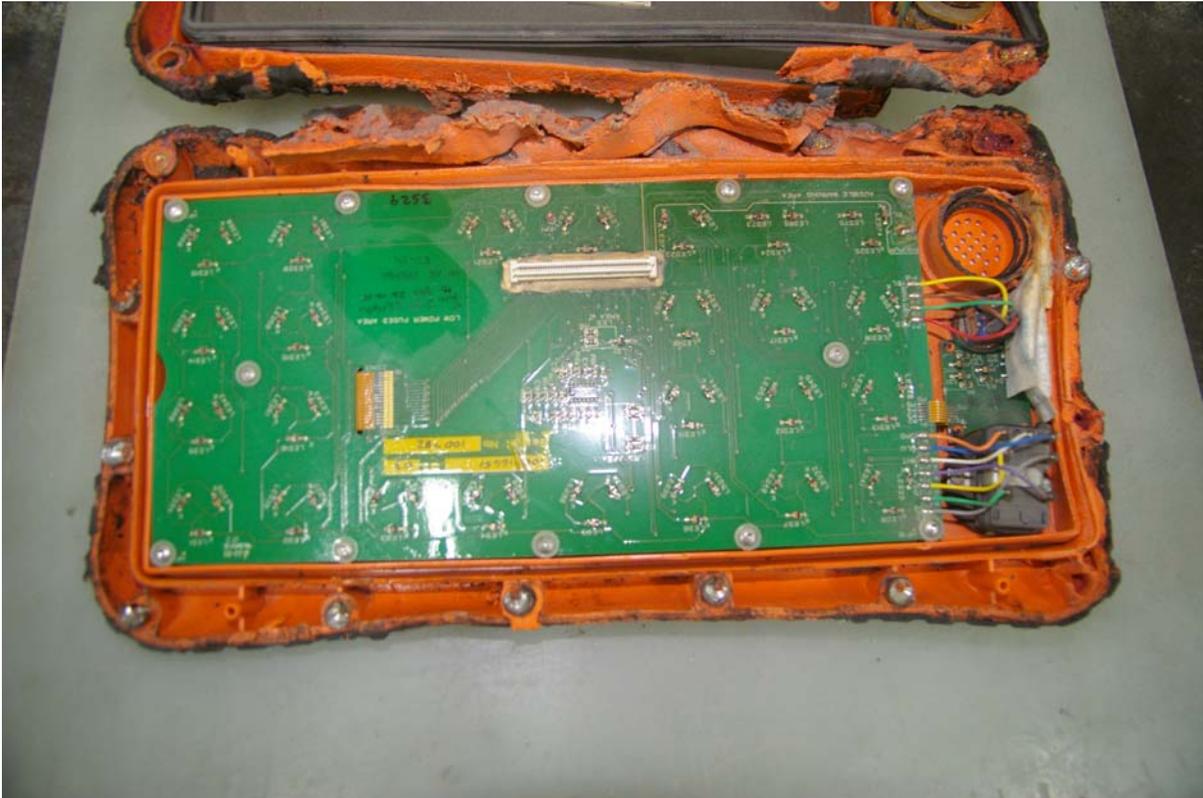
Photo 6 – closer view showing back of keypad board

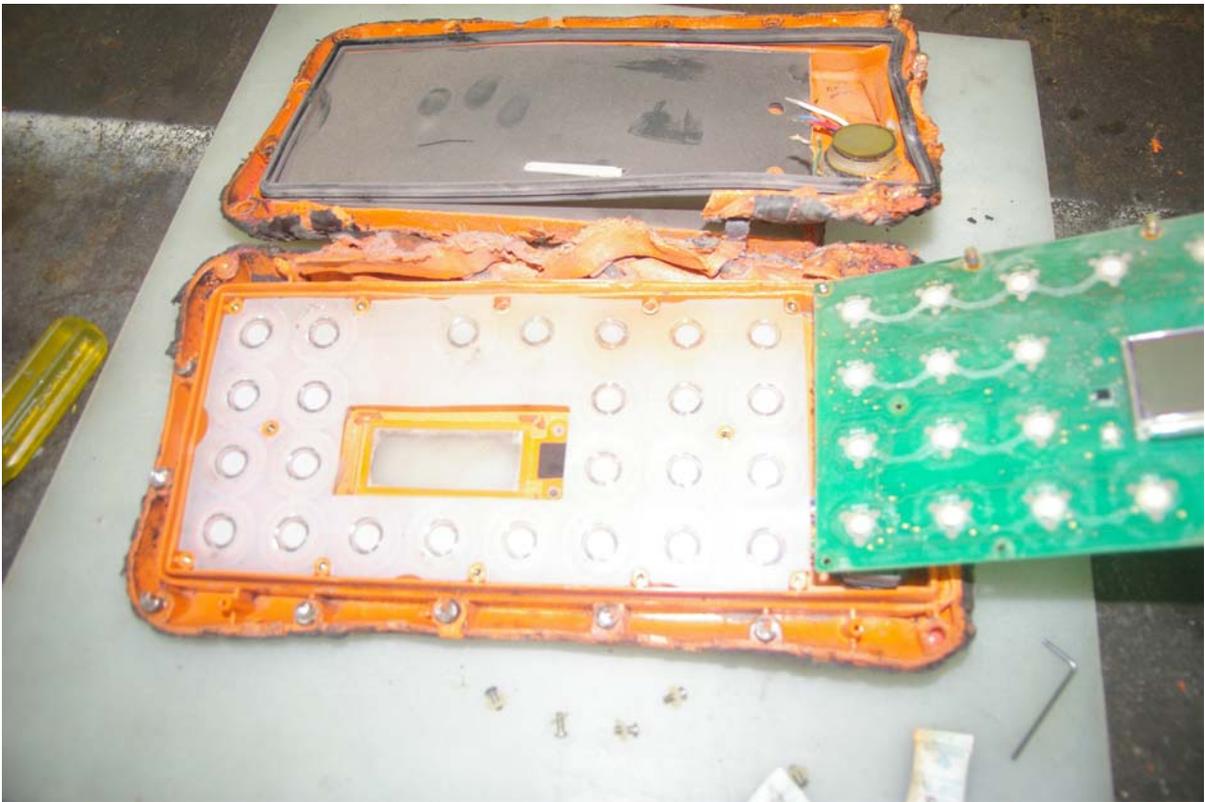
Photo 7 – keypad, membrane & circuit board separated

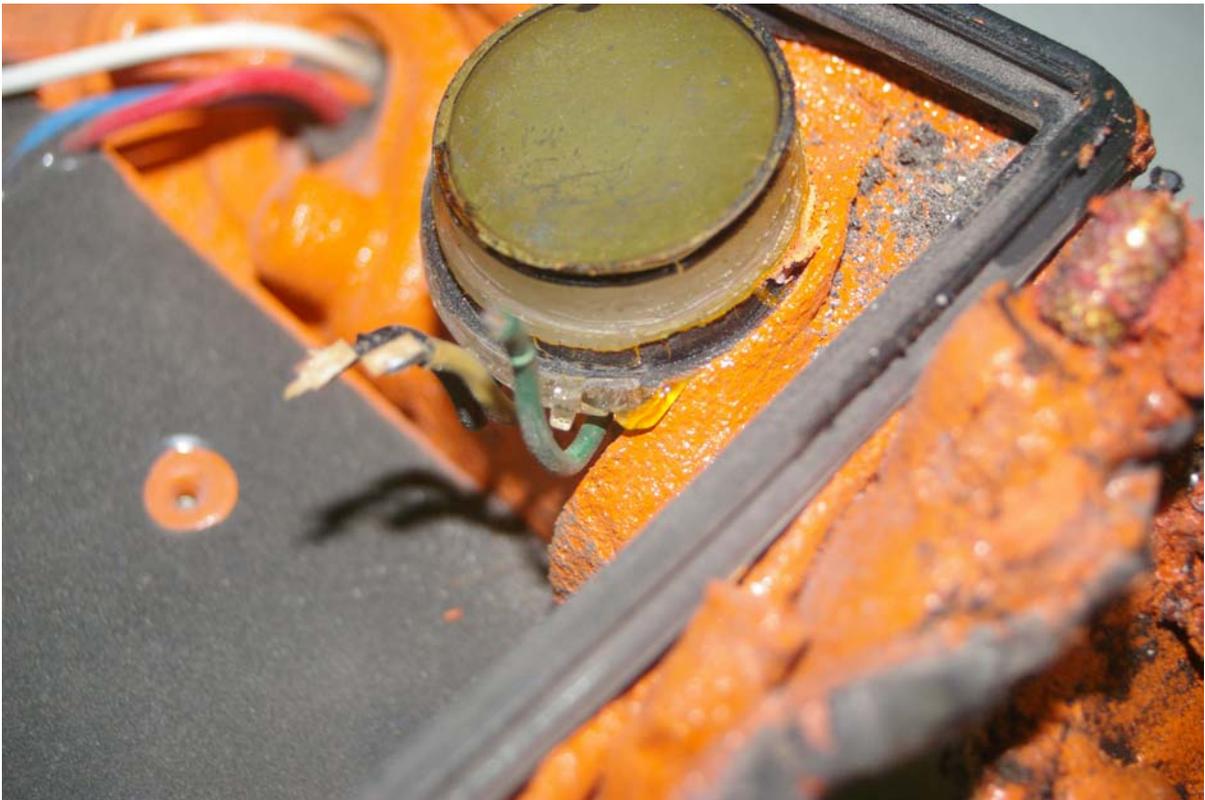
Photo 8 – internal wires detached during separation of boards
