DANGEROUS INCIDENT

Fuel service truck catches fire at coal mine

Event: Diesel flowing from a tank breather assembly causes fire on a service truck

Location: Maules Creek Mine, Boggabri, NSW

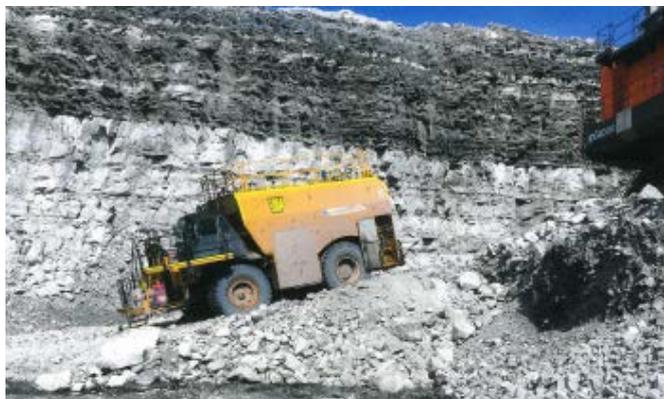
The fuel truck operator exited the cabin and saw diesel flowing from underneath the filter on the front diesel breather assembly. Due to the incline of the truck 11.9° (survey estimate) the diesel flowed from the breather vent directly onto hot surfaces on the engine.

Back on ground level the operator saw flames around the engine turbo and unsuccessfully tried to extinguish the fire with a dry chemical fire extinguisher. Another worker activated the truck's onboard fire suppression system, which failed to extinguish the fire, that had spread to the cabin and tank. Several water carts were used to extinguish the fire. After the fire was extinguished, diesel was seen to continue to flow from the check valve on the breather assembly.

Figure 1: View of the fuel service truck on the ramp after the fire. (Photograph courtesy of the mine)

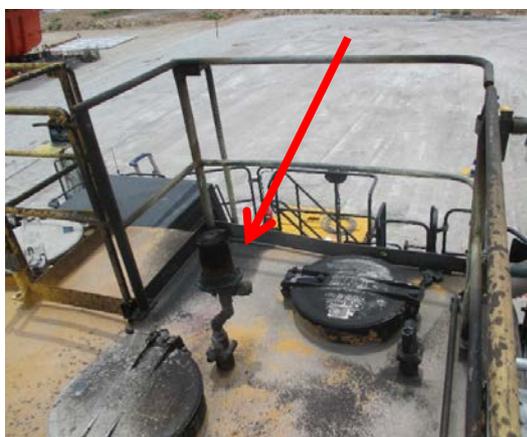
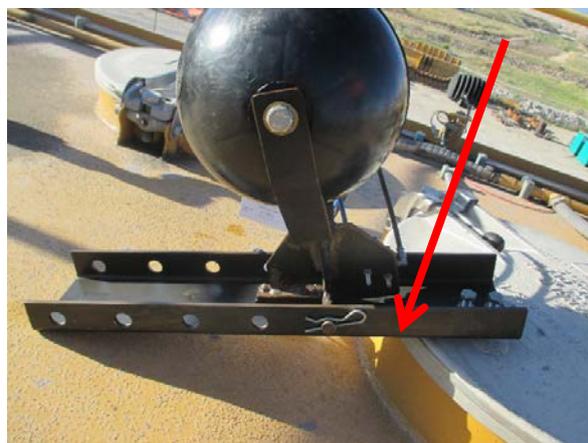
- the diesel tank ball float had been raised to the top position on the support bracket to increase the capacity of the diesel tank from 30,000 litres to 33,400 litres (calculated).
- the breather assembly was designed to allow air to ventilate during filling and discharge of the diesel tank. The breather paper filter base was 420 mm above the top of the tank. The breather assembly components had been replaced and were not as originally designed.

Figure 2: View of burnt breather vent and the setting of the diesel ball float valve in the support bracket (Photographs by Resources Regulator)

2. the design arrangements of the ball float and breather vent settings on fuel service trucks to ensure that they meet OEM specifications
3. controls to manage the hazard of fuel venting through breathers during fuelling and roll-over event are effective

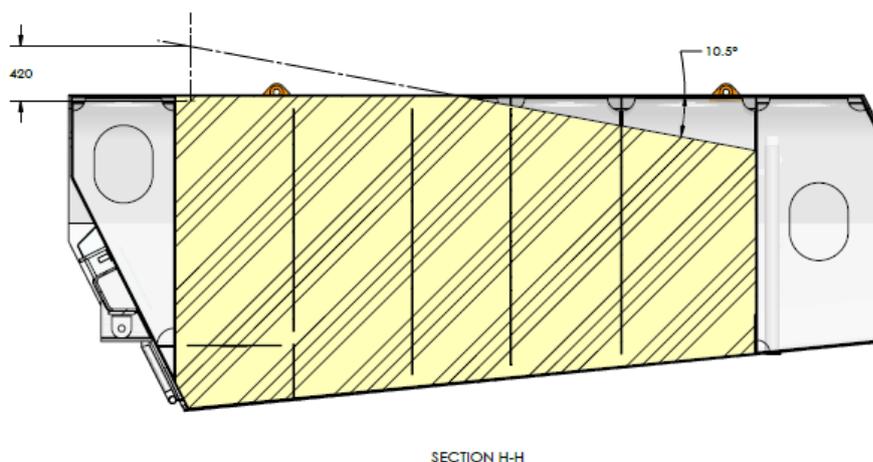
- when the tank was filled to 33,400 litres, the angle of inclination for fuel to run out through the breather assembly filter base (420 mm above the tank) was 10.5° (OEM calculated)

Figure 3: Side view of the tank at inclination of 10.5° and filled to 33,400 litres will cause fuel to flow through the base of the filter on the breather assembly (OEM-supplied drawing)

4. the operating gradients of fuel service trucks are within OEM design specifications
5. maintenance practices of ball float and breather vent settings on fuel service trucks to ensure life cycle inspections and maintenance programs are effectively performed

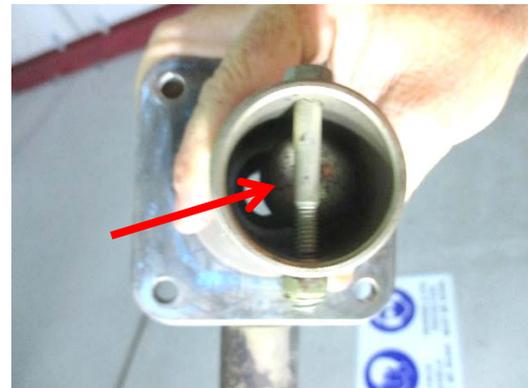
- the roll over adapter on the breather assembly consists of a steel ball locating onto a metal seat and relies on gravity to close fuel flow in a roll over. The rollover adapter was not designed to shut off fuel flow on a low incline. Fuel continued to flow through the roll over adapter at the 11.9° angle on the ramp.

Figure 4: View of steel ball in the roll over adapter. (Photograph by Resources Regulator)

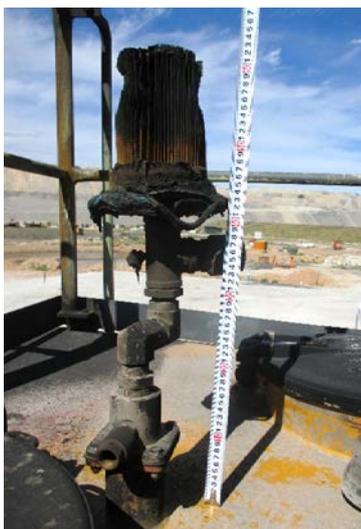
- Fuel was initially observed to flow from the base of the paper filter on the breather assembly. The original design was a desiccant-type filter that would have reduced the volume of diesel flow.

Figure 5: View of paper filter breather assembly. (Photographs by Resources Regulator)

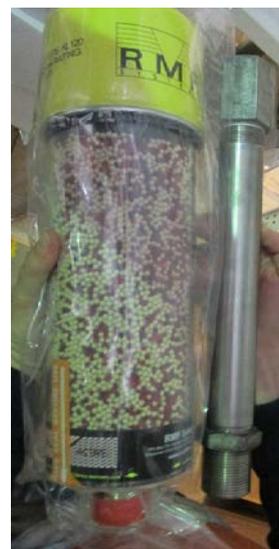
Figure 6: View of desiccant filter used in original design.

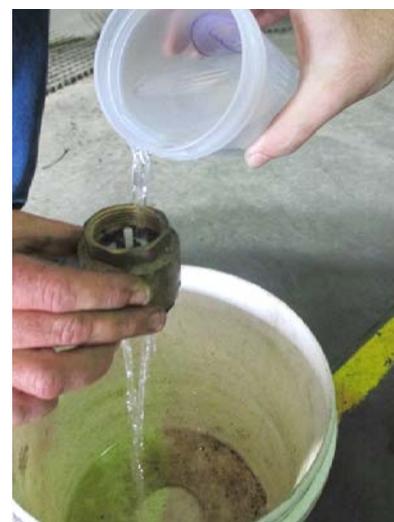
- Fuel was later seen to flow through the check valve on the breather assembly after the fire was extinguished. Testing of the check valve confirmed the observation that diesel would continue to flow through the fire-damaged check valve.

Figure 7: View of testing the check valve showing fluid running through the fire damaged check valve. (Photograph by Resources Regulator)
