**NSW  
Resources  
Regulator**

# **INVESTIGATION REPORT**

Bulga Open Cut dump truck collision

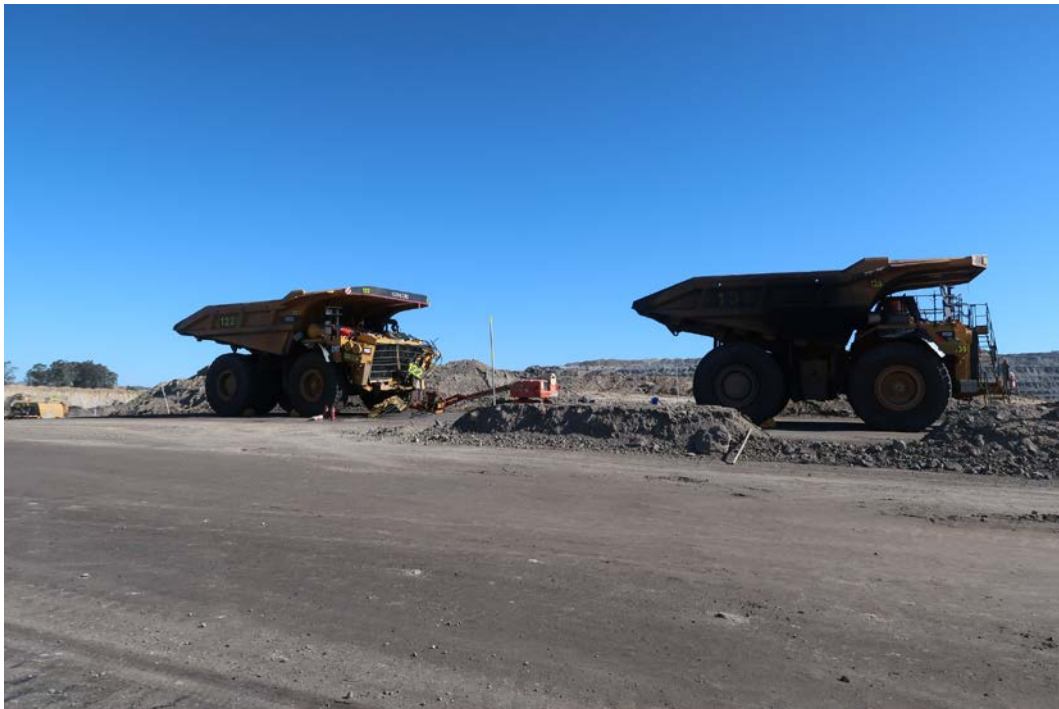
The cabin of DT122 collided with the rear edge of the tray body of DT139. This resulted in the two pillars of the operator's cabin being pushed inward toward the driver. The force of the collision shunted DT139 forward about 20 metres.

*Figure 1: Final resting position of DT122 and DT139*

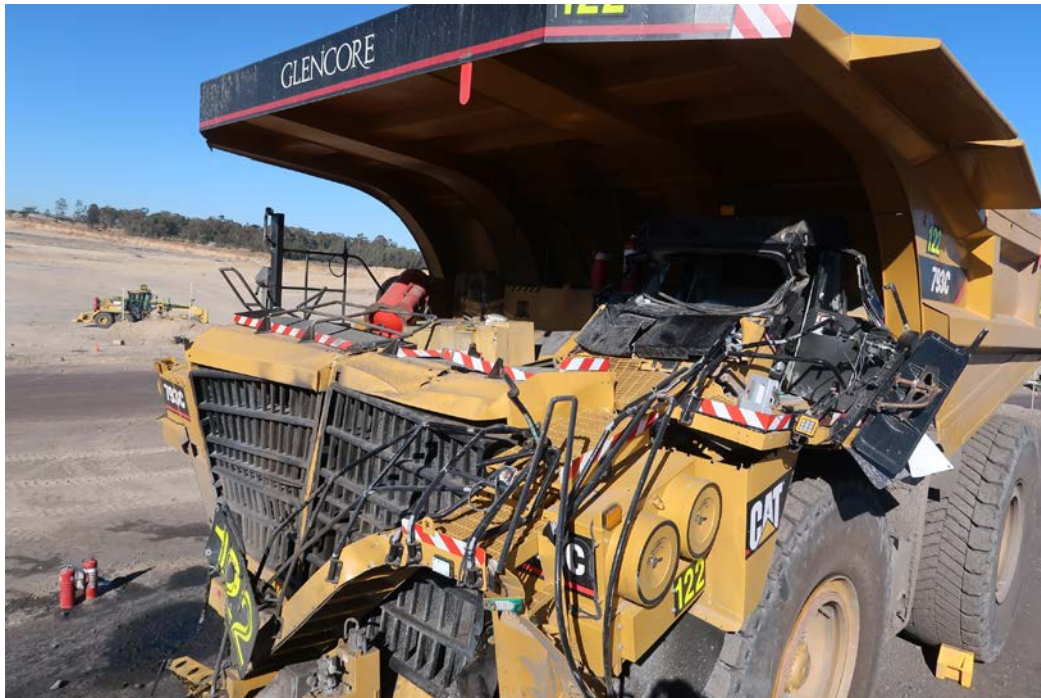
The front of DT122 hit the rear of DT139. Vehicle data records show that DT122 was travelling at 41 km/h in sixth (top) gear at the time of the collision. There is no evidence on the plant data records to support any action on steering, emergency braking or application of retarder by the driver.

The cabin of DT122 collided with the rear edge of the tray body of DT139. This resulted in the two pillars of the operator's cabin being pushed inward toward the driver. The force of the collision shunted DT139 forward about 20 metres.

Figure 2: Damage to front and cabin of DT122

- implement strategies to eliminate or minimise risks associated with fatigue
- implement real-time fatigue monitoring systems
- implement systems to encourage workers to self-report fatigue and medical conditions
- engage with workers about the effective management of fatigue and medical conditions
- review roster cycles
- install proximity detection and collision avoidance systems on mobile plant.

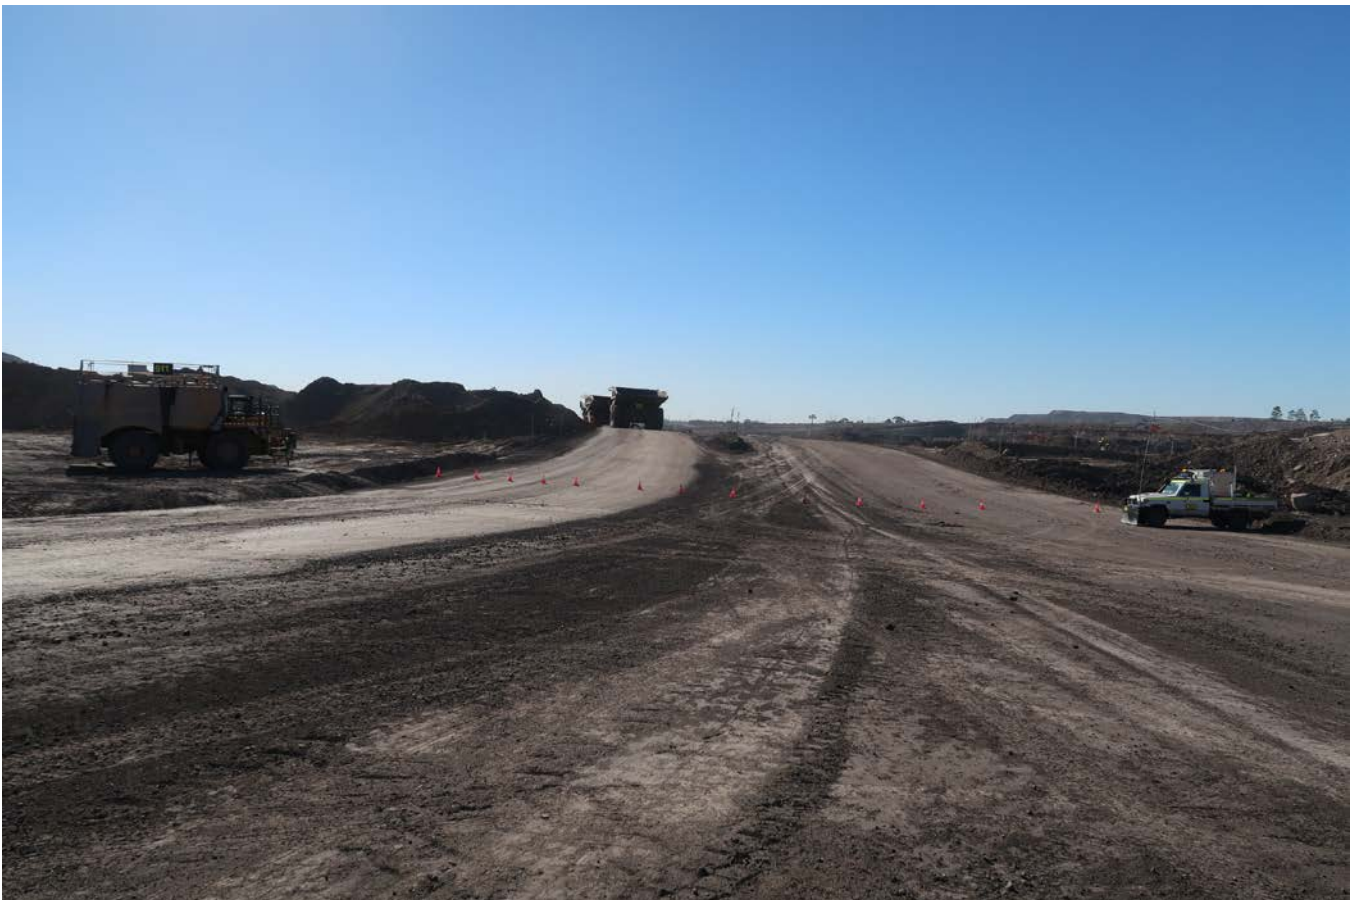
The incident occurred on a main haul road, known as Swan Lake Road. The surface roadway is of hard, compacted clay. The grade of the roadway at the point of impact was +3.5% with a cross grade of 2.0%. The photograph below is of the roadway leading to where the collision took place. The two dump trucks involved in the incident can be seen in the centre of the photograph.

*Figure 1: Roadway where collision occurred*
