INVESTIGATION INFORMATION RELEASE

Worker receives crush injury to foot from hydraulic stabilising jack on jumbo rig

Incident date: 15 September 2020

Location: CSA Mine, Cobar, NSW

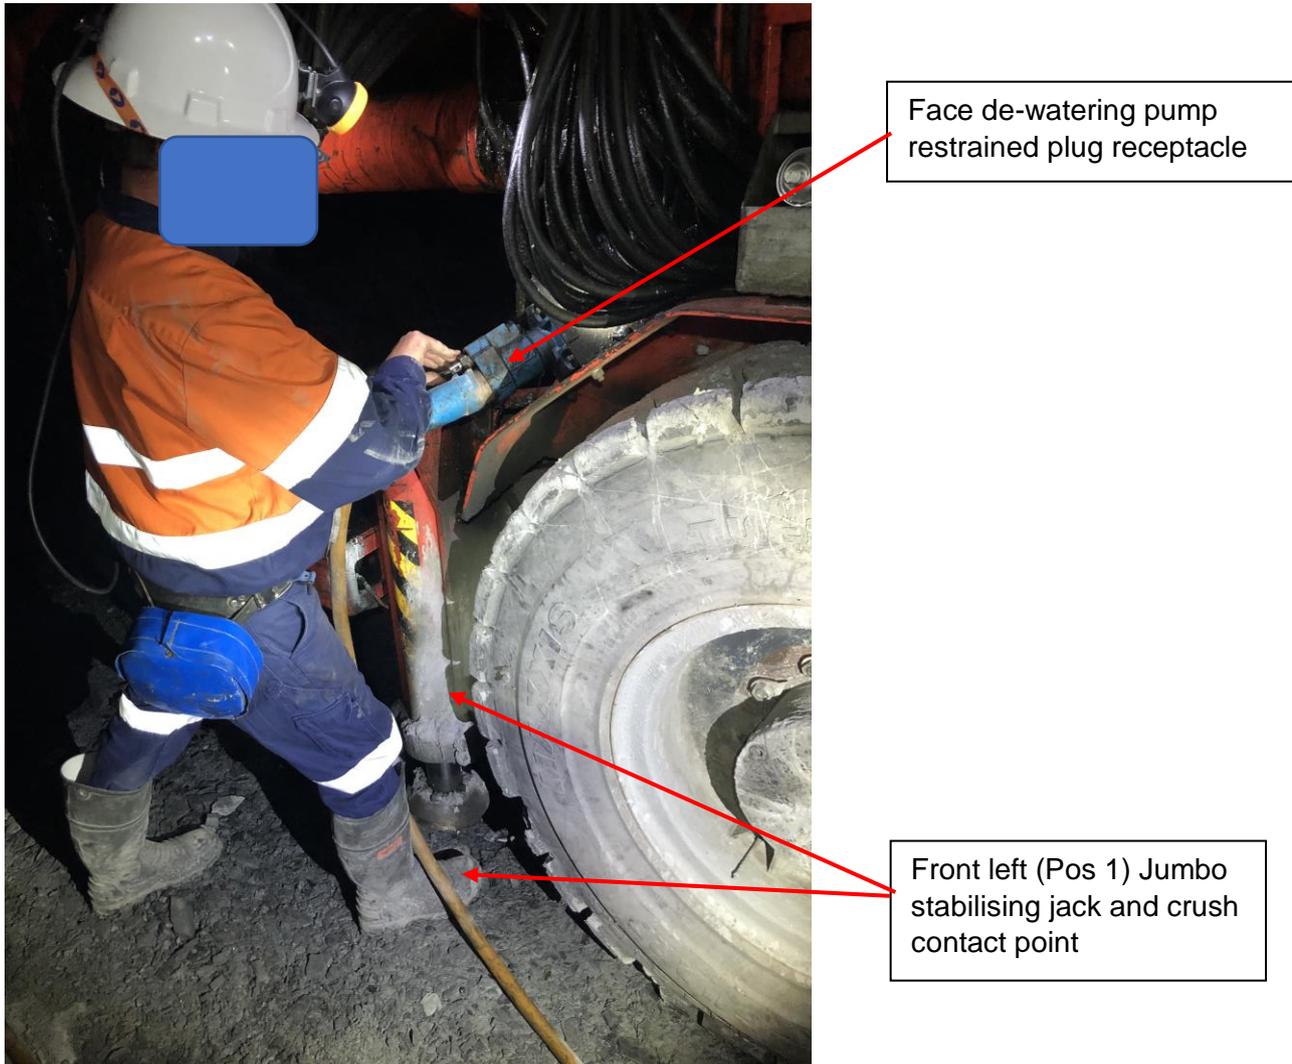
Figure 2. Re-enactment of nipper's positioning at the time of incident

The driller lowered the front left jack leg (Pos 1) when it contacted the nipper's right foot, crushing it. The driller heard the nipper yell and from his seated position observed the nipper's hand waving inside the jumbo's cabin. The driller immediately raised the jack leg which released the nipper's foot. A maintenance fitter in the vicinity was alerted to the incident and called an emergency over the radio. The nipper was transported to Cobar Base Hospital and transferred to Dubbo Base hospital. The resulting injury to the nipper was an amputation of the big toe and the fracture of his second toe. Figures 3 and 4 below show the boot worn by the nipper at the time of the incident.

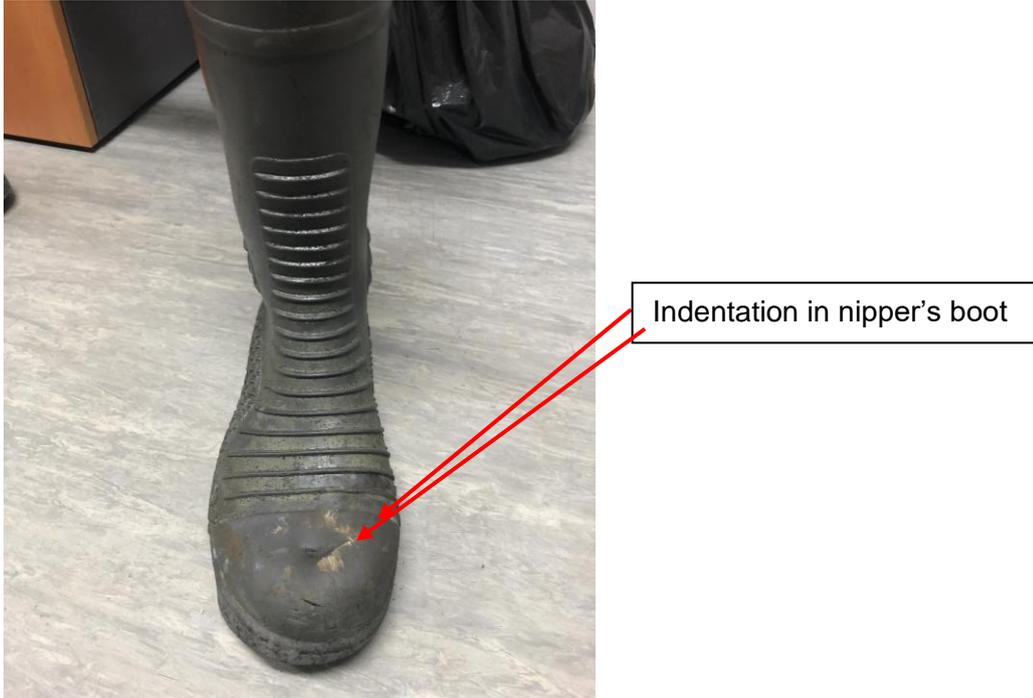
Figure 3. Top view of nipper's right boot

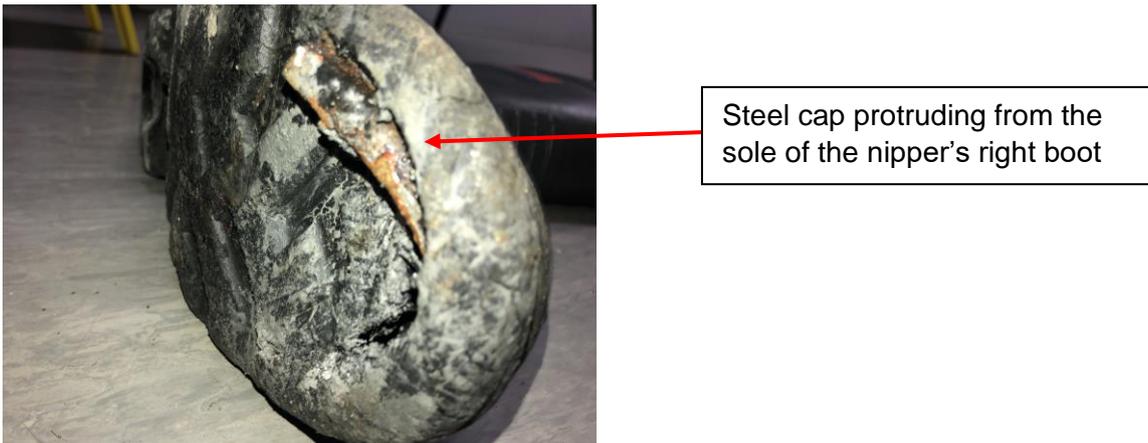
Figure 4. Sole view of the nipper's right boot

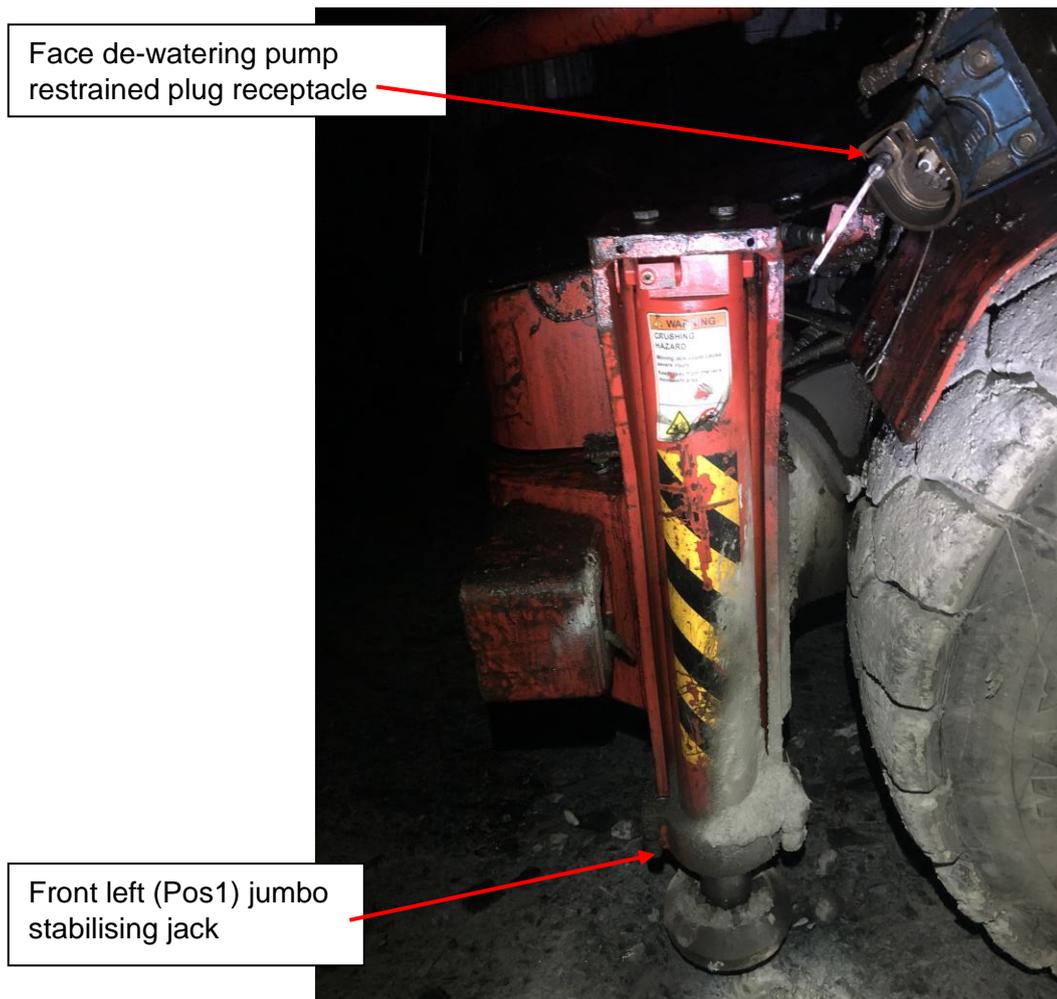
The original equipment manufacturer placement of the pump outlet / receptacle has changed with this version of the DD421 drill rig involved in the incident. The change in position was due to the positioning of the Telescopic Feed Extension (TFX) valving near the tombstone and mounting of the laser barrier (jumbo guard/ boom stop) devices at the rear of the front wheel arch, limiting real estate. Older versions of the DD421 drill rig had the pump outlet / receptacle nearer the cab, at the rear of the front wheel arch. Previous version positioning meant that workers were not exposed to the risk of crush injuries by the jack leg. Figure 6 shows an unmodified DD421 drill rig.

Site based assessment of the jumbo as fit for purpose equipment (Introduction to site) had identified the fitment of a laser barrier (jumbo guard/ boom stop) safety system to prevent personnel movement beyond the rear of the wheel arch during boom operation. Introduction to site documentation required a risk assessment be conducted for any equipment modifications identified however, this risk assessment process was not carried out. The re-location of the pump receptacle, which placed personnel near the hydraulically actuated stabilising jack, introduced a potentially hazardous situation for any person connecting a pump to the receptacle.

Figure 7. Position of pump receptacle above jack leg

- Relocation of 1000 volt outlets on affected plant to an area that does not introduce additional hazards.

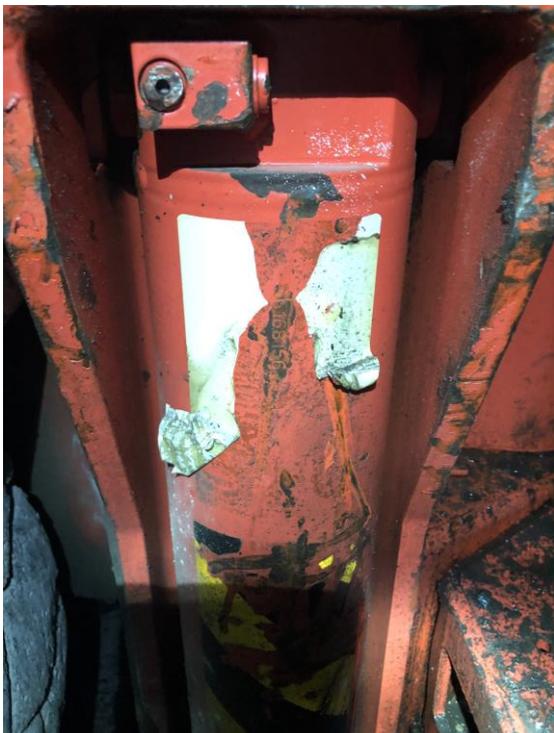
Figure 9. Damaged and illegible warning signage on opposite jack leg

- Develop and implement a training competency and associated safe work instructions specific to personnel classified as nippers working in the underground environment.
- Review and update the mobile equipment introduction to site process to ensure that mobile machinery is fit for purpose and any modifications do not introduce additional hazards.
 - Auditing drill fleet warning signage on jack legs.
