MINE SAFETY INVESTIGATION UNIT

INFORMATION RELEASE

Incident date	11 June 2014
Event	Worker dies in underground sump
Location	CSA Mine, Cobar NSW

IIR14-05

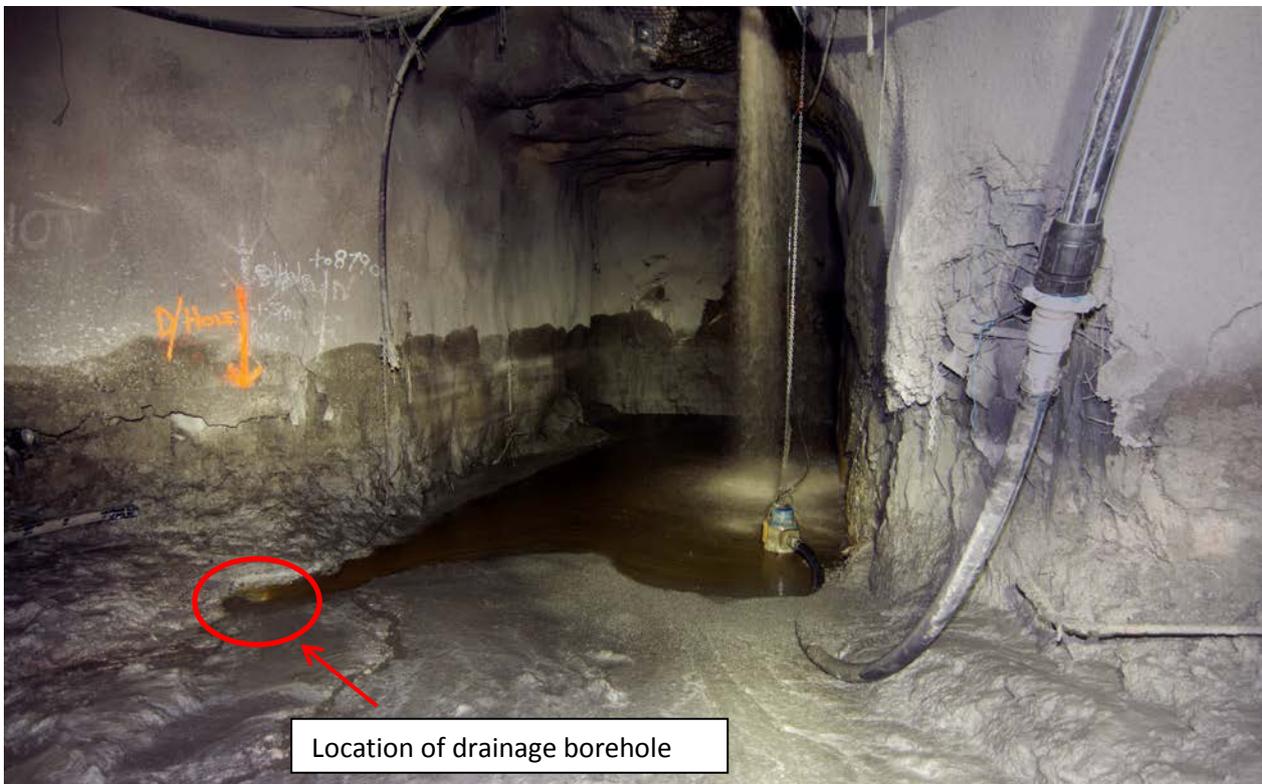
Location of drainage borehole

Underground sump – water level at the time of the incident on side wall - Photograph by Investigation Unit

There was a large volume of water covering the sump area and adjacent roadways. The borehole was not visible because of the expanse of deep water.

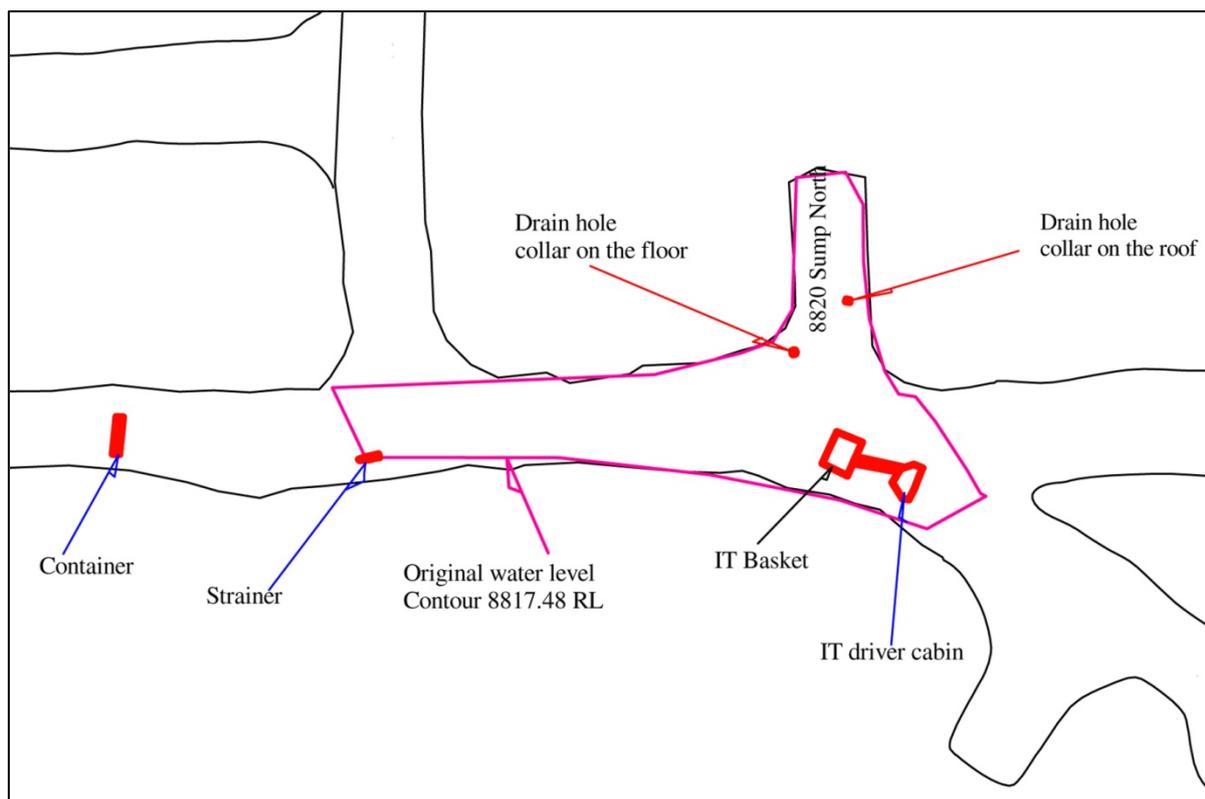
Incident site plan – Excerpt of plan supplied by the mine operator

The incident site was at the 8820 level, about 1400 metres underground. The incident site was designated as a sump for collecting ground water from the mine. Water can enter the 8820 Nth sump through a borehole from the sump directly above (8850 Nth) and from the main access decline and roadways.

Water can be pumped from the 8820 Nth sump, or drained by a borehole to the lower 8790 Nth level. At the time of the incident, the borehole was blocked, the cause of which is being investigated. It would appear that the borehole did not have any guarding or cover to prevent a person from being sucked into it. It is unclear what signs were present to indicate the position, or warn of, the open borehole.

Mine operators should ensure that open holes and boreholes are appropriately guarded and hard barriers are in place to prevent similar incidents from occurring. All open holes should be appropriately signposted. Workers should be prohibited from entering water filled sumps and water bodies without using certified water craft and appropriate flotation protective equipment.

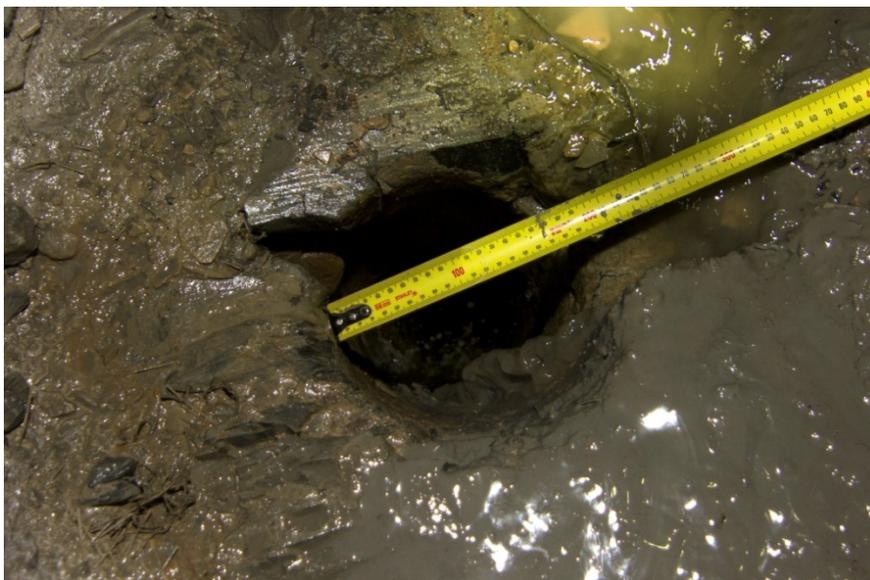
The borehole linking the 8820 Nth sump (incident scene) with the 8790 Nth sump below was about 180 mm in diameter and about 30 m deep.

The borehole was drilled in competent rock and was unlined.

The lower (discharge) end of the borehole at 8790 Nth was accessible and workers checked it before the incident. It is reported that there was no water flowing from the borehole indicating that the borehole was blocked.

Borehole in the bottom of the incident sump - *Photograph by Investigation Unit*

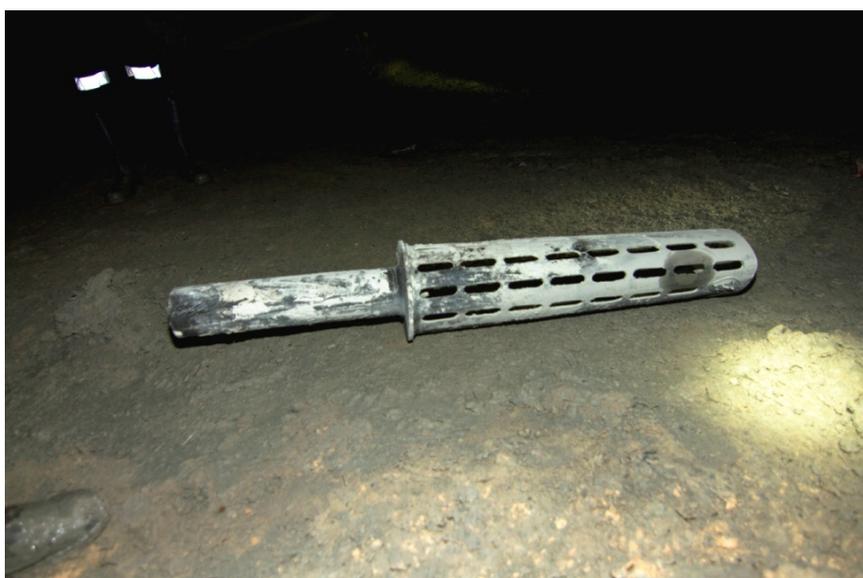
The borehole had been fitted with a strainer at some stage. A search of the area found a strainer nearby, but it is not known whether the strainer was fitted in the borehole or, if so, how it came to be separated from the borehole.

During inspection of the strainer, investigators observed an inflatable bag in the solid tube section of the strainer. Investigators will determine if this blockage contributed to the incident.

Strainer found in the vicinity - *Photograph by Investigation Unit*
