# WEEKLY INCIDENT SUMMARY

Week ending Friday 27 November 2020

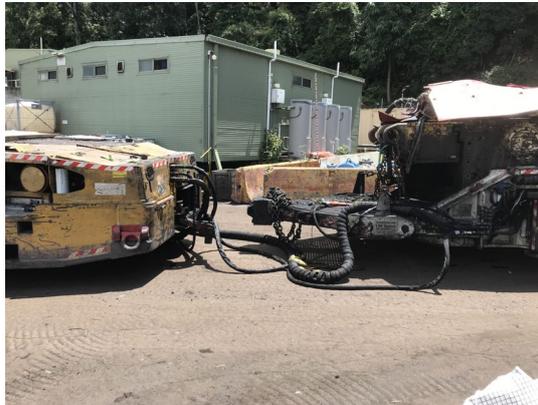
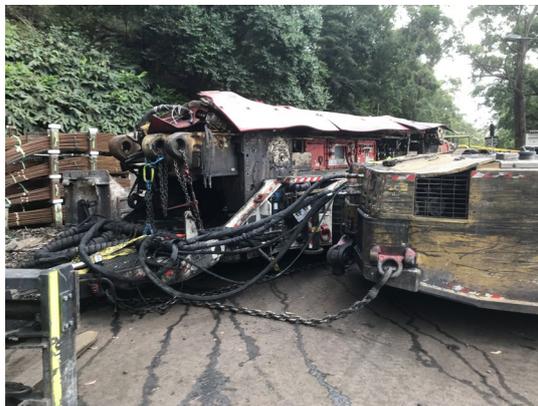
INCIDENT TYPE	SUMMARY	COMMENTS TO INDUSTRY
Dangerous incident IncNot0038712 Underground coal mine	<p>An operator was using a heavy lift loader to move a loaded shearer transporter a short distance. When negotiating a slight decline, the shearer transporter jack-knifed and snapped the tow hitch on the heavy lift loader.</p> <p>Preliminary investigation suggests that speed was a factor, as well as lack of knowledge/experience in moving heavy machinery on a decline. The investigation will determine if there was a delay in the shearer transporter brakes engaging, following application of the brakes on the heavy lift loader and if there was a requirement for a tow vehicle to assist braking.</p>	<p>It is imperative that operators have a procedure for towing heavy loads, including the weight of loads and the vehicle/s to be used.</p> <p>These procedures must refer to the OEM specifications of the towing vehicle and include road grades, road surfaces and vehicle to road surface contact.</p> <p>Operators should be trained in the requirements for towing heavy equipment, particularly in the effects of braking when on a decline and when the towed load is turning.</p>

Refer to:

[MDG 1009 - Managing road and vehicle operating areas in underground coal mines.](#)

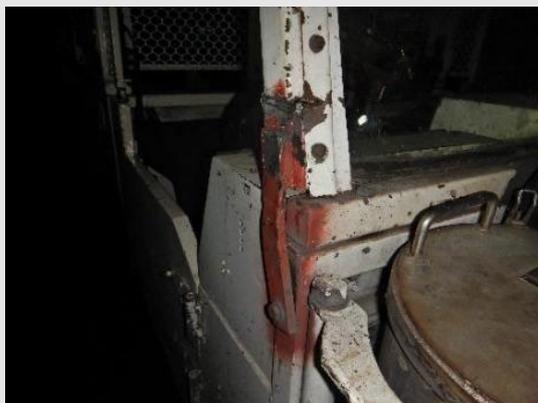
Dangerous incident  
IncNot0038720  
Underground coal  
mine

A load haul dump vehicle (LHD) and PJB collided in an underground coal mine. Two PJBs were travelling in convoy passing the LHD that was in a cut through. The first PJB passed safely, but the LHD pulled out and collided with the second PJB. The bucket of the LHD contacted the frame of the windscreen of the PJB on the driver's side. Nobody was injured.

Lack of positive communications continues to be an issue throughout the industry.

Mine operators, supervisors and vehicle operators all have a role to play in ensuring effective communications between vehicle operators.

Mine operators must have protocols and procedures documented and implemented, including signalling when entering a roadway, and should consider proximity detection and collision avoidance technologies.

Supervisors must ensure that vehicle operators comply with the protocols and procedures.
