INVESTIGATION INFORMATION RELEASE

Shot firing incident damages vehicles

Incident date: 10 April 2018

Location: Albury Quarry, Albury NSW

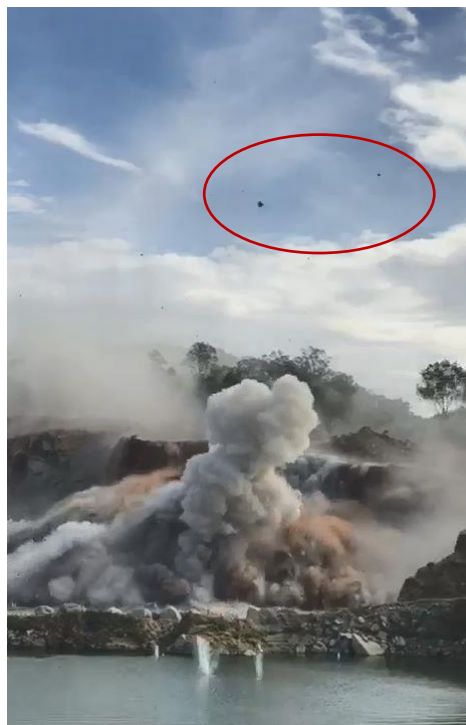
Flyrock from overburden struck three light vehicles which remained in an exclusion zone during blasting at a quarry. There were no injuries, however, workers and members of the public who were in the exclusion zone at the time of the incident were at risk of being seriously injured.

Figure 1 Flyrock moving through the air following the blast. Photograph obtained from video footage supplied to the NSW Resources Regulator.

Mine operators must ensure that appropriate information, instruction and supervision is provided to workers and members of the public in relation to exclusion zone requirements set out in blast control plans.

Mine operators are reminded that appropriate systems must be in place to review and audit the explosives control plan and blasting work practices to ensure that exclusion zone requirements are enforced. No persons should remain within exclusion zones during blasting activities.

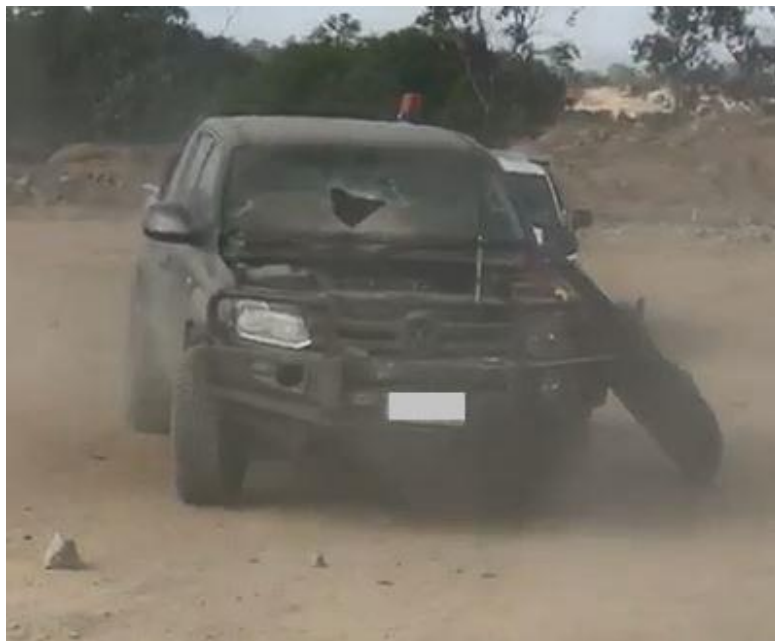
Preliminary enquiries have identified that mine workers and members of the public were between 300 and 340 metres from the blast location. Flyrock from the blast travelled through the air and damaged three light vehicles parked a short distance away from people. Seven people were at risk of being struck by flyrock.

Figure 2 One of the light vehicles damaged by flyrock. Photograph obtained from video footage supplied to the NSW Resources Regulator.
