INVESTIGATION INFORMATION RELEASE

Event: Dangerous incident

Location: Ravensworth Open Cut Coal Mine, Muswellbrook, NSW

Light vehicle drives over open edge

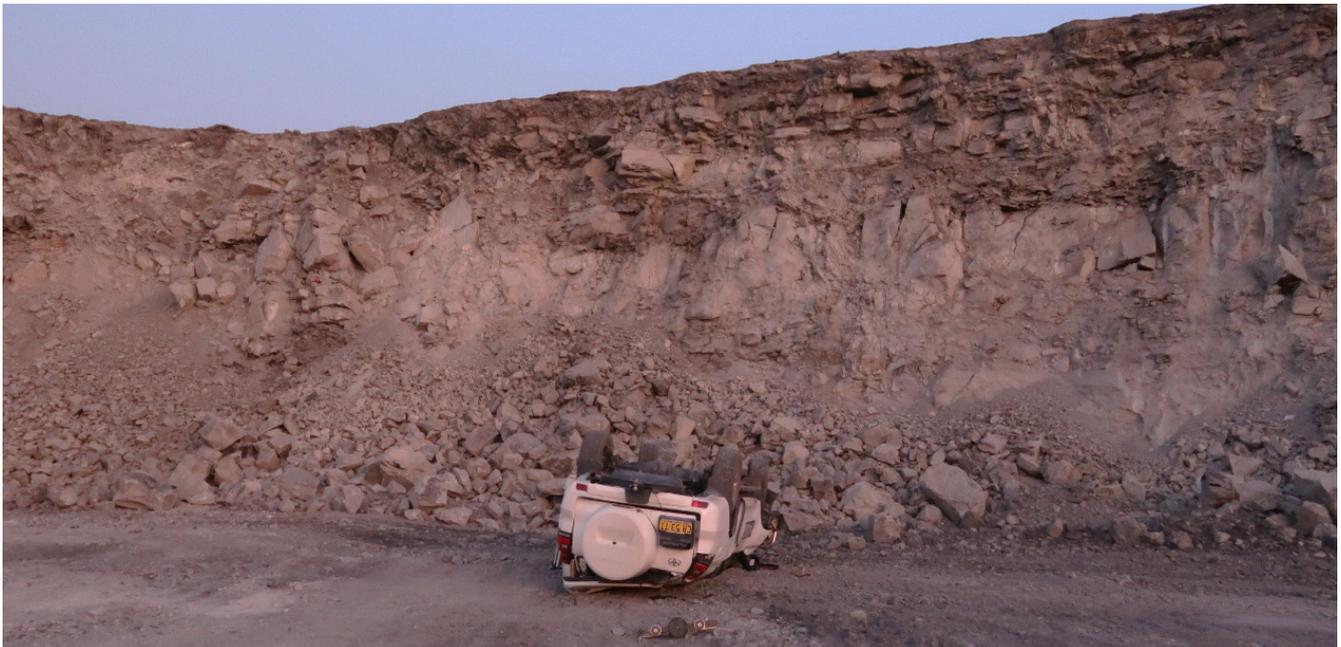
A worker drove a light vehicle off a 12 metre bench. The worker was able to free himself from the vehicle and call for help. He suffered minor injuries.

Figure 1 The position of the light vehicle

The worker continued driving toward what he believed was an access ramp, but instead, drove over the edge of a bench. The light vehicle fell about 12 metres before hitting the ground, then rolling onto its roof. The worker freed himself and used a hand-held radio to call for help. The worker was taken by ambulance to a nearby hospital. He was later transported to another hospital by helicopter.
