NSW DEPARTMENT OF  
PRIMARY INDUSTRIES

# SAFETY BULLETIN

## Electrical fuse safety

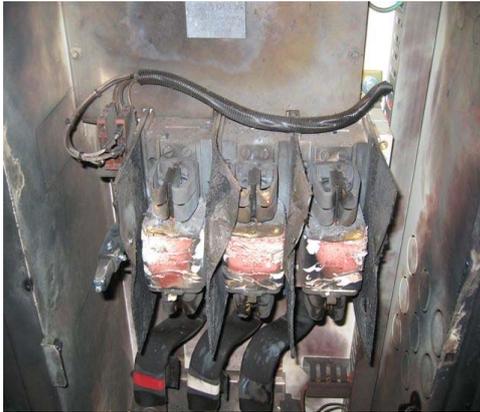
Failure 1: 630 amp 690v fuses  
Cat. Bussman Czech 630 NH3G-690

All mines should review all fuses they have in service and all spare fuses at the site. If the above fuses are in use, the mine must contact the fuse supplier for advice, assess the risks and take immediate action to control the risks. Where these fuses are in use, it may be necessary to prevent access to the associated switchgear locations while ever the switchgear is energised, until suitable replacement fuses are installed.

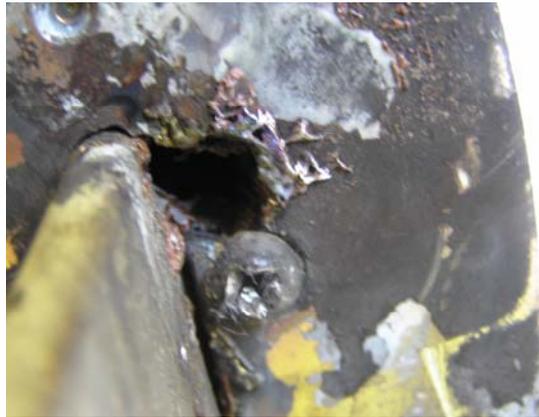
Failure 2: 630 amp 690v fuses  
Cat. Bussman Czech 630 NH3G-690

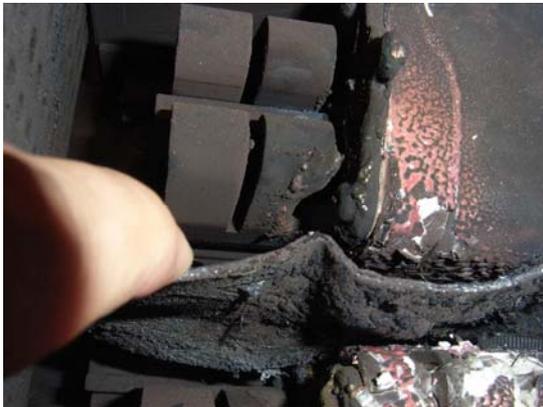
Failure 3: 500 amp 690v fuses  
Cat. Bussman OEZ Czeck 500 NH3G-690
