SAFETY ALERT

Concerns about possible tampering with explosion protected diesel engine safety systems

CM9 reference	DOC20/732076
Mine safety reference	SA20-07
Date published	11 September 2020
Authorised by	Chief Inspector of Mines Office of the Chief Inspector

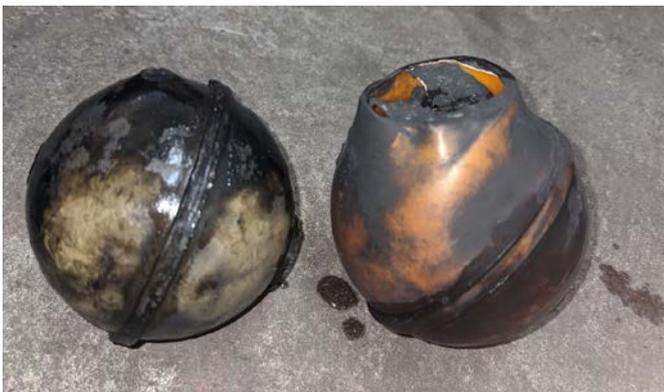
A tradesperson, who was investigating an issue with an explosion protected diesel engine system (ExDES) found that both scrubber floats were damaged due to heat exposure. This indicated the engine had been operating in a non-explosion protected state.

Figure 1 Heat-affected scrubber floats

A fitter in an underground diesel workshop was working on a broken-down skid steer loader. He found that the loader's two scrubber floats had been exposed to heat. One had melted and fallen off, which was preventing the machine from starting. The engine system may have been operating for some time without water in the scrubber. Both floats were replaced, and the low water cut out tested satisfactorily. With no other issues found to restore normal operation, other than replace the damaged

floats, it was considered that the safety system may have been temporarily defeated. Investigations are continuing at the time of publication. With this model of plant, it is possible to defeat both the water make-up reservoir level sensor and exhaust conditioner level sensor (floats) by securing the test valves closed.

- Mine operators should communicate to workers:
 - that ExDES must be operated and maintained in accordance with their design and item registration technical requirements and conditions
 - safety shut down systems such as those used on ExDES must not be defeated or altered from registration specifications
 - workers should use the appropriate defect reporting systems or notify their supervisors of any plant defects and tag out-of-service plant that is unfit for service.
- Mine operators should also communicate that while they are at work, workers must take reasonable care that their actions do not adversely affect the health and safety of other

- Mine operators should conduct an audit of variable flow restrictors fitted to explosion protected diesel engine systems and confirm they are protected against unauthorised tampering.
- Mine operators and original equipment manufacturers (OEMs) should review the availability and suitability of ways to reduce unauthorised adjustment of variable restriction device and prevent the deliberate tampering of safety systems.
- Mine operators should review the inspection frequency and accessibility for inspection of tamper proofing mechanisms where used.
- When developing new equipment, OEMs should consider more robust and fault tolerant alternatives to pneumatic safety circuits reliant on fine flow rate adjustments.
