SAFETY BULLETIN

Portable power tools

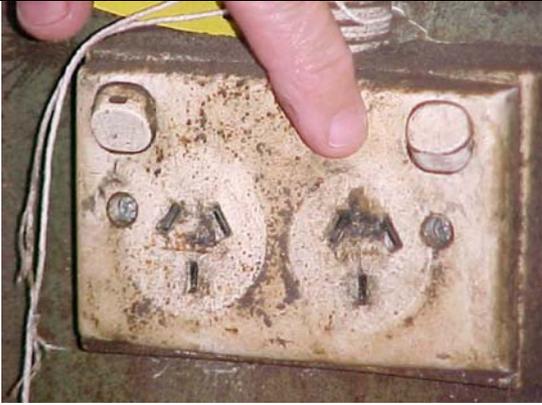
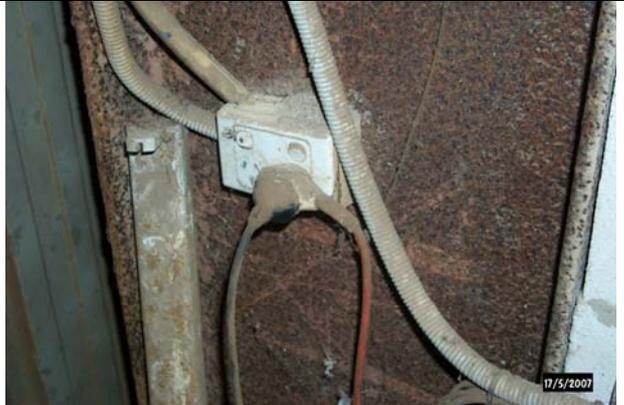
<p>Power outlet unsuitable for the environment</p>	<p>Socket outlet not rated for the location, poor wiring standards to the socket outlet and the inappropriate use of piggy-back plug / sockets</p>

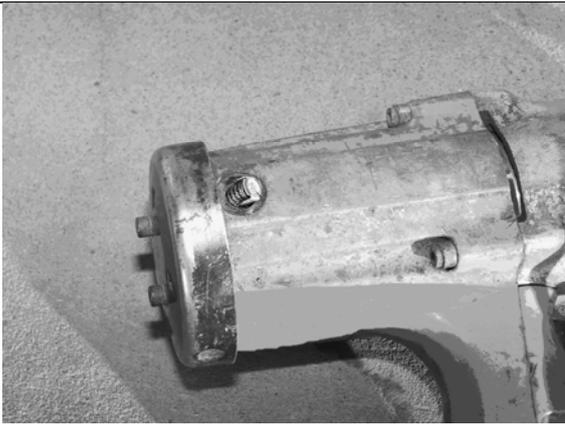
<p>Impact wrench – brush holder damaged</p>	<p>Impact wrench – cracked casing</p>

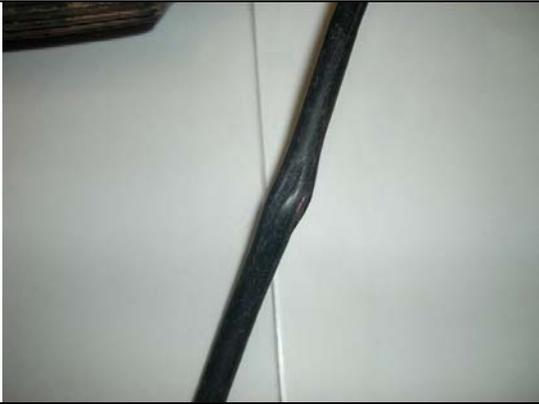
Damaged impact wrench lead

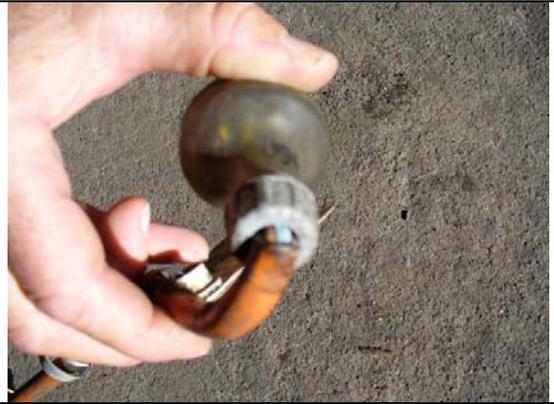
Defective cable connection to the plug

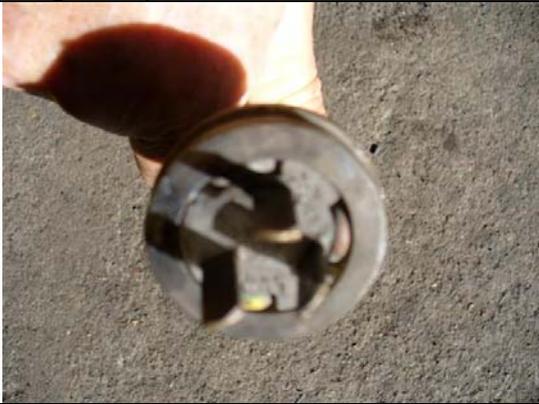
Plug inadequately IP-rated

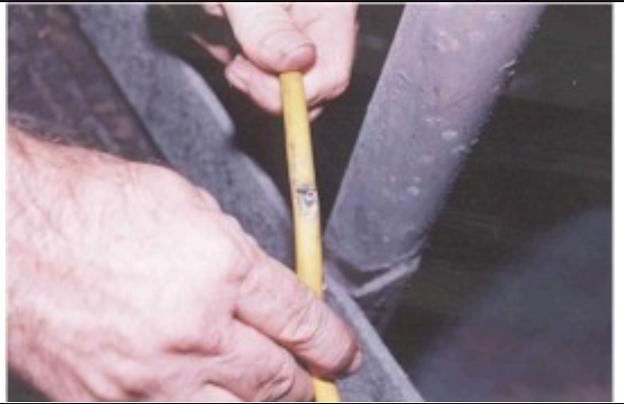
Damaged extension lead due to poor installation practices.

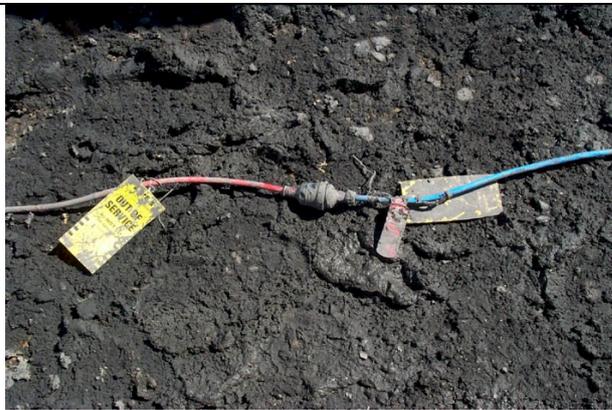
Leads not suitable for the environment and poorly installed

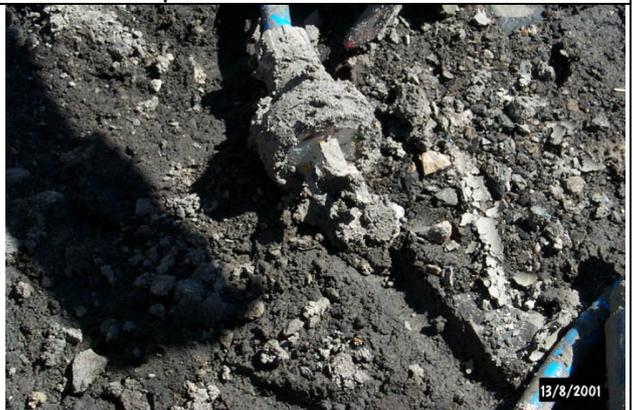
Plug not suitable for the environment, poorly installed and poorly maintained

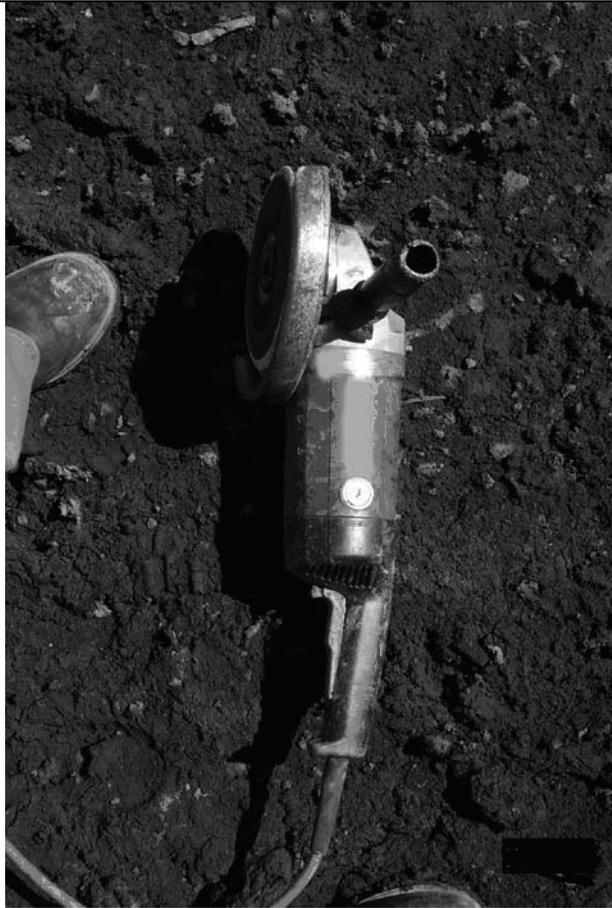
Angle grinder not suitable for the wet and muddy environment

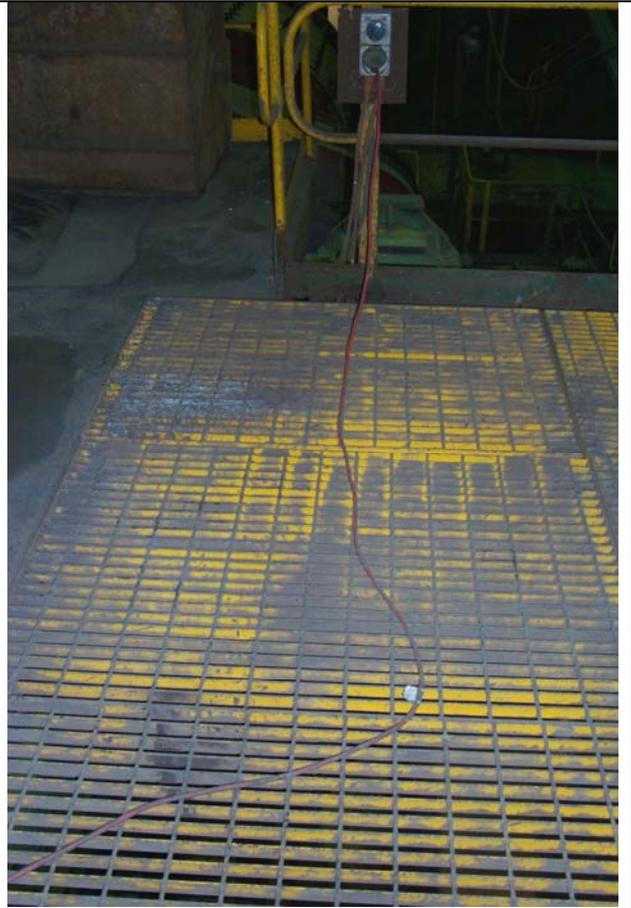
Extension lead poorly installed
