# MINE SAFETY INVESTIGATION UNIT

INFORMATION RELEASE

## Serious injury

<b>Date</b>	Incident occurred on 7 December 2011
<b>Event</b>	Person crushed between telehandler/forklift and delivery truck
<b>Location</b>	Tasman Underground Coal Mine, Newcastle, NSW

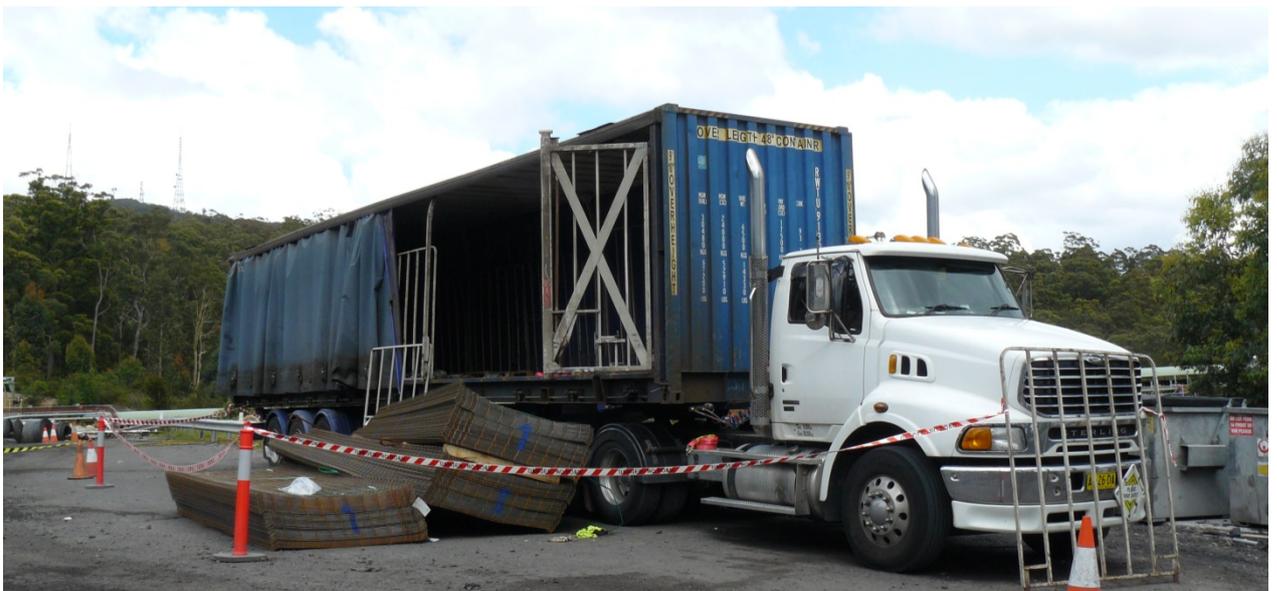
A delivery truck driver received serious spinal and pelvic fractures when he was crushed by steel mesh being unloaded from his truck by a telehandler/forklift.

- A telehandler was being used to unload roof mesh from a delivery truck.
- The attempted load was at the limit of the machine's capacity.
- The truck driver moved between the suspended load and the truck.
- The load slid forward from the tines and crushed the truck driver against the truck.
- There are important observations for all mine operators.

The overall dimensions of the bundles of mesh meant that the effective centre of the load was 0.125 metres past the centre of the forks.

This reduced the effective lifting capacity of the load from 4 tonne to 3 tonne, meaning that the three bundles of mesh being lifted were at the outer limit or beyond the rated capacity of the machine.

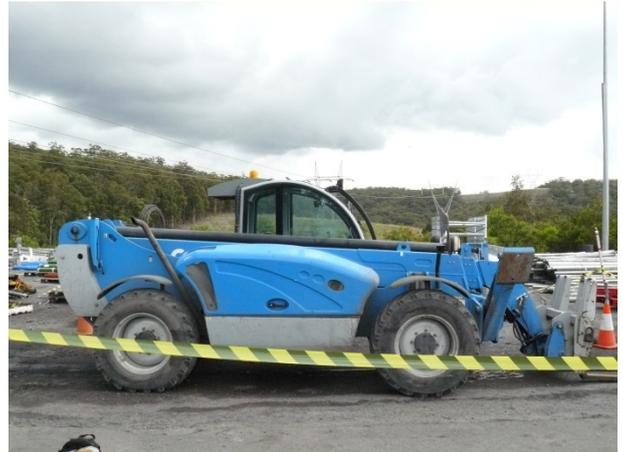
The mine deputy undertook to unload the truck using the mine's telehandler, which is a multi-purpose materials handling machine (pictured).
