SAFETY ALERT

DATE: APRIL 2019

Non-metallic materials add fuel to underground truck fire

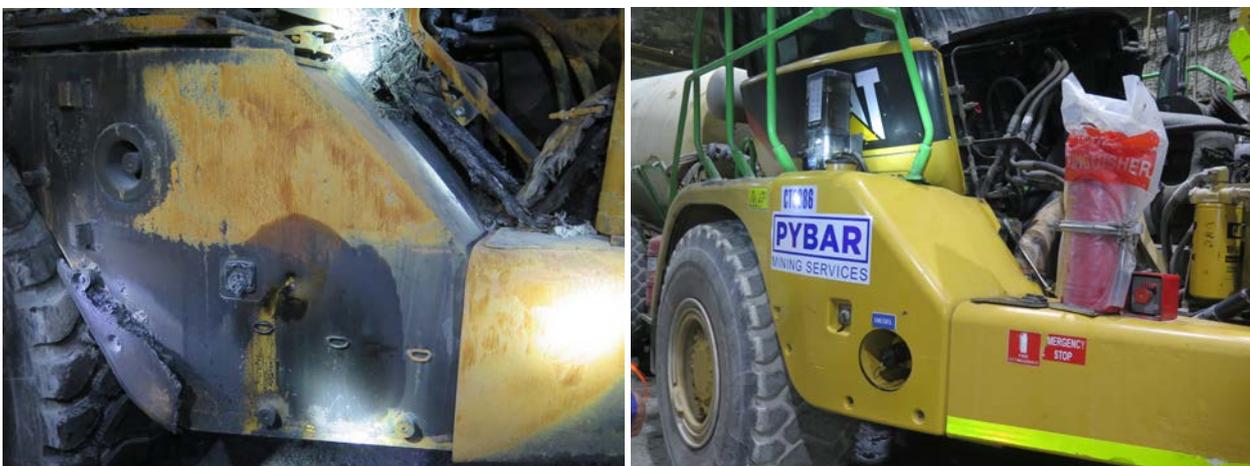
The truck's fuel tank was punctured, allowing diesel fuel to escape. The truck was being driven down the decline. At a local up-grade, the operator noticed additional drag on the engine and towards the top of the local climb the operator discovered a fire. The operator managed to escape from the truck without injury.

Figure 1 and 2: Damaged fuel tank with non-metallic cover consumed by fire

Designers should minimise the use of non-metallic materials that burn and produce toxic emissions.

Trucks that are not specifically designed for underground conditions may require further scrutiny to ensure that there is suitable protection from ribs/walls for fuel and hydraulic tanks.

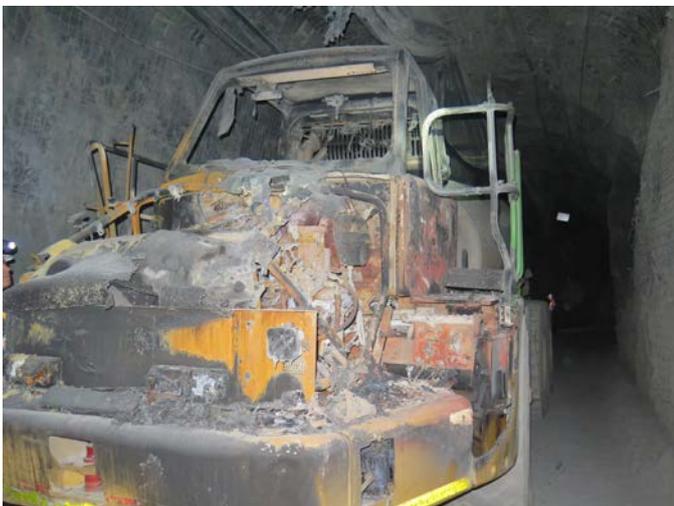
Non-metallic, non-fire resistant materials were used for covers, guards, and components.

Figure 3: Damage to the burnt guards and bonnet

The fire suppression system design should include reasonable provision to cover non-metallic materials where these materials are used.

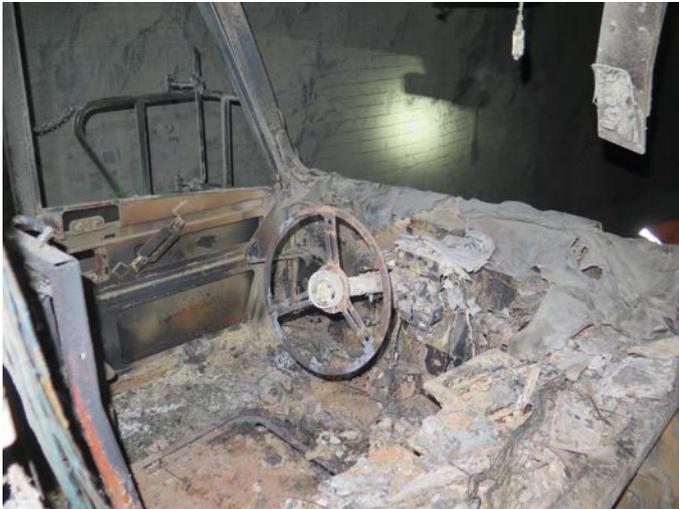
The fire suppression system nozzles were only targeting hot surface ignition in the engine bay. The truck contained substantial non-metallic fuel loads adjacent to the engine bay, in sound suppression materials, and in the operator cabin, and the suppression system was not capable of extinguishing the fire.

Figure 4: Non-metallic materials in cabin affected by fire
