SAFETY BULLETIN

Fluid injections result in surgery

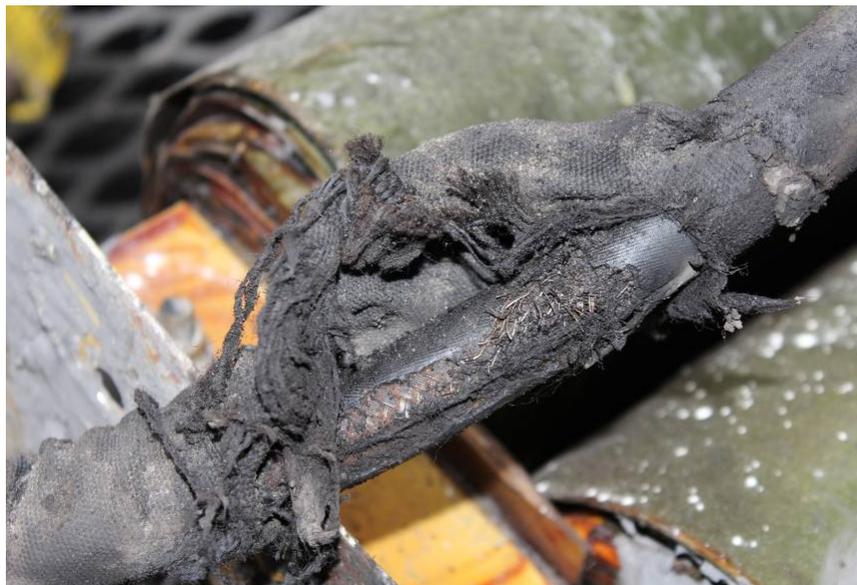
The worker was operating the right hand inner bolting rig on a continuous miner. He was lowering the bolting head to the floor after installing a roof bolt and went to remove the drill dolly (bolt tightening device) from the drill head chuck. As he reached down to remove the dolly, a hydraulic hose burst, injecting fluid into his right forearm. (see figure one)

- External wear and abrasion on the exterior case of the hoses
- Corrosion

Figure one – Hose failure through external wear and abrasion

1. Implement a hydraulic hose management system that includes:
 - a. reviewing hose layout, routing, protection and support methods.
 - b. an inspection and replacement schedule for hydraulic hoses to determine frequency and identifying their condition for replacement.
 - c. a Trigger Action Response Program (TARP) to identify when to change hydraulic hoses based on hose condition.
 - d. reviewing maintenance schedules and checking lists in relation to the testing and recording of hydraulic system condition against original equipment manufacturer specifications.
2. Review isolation and safe work procedures relating to identifying and changing out unserviceable hydraulic hoses.
3. Ensure workers using hydraulic systems are trained in these areas for each item of hydraulic plant.

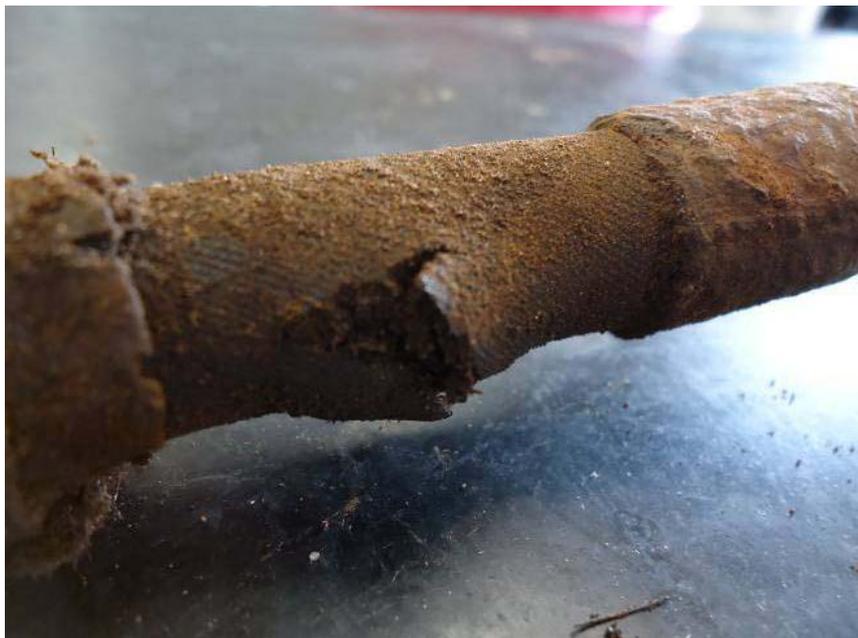
A fitter was attempting to identify a blown hydraulic hose on an air track bolter. The fitter was moving hoses out of the way with his left hand and at the same time operating a hydraulic lever with his right hand. While doing this he suffered an oil injection injury to his left hand ring finger. (see figure two)

- Bend radius insufficient
- Poor hose inspection
- No scheduled change out program implemented
- Hydraulic pressure control, identification and testing not to original equipment manufacturer requirements
- Management of isolation and identification of failed components
- Human error

Figure two – Hose failure through corrosion and too tight bend radius

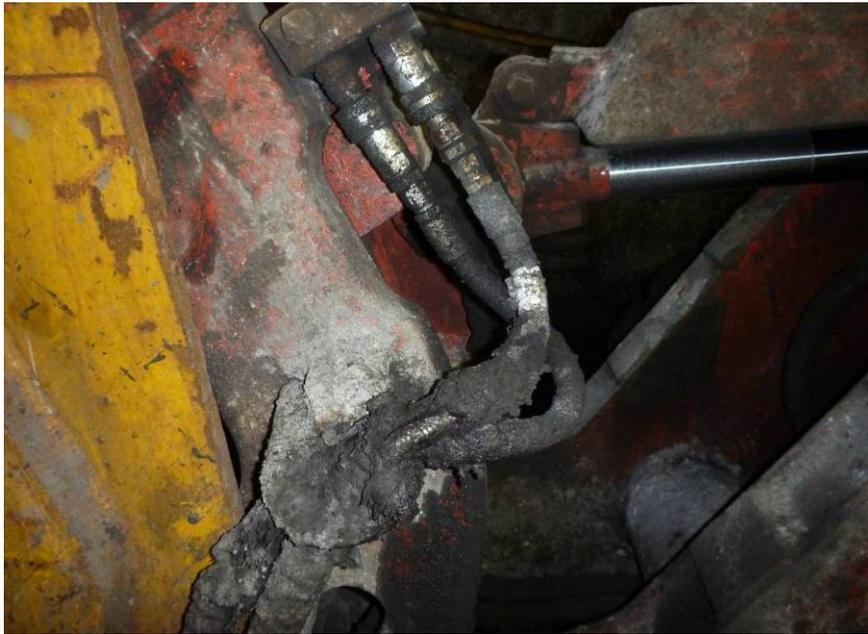
Figure three – External wear and abrasion
