INVESTIGATION INFORMATION RELEASE

Worker receives crush injury to foot from hydraulic stabilising jack on jumbo rig

Incident date: 15 September 2020

Location: CSA Mine, Cobar, NSW

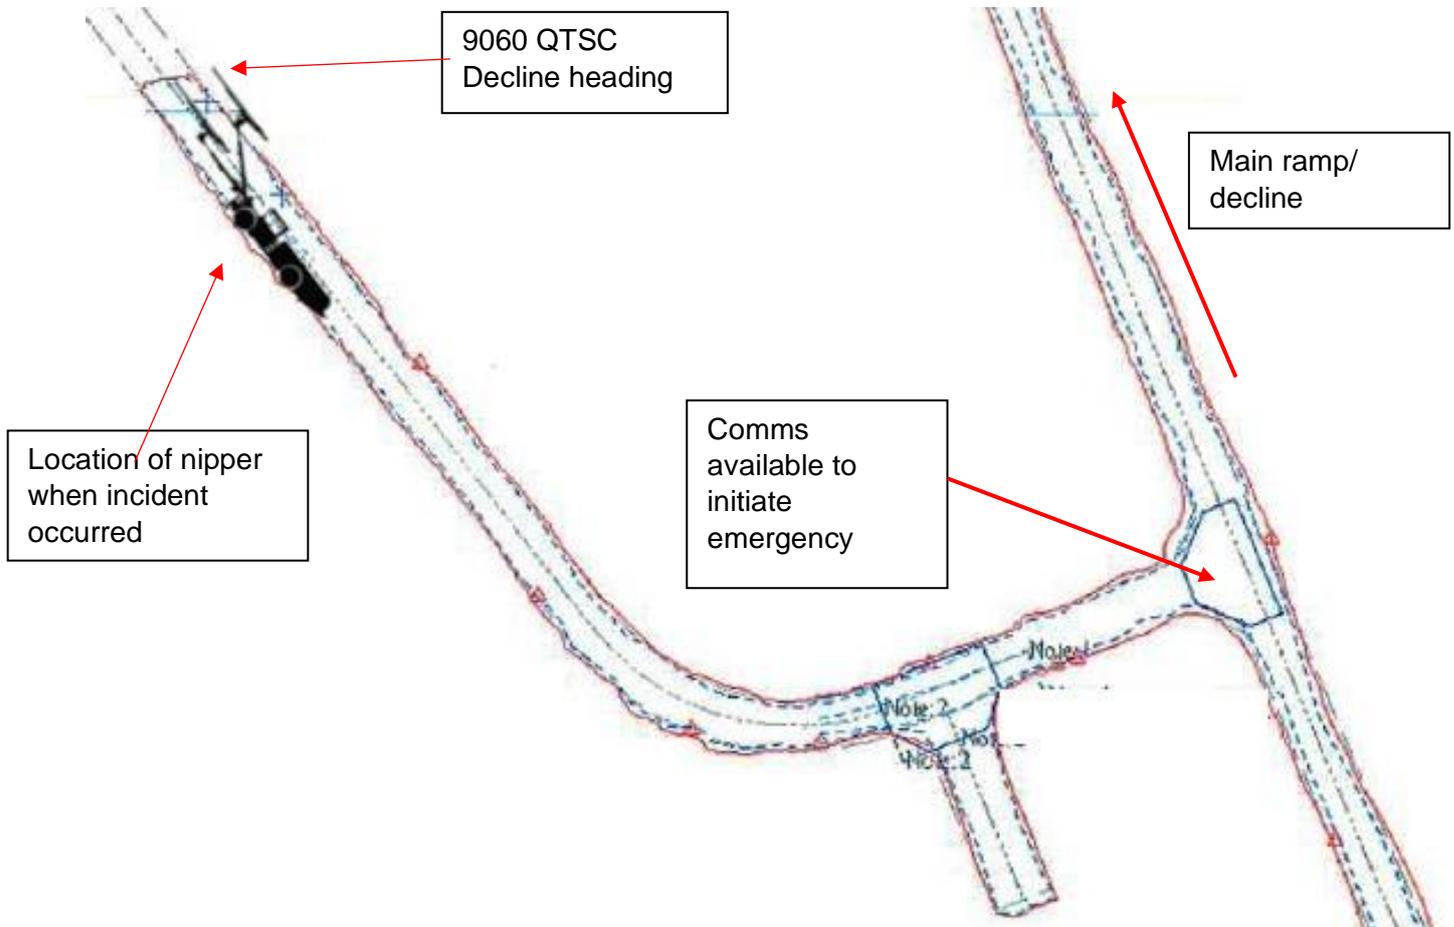
On the morning of 14 September 2020, a Sandvik DD421 Twin Boom Development drill rig (jumbo) was installing ground support to enable progression of the 9060 QTSC Decline Heading (see figure 1). The task was being carried out by two contract workers, an experienced driller and a driller's offsider (nipper) with four months experience in the role. The jumbo was introduced to site from another mining operation and an inspection was conducted on the jumbo on 13 February 2020.

Figure 1. Level plan showing location of jumbo

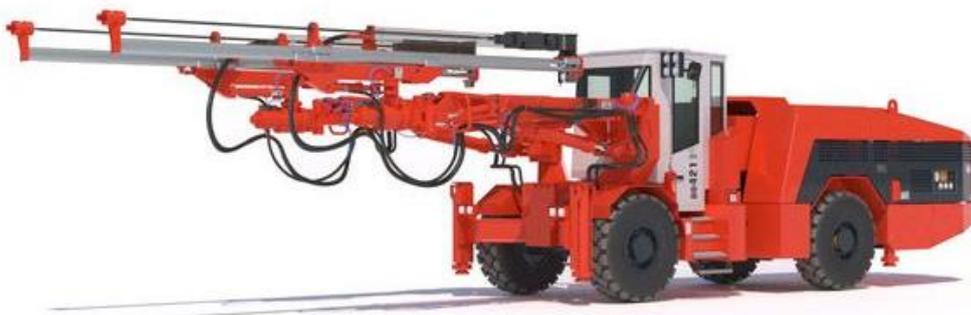
The original equipment manufacturer placement of the pump outlet / receptacle has changed with this version of the DD421 drill rig involved in the incident. The change in position was due to the positioning of the Telescopic Feed Extension (TFX) valving near the tombstone and mounting of the laser barrier (jumbo guard/ boom stop) devices at the rear of the front wheel arch, limiting real estate. Older versions of the DD421 drill rig had the pump outlet / receptacle nearer the cab, at the rear of the front wheel arch. Previous version positioning meant that workers were not exposed to the risk of crush injuries by the jack leg. Figure 6 shows an unmodified DD421 drill rig.

Figure 6. the DD421 development drill rig, colloquially known as a jumbo. (Renderhub/ ArqArt)

- Relocation of 1000 volt outlets on affected plant to an area that does not introduce additional hazards.
