**NSW
Resources
Regulator**

NSW mining dredges
Planned inspection program

Title: Consolidated report: NSW mining dredges

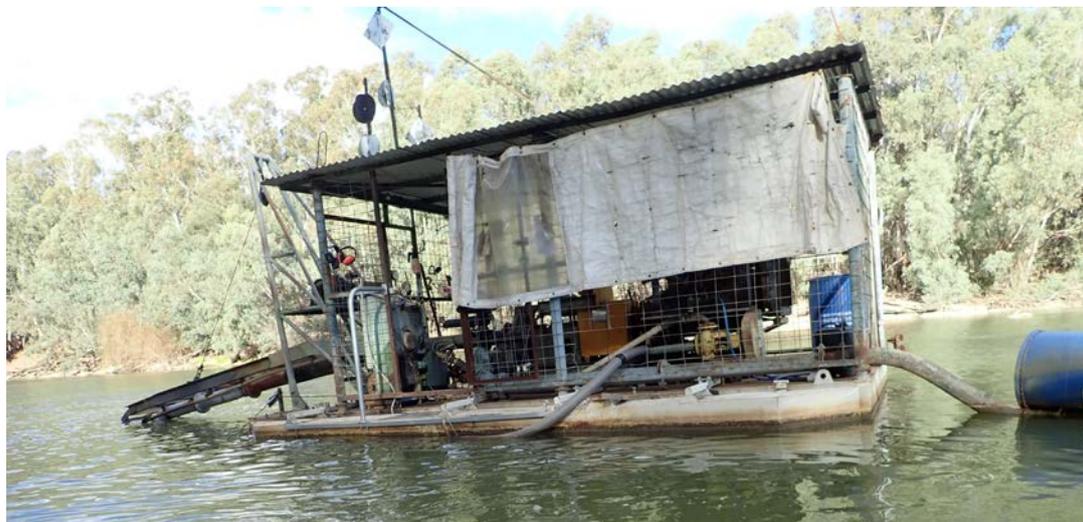
Figure 1: Dallas Sand Pump, Murrumbidgee River Whitton NSW. Photography by Resources Regulator inspectors.

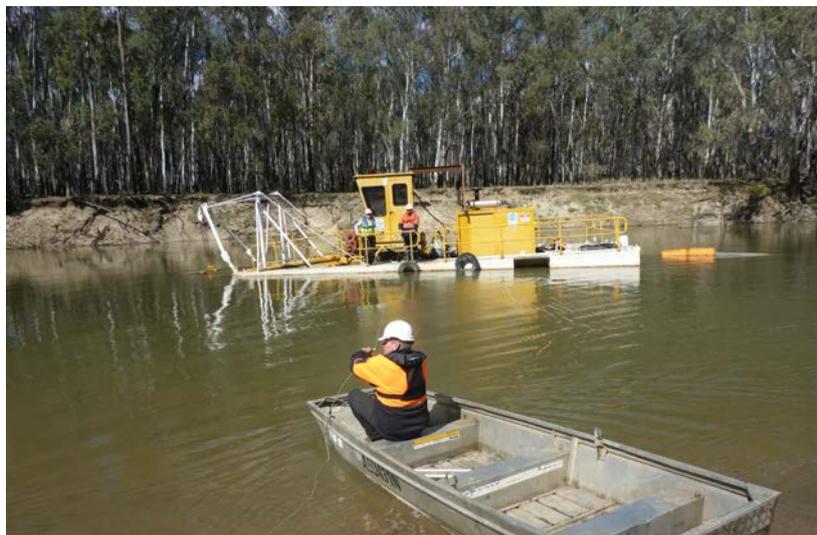
Figure 2: APM Sands Riverblock, Murrumbidgee River, Leeton NSW. Photography by Resources Regulator inspectors

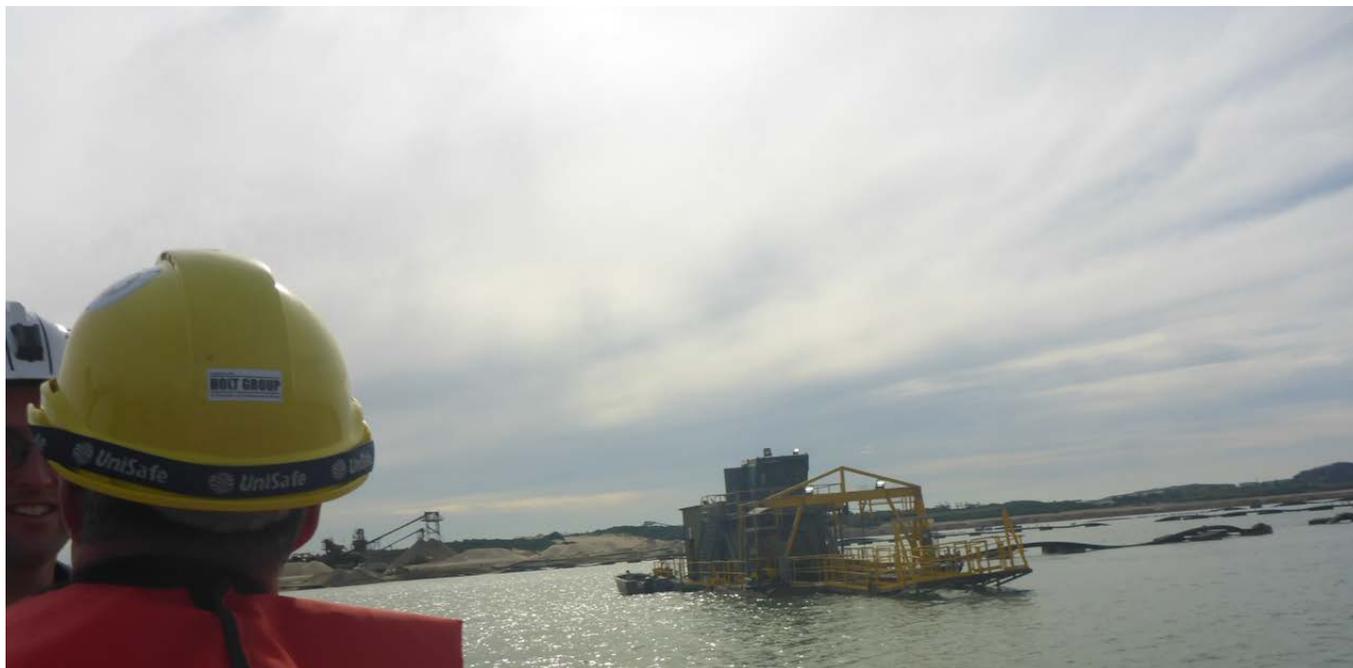
Figure 3: Allsands Mine (enclosed pond) Kurnell NSW. Photography by Resources Regulator inspectors.

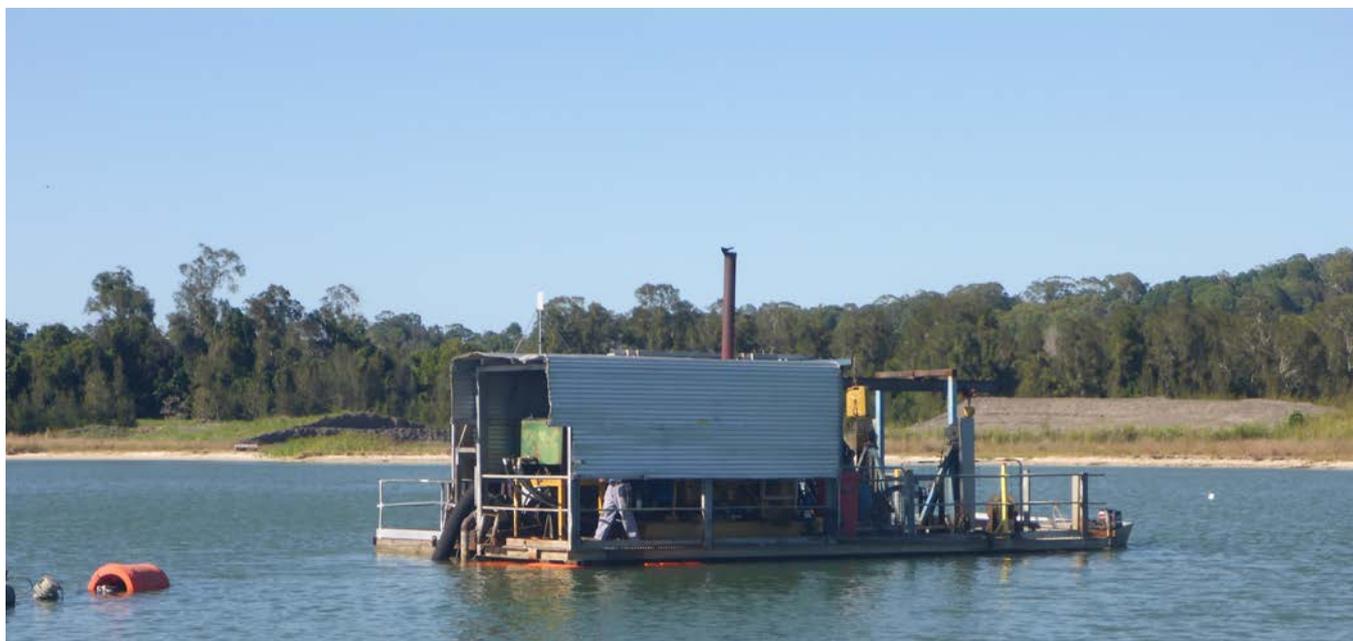
Figure 4: Hanson Tweed Sand Quarry (enclosed pond) Cudgen NSW. Photography by Resources Regulator inspectors.

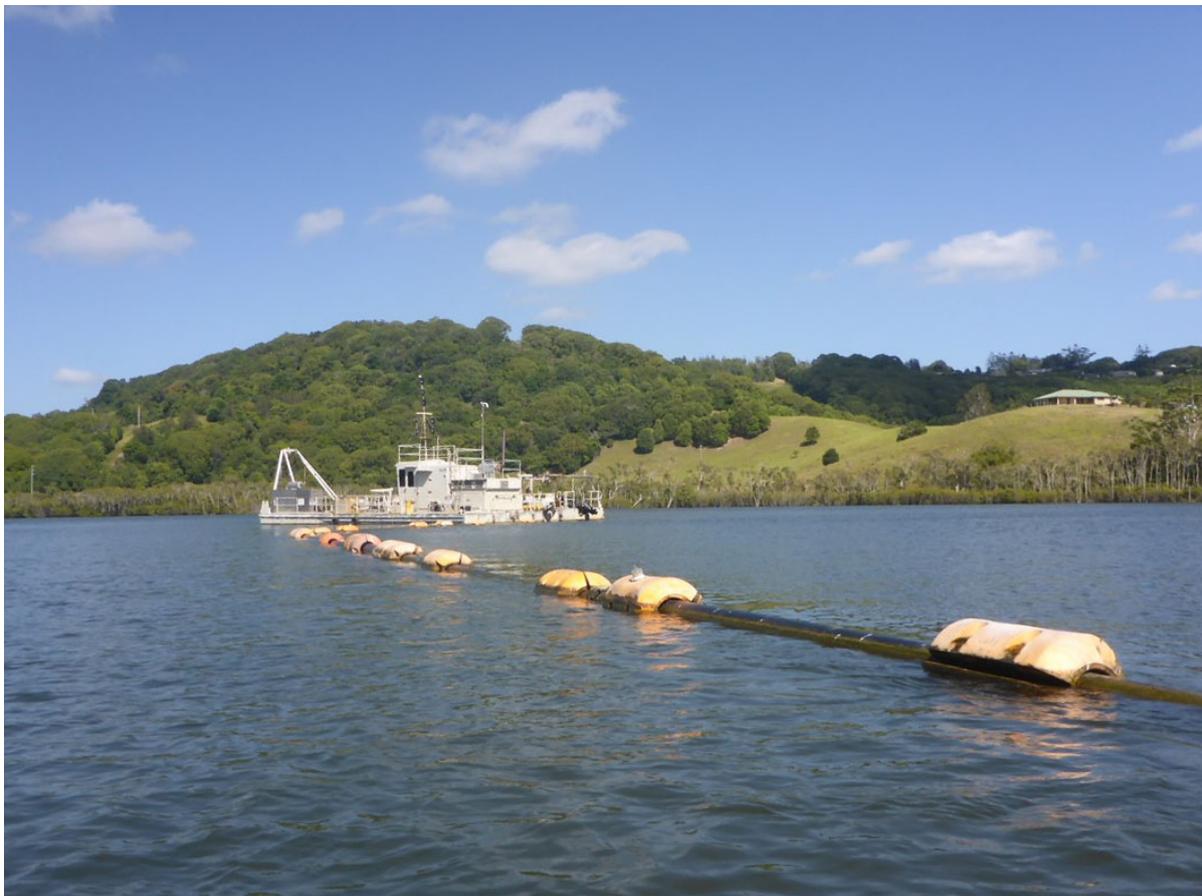
Figure 5: Action Sands, Tweed River, Chinderah NSW. Photography by Resources Regulator inspectors.

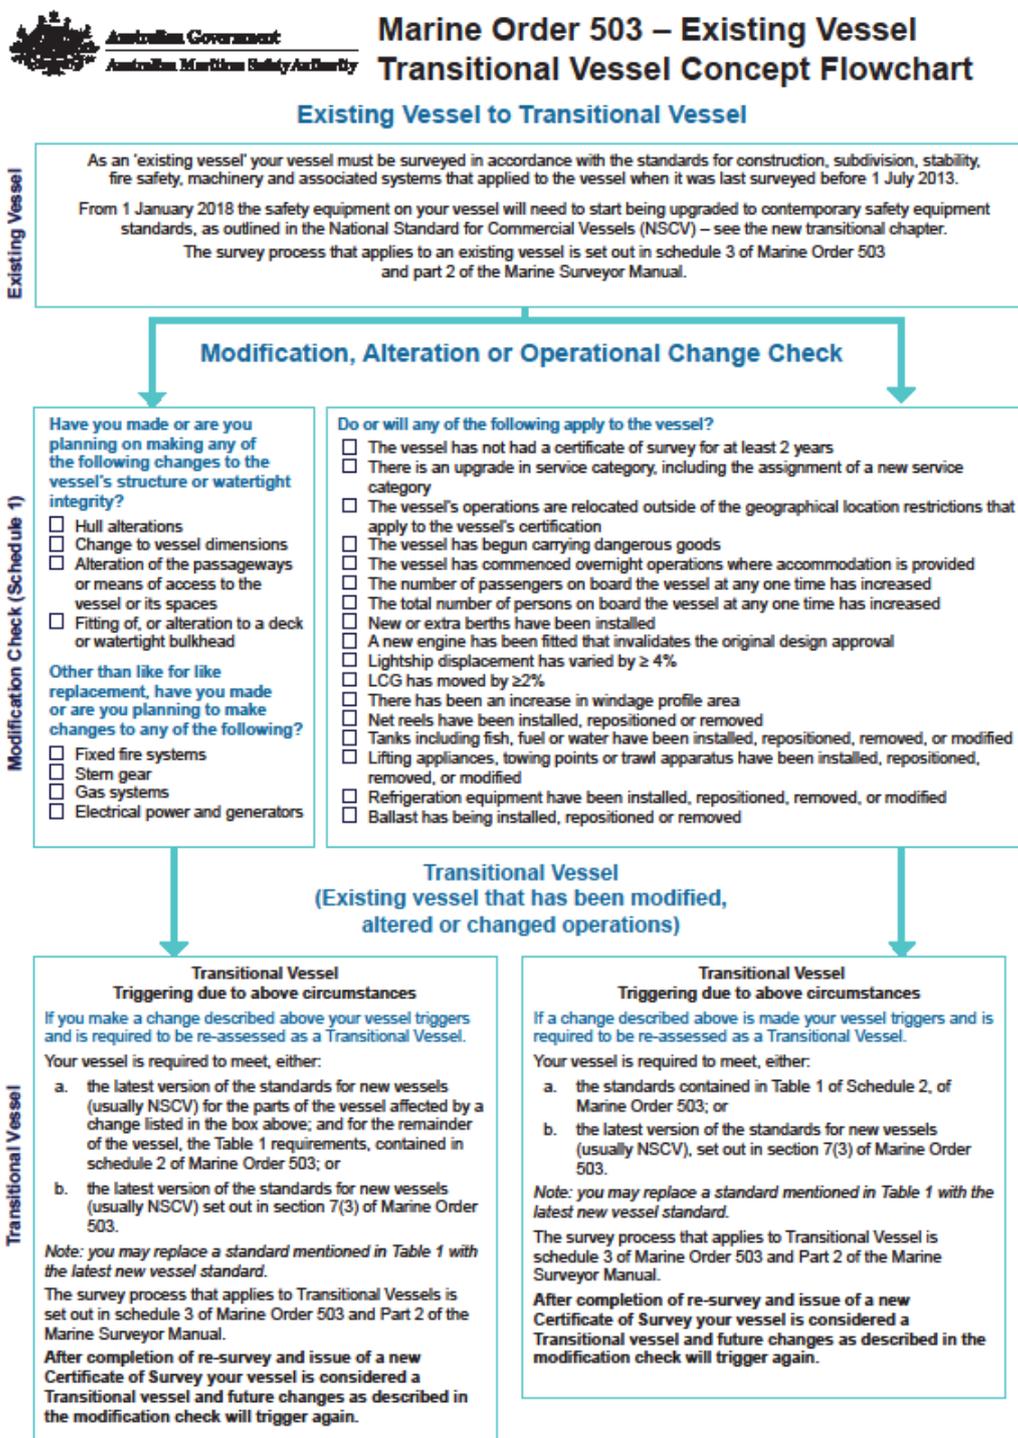
Appendix 4 – Marine Order 503 flowchart

Flowchart can be found on the AMSA website: <https://www.amsa.gov.au/sites/default/files/amsa241.pdf>
