# SAFETY ALERT

**DATE: April 2020**

## Worker sucked into auxiliary fan ventilation tube

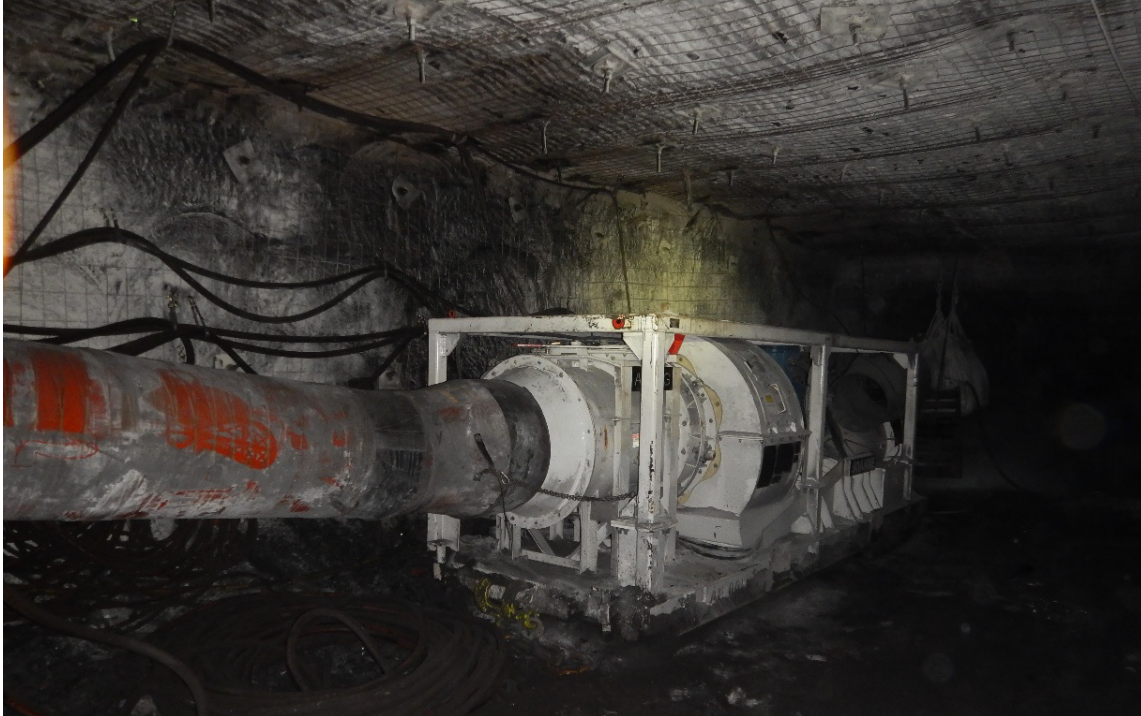
*Figure 1 The auxiliary fan*

The auxiliary fans specifications were 200KW and 26 m<sup>3</sup>/s open circuit capacity. The variable inlet vanes (VIVs) were set at 13 m<sup>3</sup>/s and 618 millimetre diameter tubes were being used.

The photographs in figures 1 and 2 show the auxiliary fan and the ventilation ducting involved with the incident.

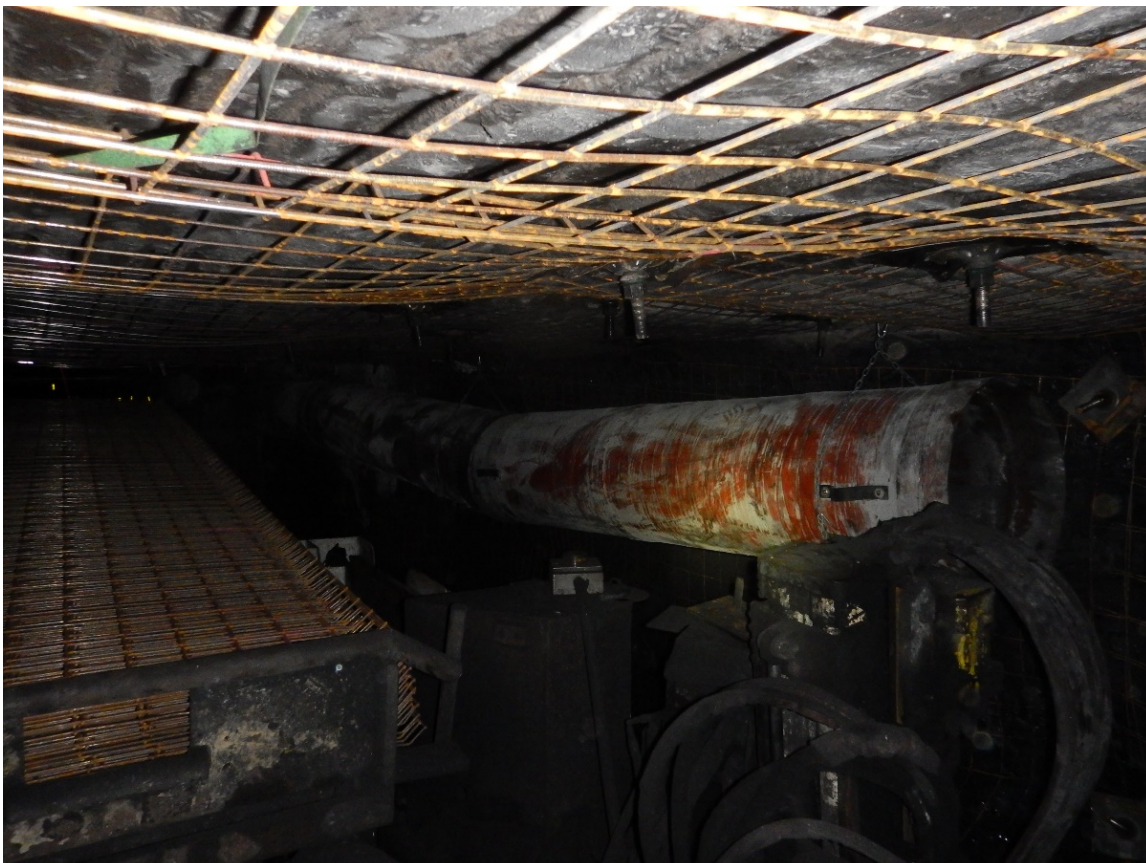
*Figure 2 The incident scene at the mine face*

A mine worker, who was installing an auxiliary fan ventilation tube, was sucked into the end of the tube. Due to the pressure around his neck, the worker briefly lost consciousness.

The ventilation duct run was about 90 metres to the face. The run included a 90 degree elbow and an inline T-piece with an end cap fitted.

- There was no determination regarding the safe operating range of the auxiliary fan (in terms of air quantity, air velocity or pressure) to allow for safely adding of ventilation ducting.
- There was no procedural detail about where the air velocity reading should be taken (i.e. 10 metres behind the miner or at the duct itself) and at what frequency.
- The procedure lacked detail about safe standing zones.
- The process steps for workers to install ventilation tubes safely required further development.
- There were no details about guarding requirements of the most inbye tube to protect loose items and debris being sucked into the duct or workers being sucked into or against the duct while working in close proximity (such as working on continuous miner platforms).

- Mine operators should review their auxiliary fan operational risk assessments (for each type of auxiliary fan in use at each site) and ensure the risks to health and safety for people working in close proximity to ventilation ducts during installation, operation, maintenance and repair are identified and controlled. The specific hazard identified with this incident (workers being drawn into or against the ventilation ducting) should be considered.
- With the review of risk assessments above, mine operators should implement controls in accordance with the hierarchy of control measures as required in clauses 35 and 36 of the Work Health and Safety Regulation 2017.
- The operating range of auxiliary fans (i.e. VIV settings) should be determined through modelling and testing, to ensure the ventilation tubes can be added into the circuit without

risk to workers being sucked into or onto the end of a tube while clearing gas, dust, and diesel exhaust pollutants, as well as preventing recirculation.

- The location used for monitoring ventilation performance and hence determining any change in fan operational parameters must be formalised in the mine's safety management system (for example – the procedure for auxiliary fan operations).
- Safe standing zones and the detailed process steps to safely install ventilation ducting should be formalised and documented in the mine's safety management system.
- The relevant sections of the workforce should be trained and refreshed (at a frequency determined by the mine) in the safe operation of auxiliary fans on site – including the installation/extending of ducting.
